Groundwater Contamination and Sinkhole Collapse

**Induced by Leaky Impoundments
in Soluble Rock Terrain**

**Missouri Department of Natural Resources
Division of Geology and Land Survey**

1972

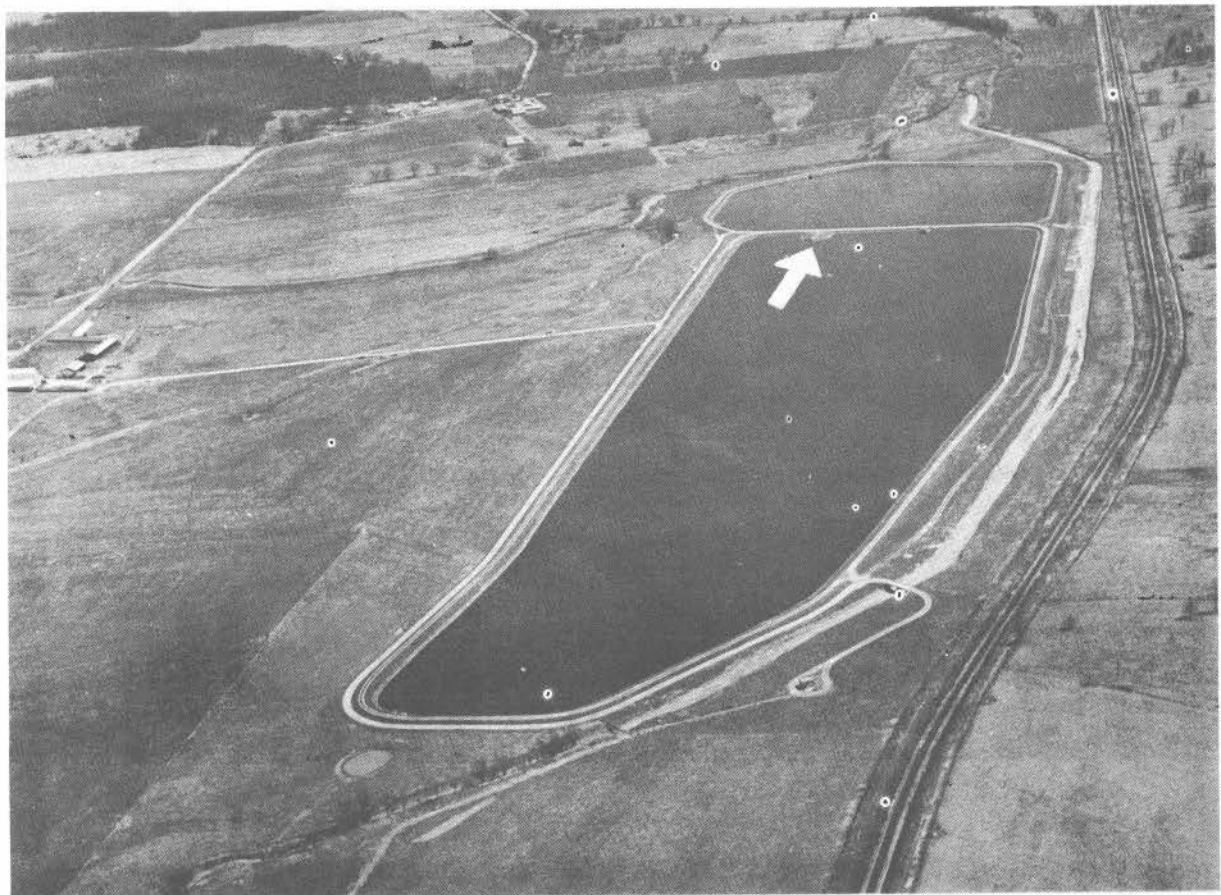
Figure 2

Aerial view of the West Plains sewage lagoon as it appeared in 1971. The area which collapsed in 1966 is shown by the arrow. Photo by Jerry D. Vineyard.

The lagoon system was constructed in 1964 and reached full operation in 1966. The smaller cell, which occupies about seven acres, collapsed in two points in 1964. The larger of these collapses was about 17 feet in diameter and probably 10 to 20 feet deep; the sinks were plugged with cement, clay, and bentonite and reportedly no longer leak.

about 136 acre-feet of effluent at the time of collapse; all the water drained out within 52 hours. Mr. Pace, City of West Plains, reports that the collapse and leakage created a vortex of such size that he was unwilling to get close to it with a boat. This is hardly surprising; the average leakage rate for the 52 hours was 29 cubic feet per second.

The 1966 collapse at the West Plains lagoon was about 34 feet in diameter, and probably 10 to 20 feet deep. This hole was filled with clay and bentonite to the level of the dike wall and the lagoon was returned to use. Mr. Renfrow, formerly Assistant City Engineer of West Plains, reported that he walked about 4 miles of the Howell Creek channel below the lagoon collapse, but found no evidence of lagoon water. There were no reports of well contamination

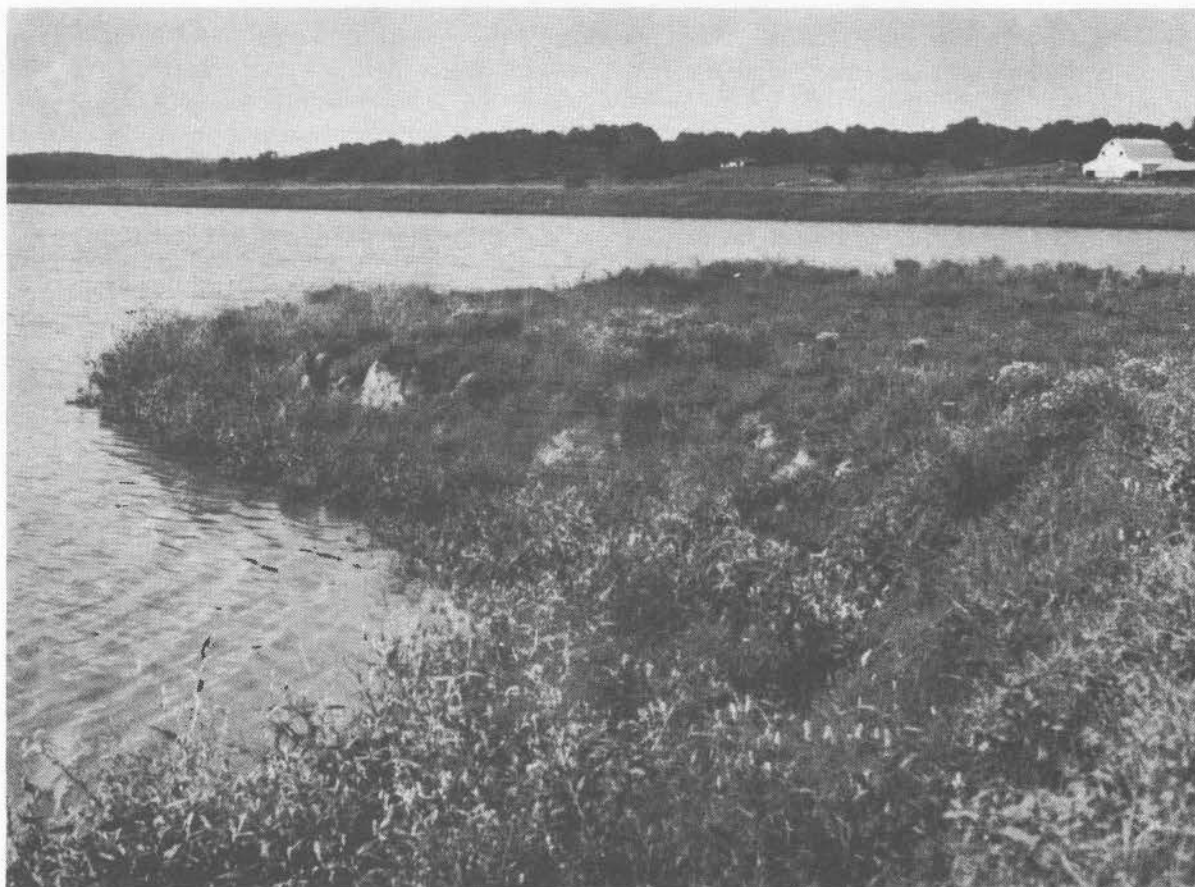
Figure 3

The large cell of the West Plains sewage lagoon. A catastrophic sink occurred in 1966 beneath the peninsula shown in the foreground. Subsequent to the collapse the sink was filled with clay and bentonite and the lagoon was returned to use. Photo by James W. Massello.

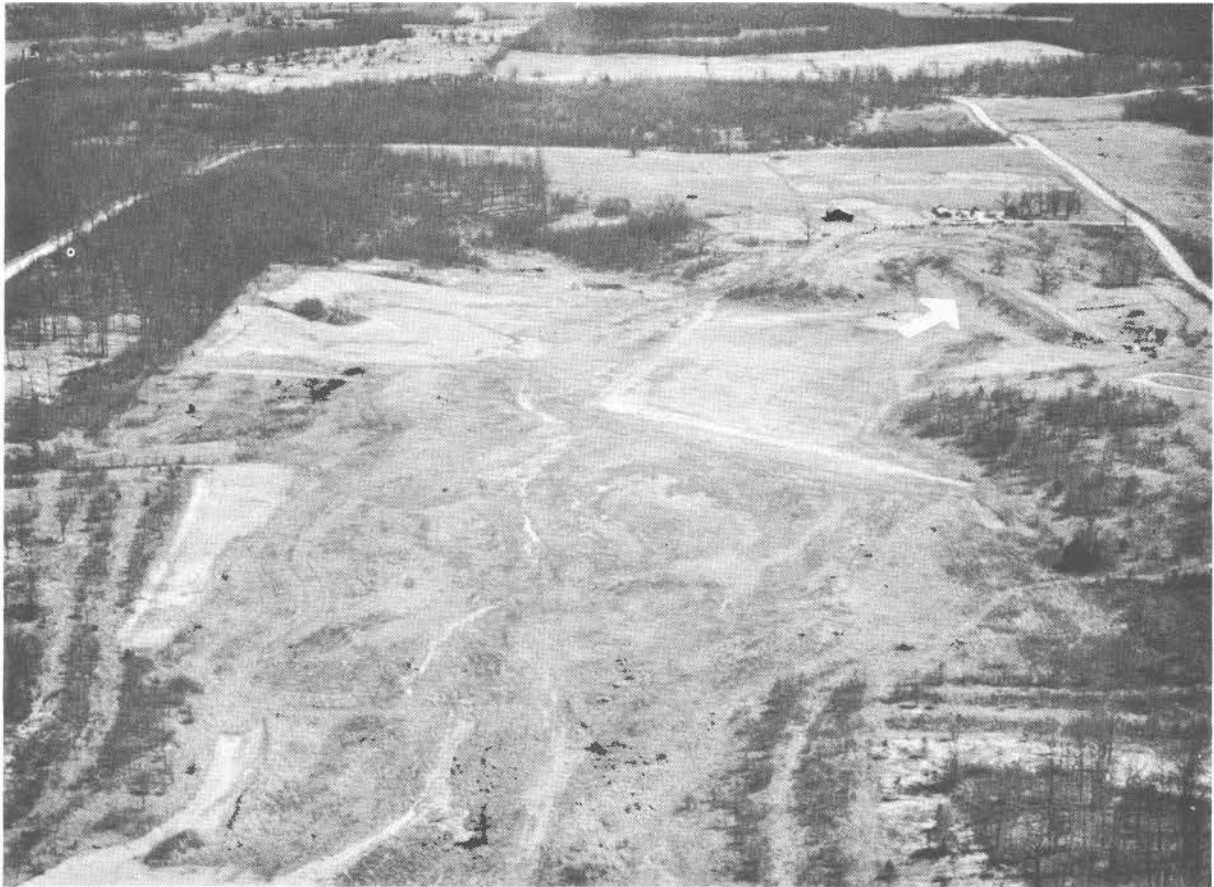
Figure 4

impoundment held a substantial volume of water. Unfortunately, a sinkhole suddenly formed in the floor of the impoundment and drained all the water from the reservoir. Substantial efforts were made to stop the leakage, but they have failed. Personnel of the Missouri Geological Survey report seeing flows of 10 cubic feet per second disappearing underground within the impoundment area.

Aerial view of a portion of the planned impoundment area of the Dean W. Davis Reservoir near Pomona. The arrow indicates the dam. A catastrophic sink formed within 75 yards of the dam and totally drained the impoundment overnight. Extensive attempts to seal the impoundment were unsuccessful. Photo by Jerry D. Vineyard.

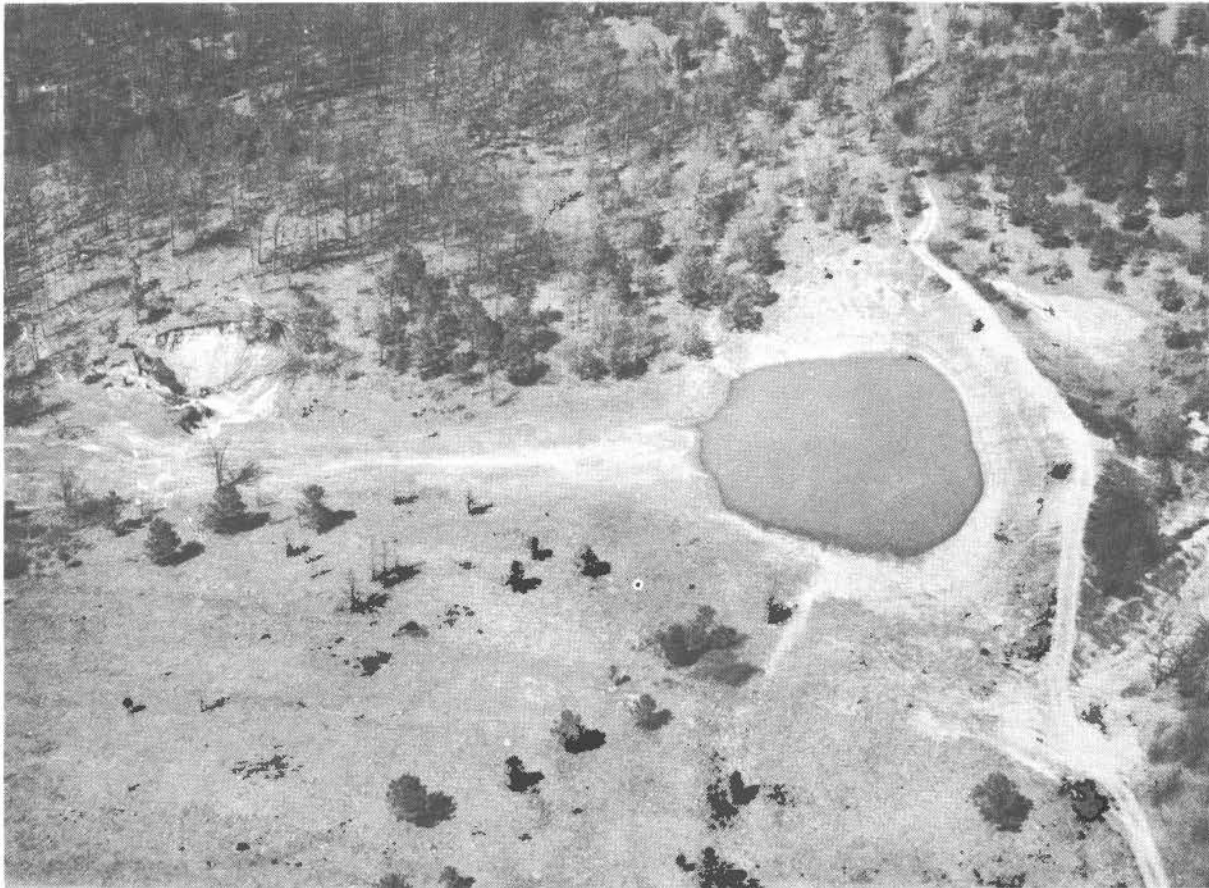
Figure 5

A most spectacular group of collapses induced by construction of an impoundment is found at Norton Dam, 2 miles south of Winona in Sec. 30, T. 27 N., R. 3 W., Shannon County, Missouri (fig. 5). The dam was built on an intermittent stream tributary to Pike Creek. The impoundment site is underlain by deep Roubidoux residuum; there are no bedrock exposures near the impoundment site.

The Norton Dam has been unsuccessful in producing a permanent lake. During storm periods the impoundment will temporarily fill, but the water level falls rapidly to about the original stream

Aerial view of Norton Dam and a portion of the impoundment area. The largest of the four catastrophic sinkholes induced by this impoundment is shown above, in the left-center of the photo. The other three sinkholes lie upstream of the area pictured. Photo by Jerry D. Vineyard.

We are convinced that the Norton impoundment led to the formation of the sinks. The dam has had four effects on water regimens in the valley. The first effect has been to spread flood water over the entire valley floor. The second effect, since the impoundment site leaks, is to induce recharge of groundwater from the impoundment area. This recharge tends to be localized in the more permeable areas, which in turn tends to move fine materials into underlying solution channels and voids. The third effect of the dam has been to make the residuum in

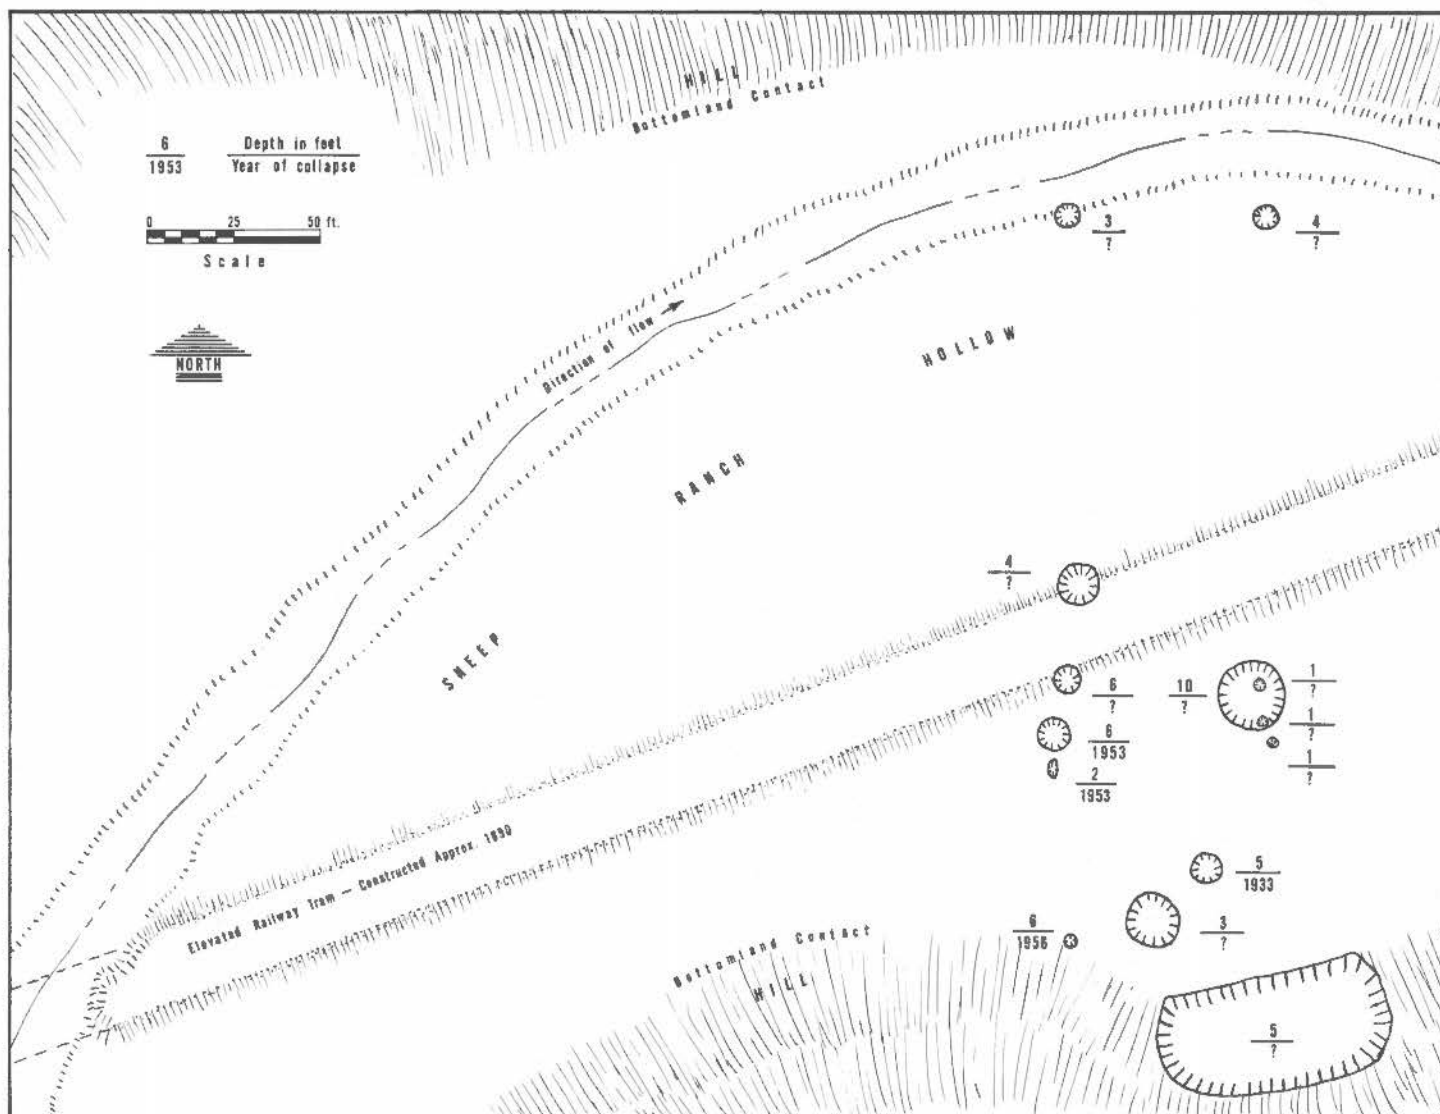
Figure 6

The catastrophic sinkhole collapses which have occurred in Sheep Ranch Hollow (fig. 6) provide an

Sinkhole collapses in Sheep Ranch Hollow induced by construction of a logging tramway in about 1890. Sinkhole sizes were measured in January 1971.
(Illustration courtesy of Mark Twain National Forest)

The sinks are found in two clusters within a ten-acre area. The illustration (fig. 6) shows only the downstream cluster consisting of 13 sinks of recent origin. The upstream cluster includes five recent sinks. Not all of the sinks formed immediately after construction of the tramway. One formed in 1933, two

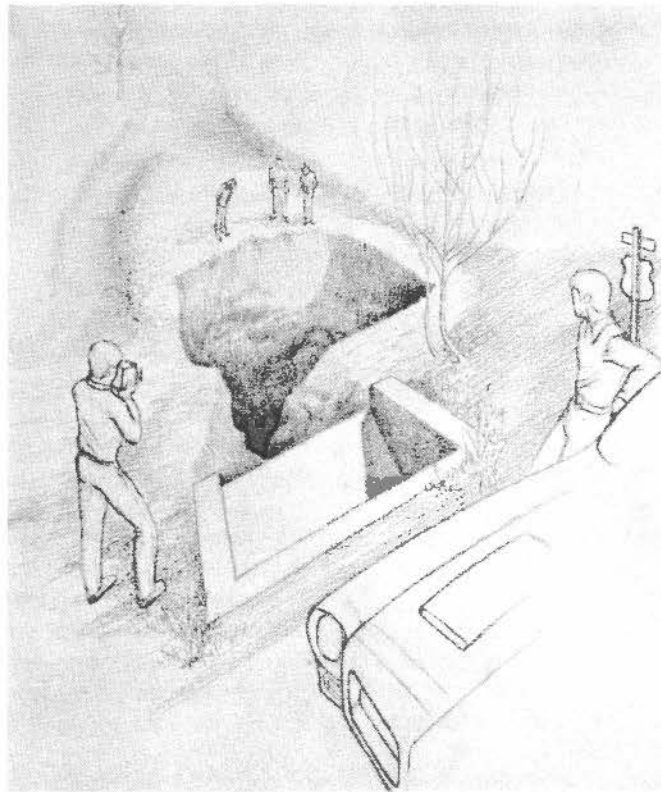
Figure 7

The Buckhorn collapse, Sec. 7, T. 35 N., R. 12 W., in Pulaski County, Missouri formed in spring, 1967 at the end of a box culvert under the westbound lane of Interstate 44 (fig. 7). At this point the highway crosses an intermittent stream valley underlain by Roubidoux residuum. The Buckhorn collapse was induced by runoff from the culvert.

When first inspected in 1967, the sink was about 20 feet in diameter and 22 feet deep. At this time a small cave could be entered from the sinkhole, and this led to a debris chamber in the residuum directly beneath the 45-foot high highway fill. Collapse of the highway in this area is a distinct possibility; the collapse which occurred in 1967 was induced by changes in the water regimen of the valley.

Catastrophic collapse occurred near Buckhorn, in the streambed of Collie Hollow, at the north end of a box culvert beneath Interstate 44. The resulting sinkhole was about 30 feet deep and accepted the entire flow of the stream until filled by the Missouri State Highway Department. Drawing by Douglas R. Stark, from a photograph by Jerry D. Vineyard.

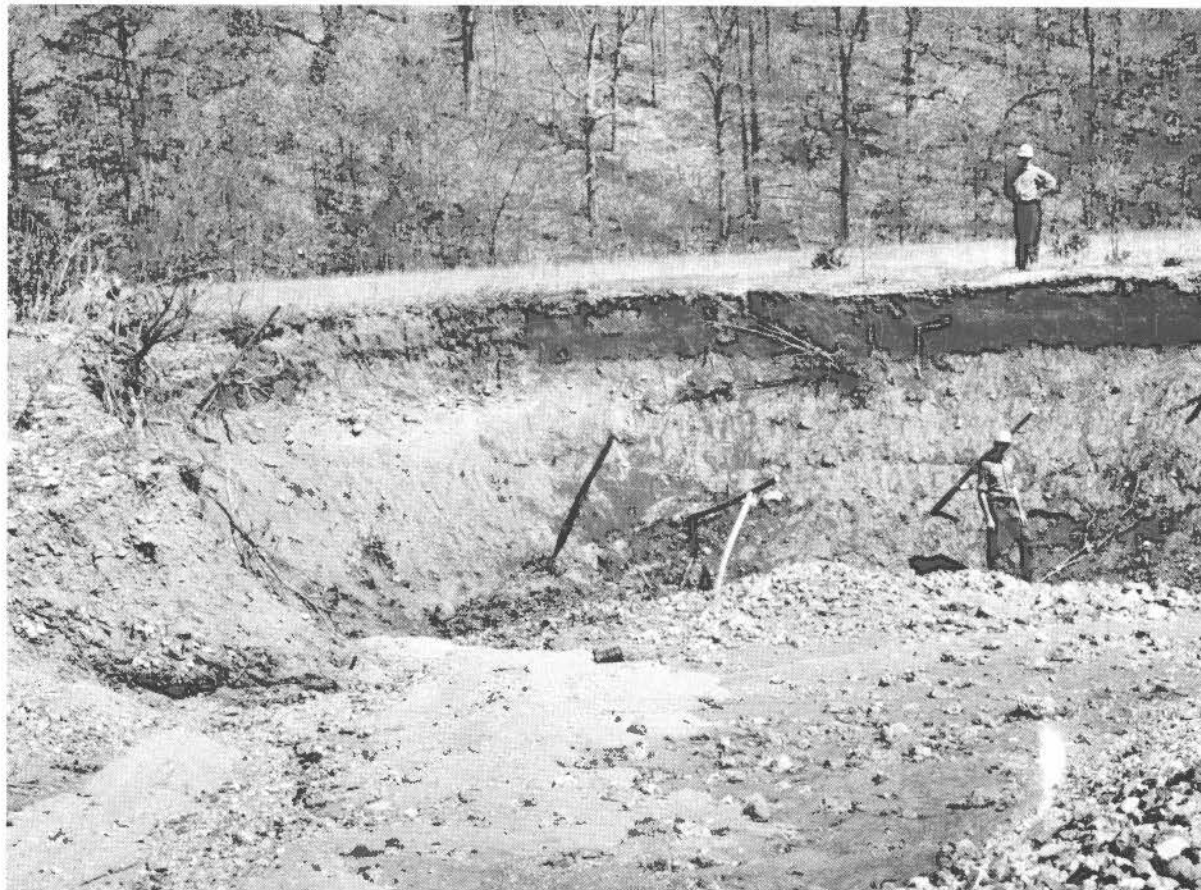
Figure 8

The sink was visited about two weeks after it formed, and at that time it was about 25 feet in diameter, 60 feet deep, and nearly cylindrical in shape. By 1968 (fig. 8) stream gravels had nearly filled the sink; in a few years most, if not all, of the topographic expression of the sink will have disappeared.

Sycamore Creek Sink two years after its formation. The sinkhole has been nearly filled with sand and gravel transported by Sycamore Creek. Photo by James W. Massello.

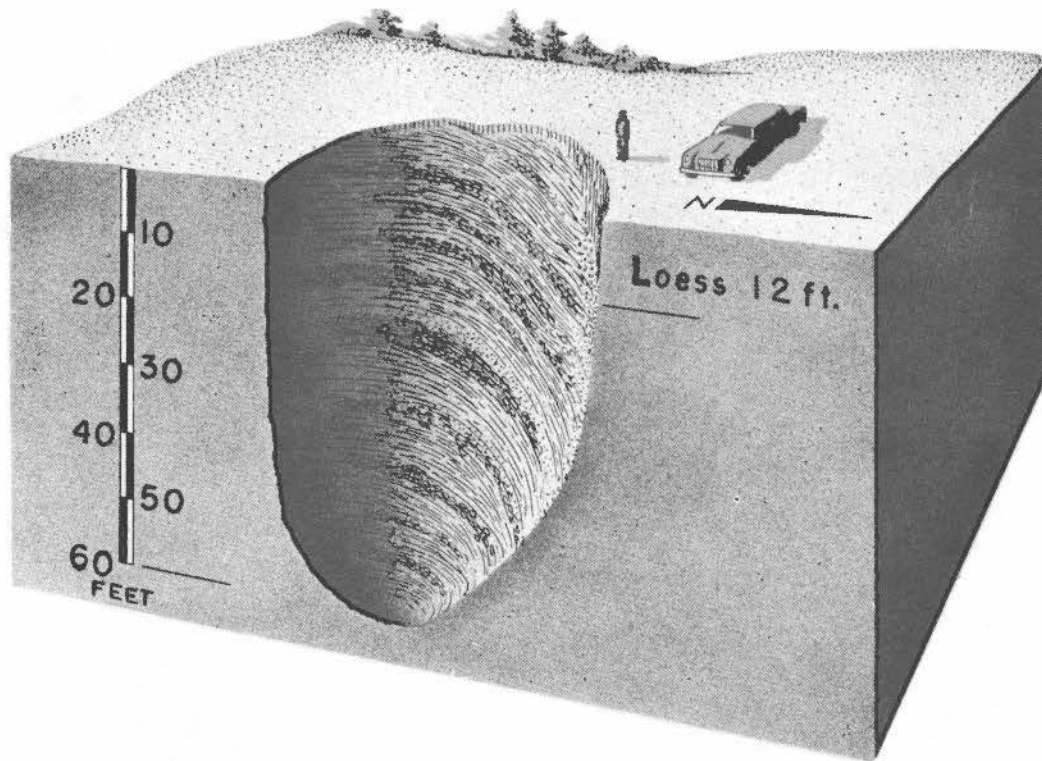
Figure 9

When the sink was first visited on April 10, 1964 it was 42 feet in diameter and 60 to 65 feet deep. The sink was cylindrical and had 10 to 15 feet

of water in the bottom (fig. 9). Vineyard and Williams (1964) suggested that the sinkhole collapse may have been triggered by the Alaskan earthquake of March 27, 1964.

Block diagram of a collapse sink that formed near Lebanon, Mo. contemporaneously with the Alaskan earthquake in March 1964. Apparent bedding is in residuum of the Roubidoux Formation. Drawing by Douglas R. Stark.

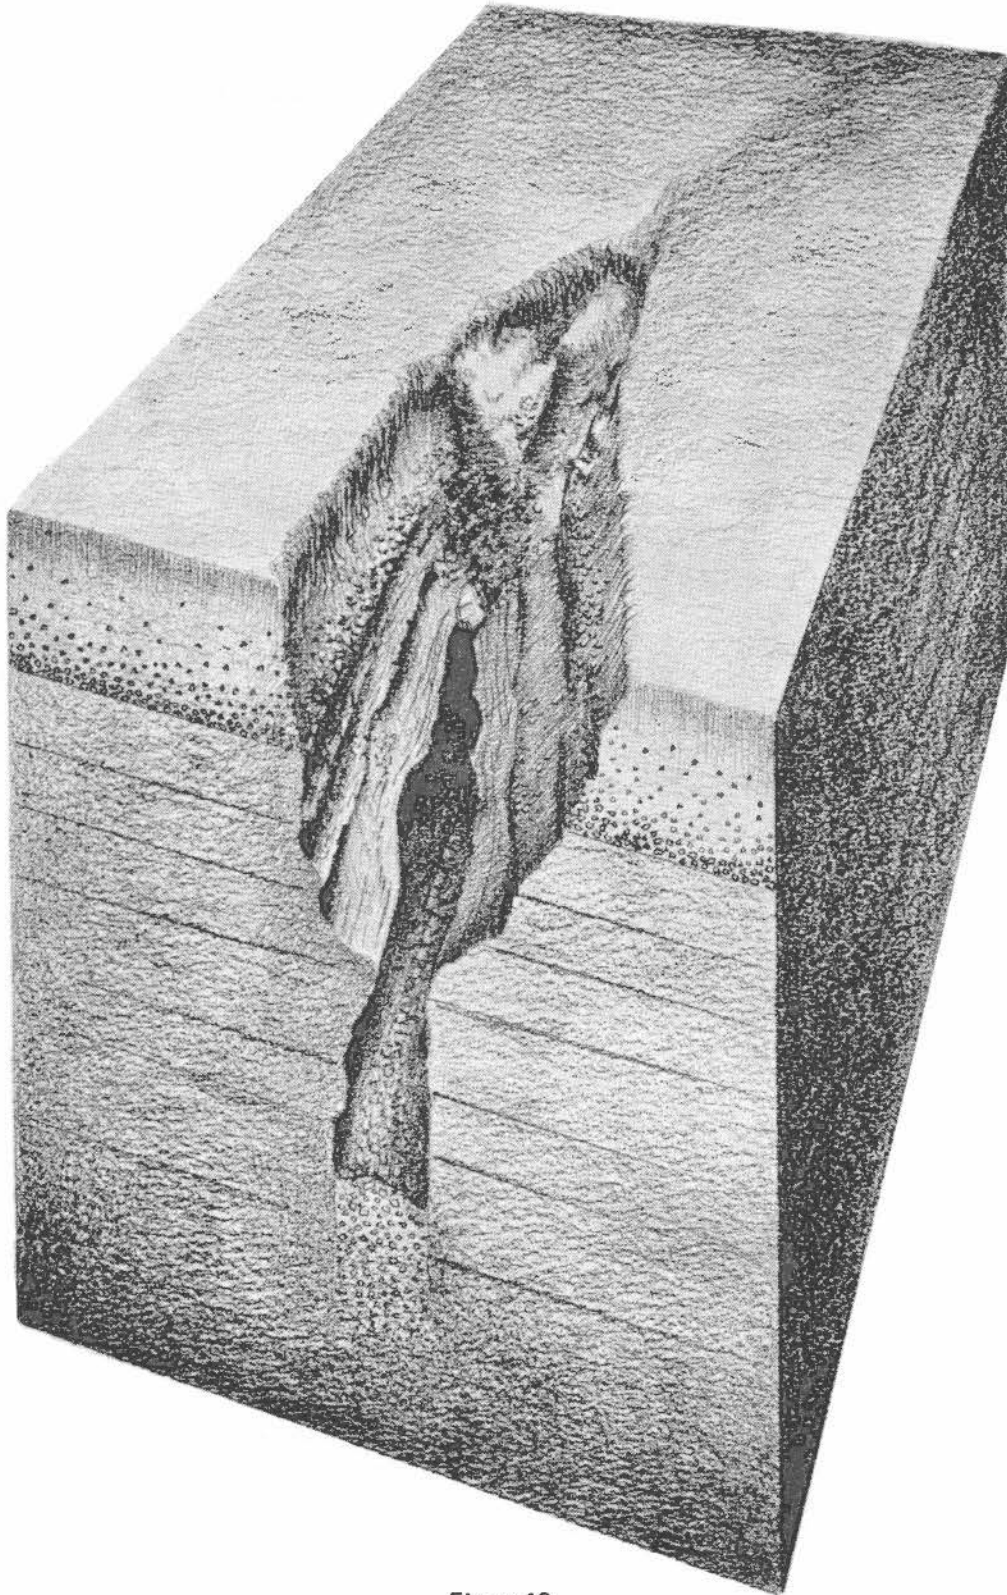
Figure 10

A third example of sinkhole collapse apparently unrelated to man's activities is the Racetrack Ridge collapse near Rueter, Taney County, Missouri, in Sec. 8, T. 22 N., R. 17 W. The sink formed in the 1960's and is about 80 feet long, 40 feet wide, and 60 feet deep. Its orientation is identical with the trend of the losing stream beneath which it has formed (fig. 10). The sink is in an area with shallow soils and numerous rock outcrops assigned to the Jefferson City-Cotter

formation; in this regard it differs from most of our other case histories, with the exception of those at Farmington. Although bedrock is exposed on the sides of the sink, there is no bedrock exposed at the ends of the sink. The senior author has explored several caves in the vicinity which also have residuum ceilings. The caves are typically narrow, vertical passages 2 to 20 feet wide and up to 60 feet high. The Racetrack Ridge sink is apparently an unroofed cave of this type.

Racetrack Ridge collapse. This sinkhole was formed by the collapse of residuum into a solutional void in the bedrock. A portion of the original void still exists and can be entered from the bottom of the sink for about 20 feet. Drawing by Douglas R. Stark from photos by Thomas J. Aley.
