# Groundwater Contamination and Sinkhole Collapse

Induced By Leaky Impoundments

In Soluble Rock Terrain

*Aley, Thomas J., James H. Williams and James W. Massello, 1972, Groundwater contamination and sinkhole collapse induced by leaky impoundments in soluble rock terrain: Mo. Geol. Survey and Water Resources, Engineering Geology Series No. 5, 40 p., 10 figs., 1 tbl.*

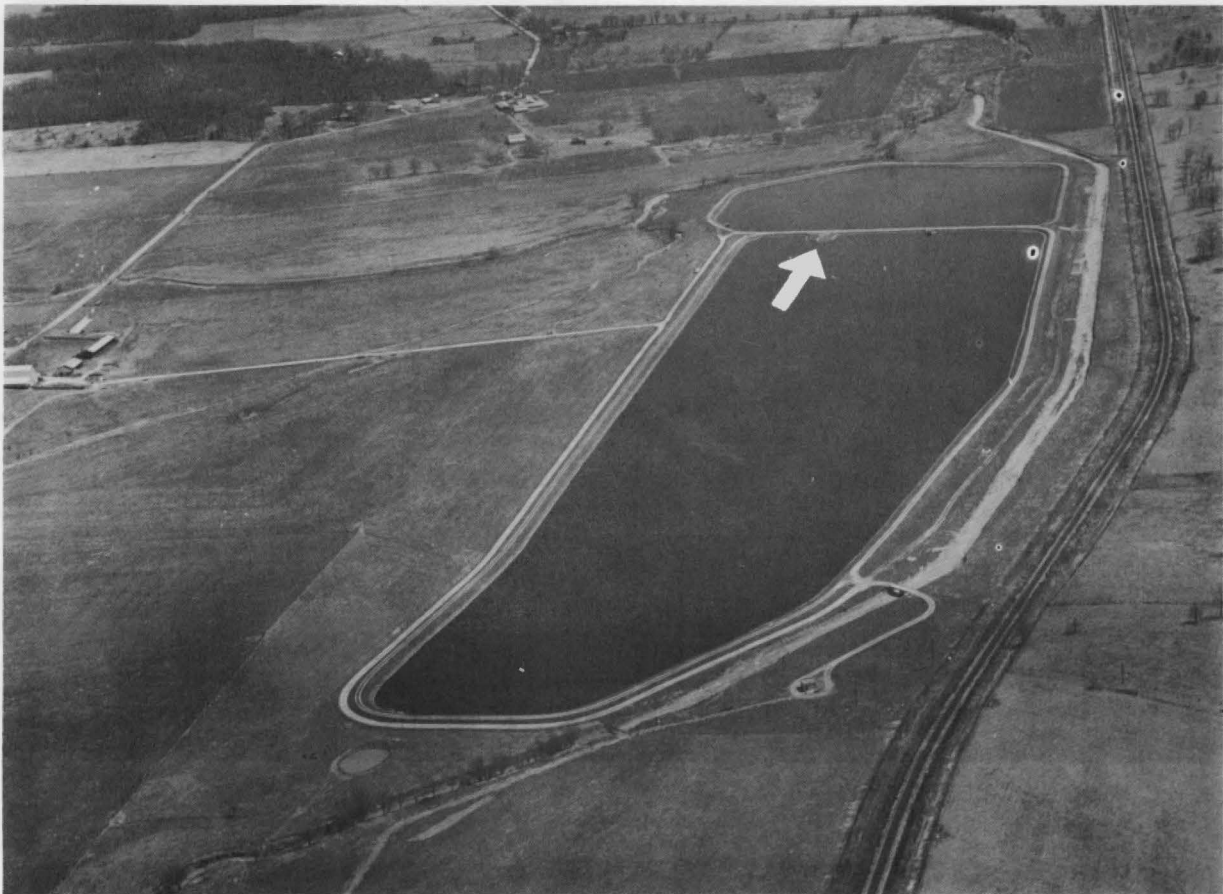
Figure 2

Collapse within sewage lagoons has also occurred at West Plains, Howell County, Missouri (fig. 2). The

Aerial view of the West Plains sewage lagoon as it appeared in 1971. The area which collapsed in 1966 is shown by the arrow. Photo by Jerry D. Vineyard.

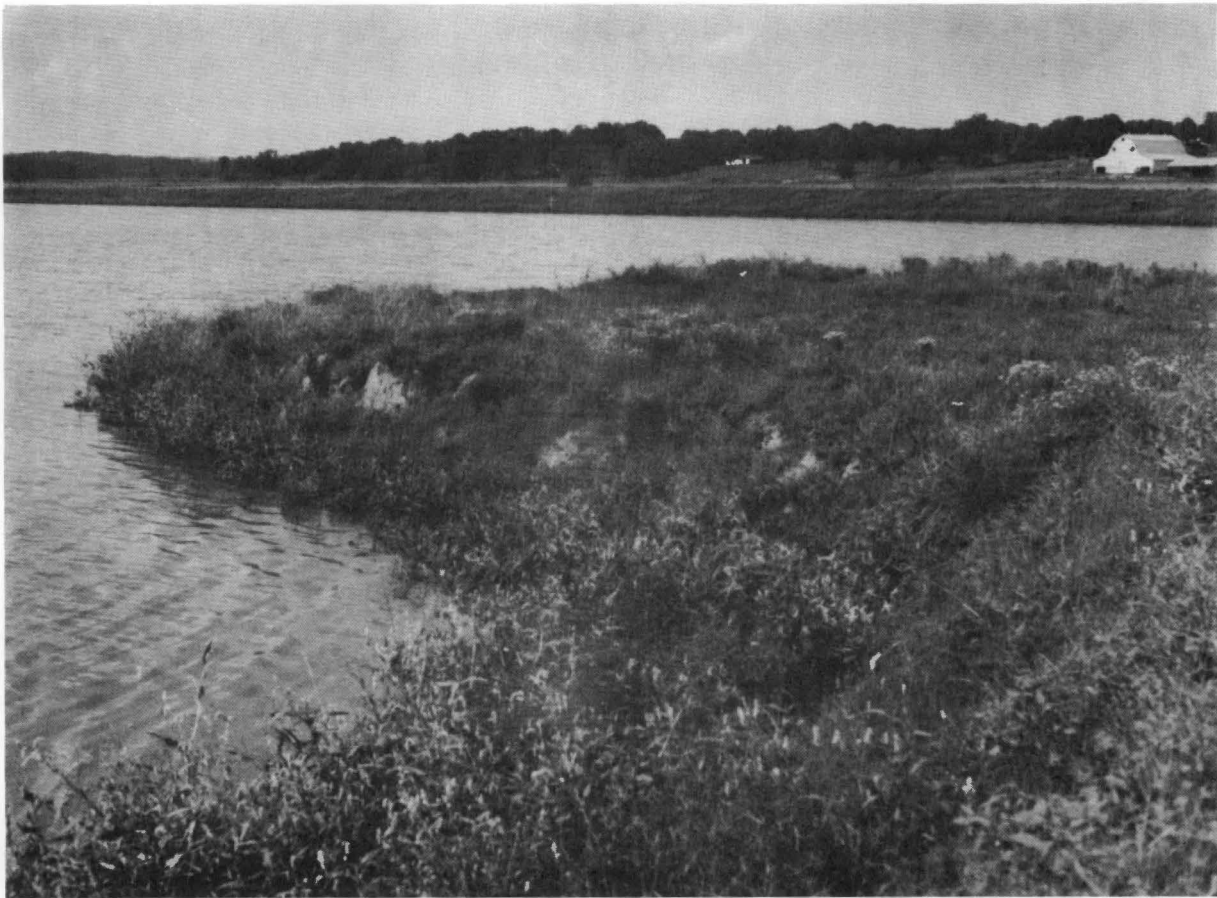
Figure 3

The large cell of the West Plains sewage lagoon. A catastrophic sink occurred in 1966 beneath the peninsula shown in the foreground. Subsequent to the collapse the sink was filled with clay and bentonite and the lagoon was returned to use. Photo by James W. Massello.

The 1966 collapse at the West Plains lagoon was about 34 feet in diameter, and probably 10 to 20 feet deep. This hole was filled with clay and bentonite to the level of the dike wall and the lagoon was returned to use. Mr. Renfrow, formerly Assistant City Engineer of West Plains, reported that he walked about 4 miles of the Howell Creek channel below the lagoon collapse, but found no evidence of lagoon water. There were no reports of well contamination

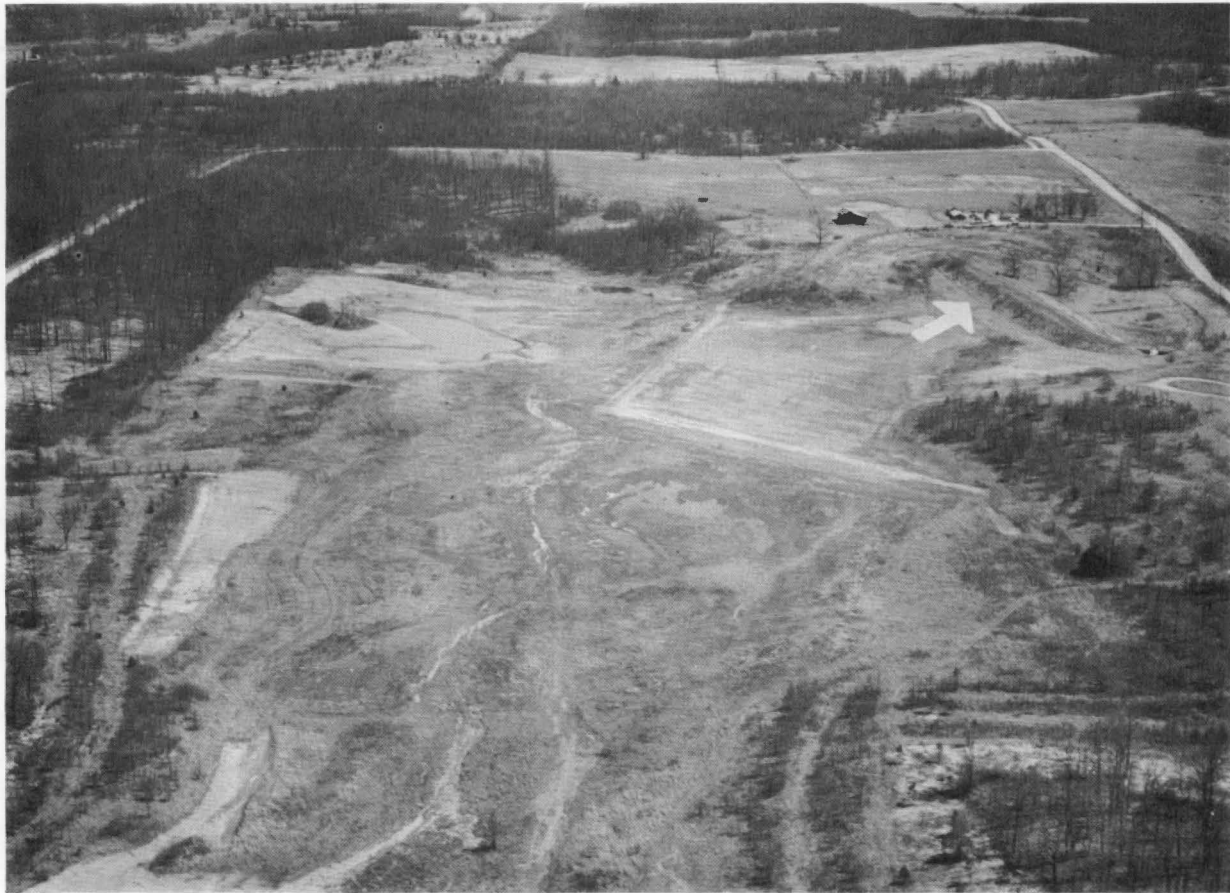
**Figure 4**

impoundment held a substantial volume of water. Unfortunately, a sinkhole suddenly formed in the floor of the impoundment and drained all the water from the reservoir. Substantial efforts were made to stop the leakage, but they have failed. Personnel of the Missouri Geological Survey report seeing flows of 10 cubic feet per second disappearing underground within the impoundment area.

Aerial view of a portion of the planned impoundment area of the Dean W. Davis Reservoir near Pomona. The arrow indicates the dam. A catastrophic sink formed within 75 yards of the dam and totally drained the impoundment overnight. Extensive attempts to seal the impoundment were unsuccessful. Photo by Jerry D. Vineyard.

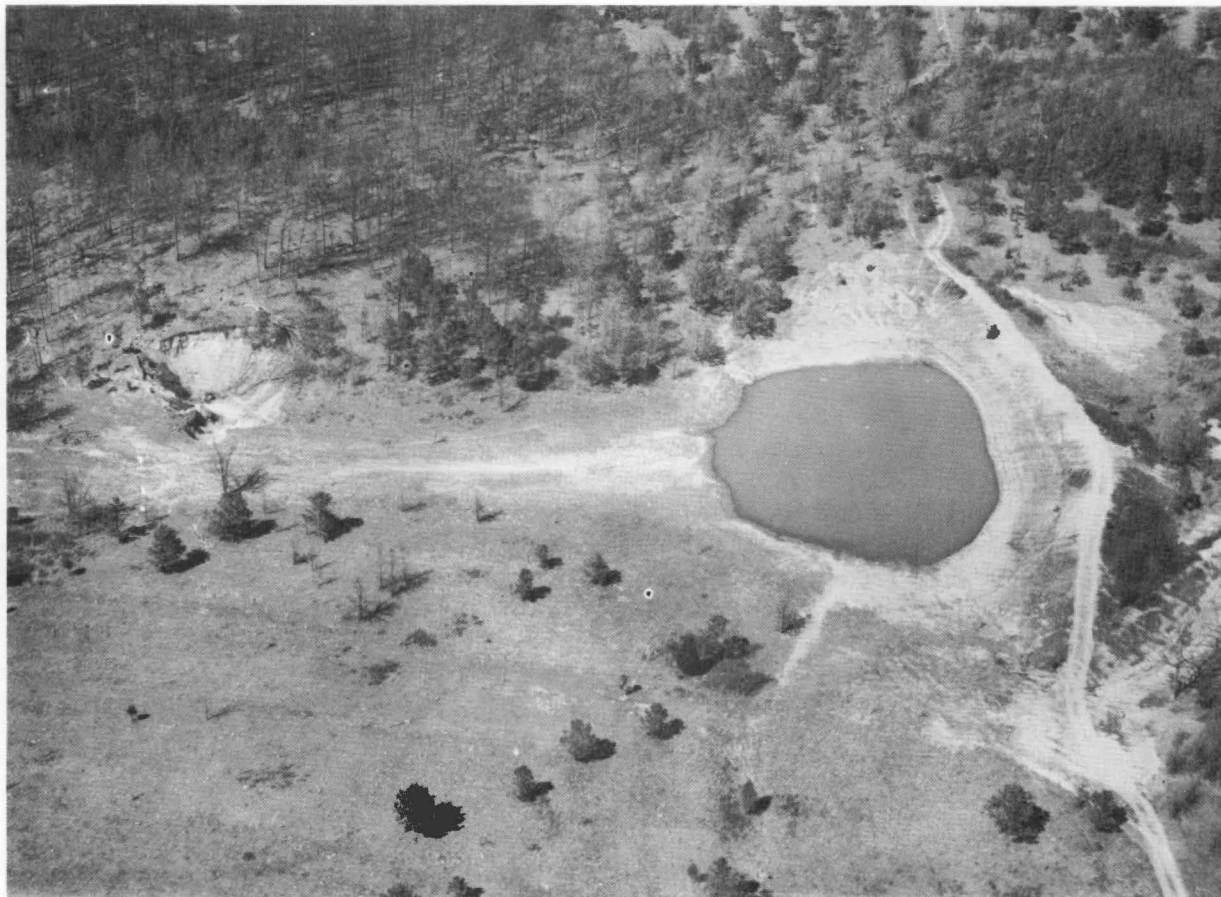
**Figure 5**

A most spectacular group of collapses induced by construction of an impoundment is found at Norton Dam, 2 miles south of Winona in Sec. 30, T. 27 N., R. 3 W., Shannon County, Missouri (fig. 5). The dam was built on an intermittent stream tributary to Pike Creek. The impoundment site is underlain by deep Roubidoux residuum; there are no bedrock exposures near the impoundment site.

Aerial view of Norton Dam and a portion of the impoundment area. The largest of the four catastrophic sinkholes induced by this impoundment is shown above, in the left-center of the photo. The other three sinkholes lie upstream of the area pictured. Photo by Jerry D. Vineyard.

We are convinced that the Norton impoundment led to the formation of the sinks. The dam has had four effects on water regimens in the valley. The first effect has been to spread flood water over the entire valley floor. The second effect, since the impoundment site leaks, is to induce recharge of groundwater from the impoundment area. This recharge tends to be localized in the more permeable areas, which in turn tends to move fine materials into underlying solution channels and voids. The third effect of the dam has been to make the residuum in

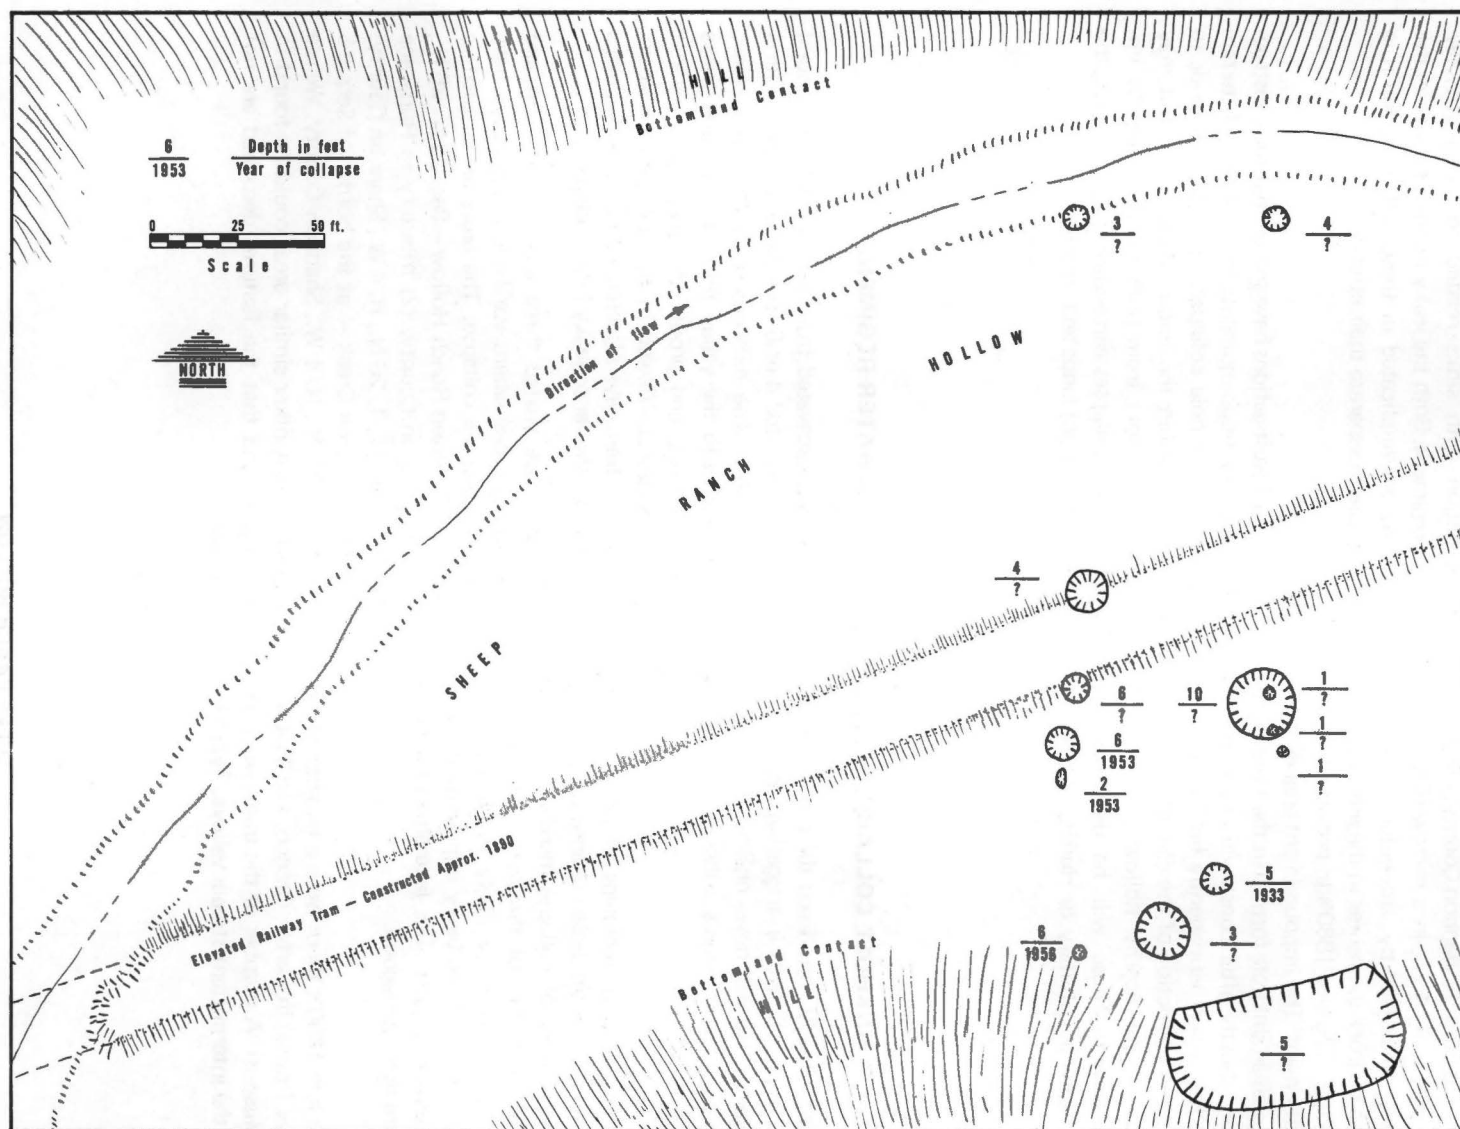
Figure 6

The catastrophic sinkhole collapses which have occurred in Sheep Ranch Hollow (fig. 6) provide an

Sinkhole collapses in Sheep Ranch Hollow induced by construction of a logging tramway in about 1890. Sinkhole sizes were measured in January 1971.  
(Illustration courtesy of Mark Twain National Forest)

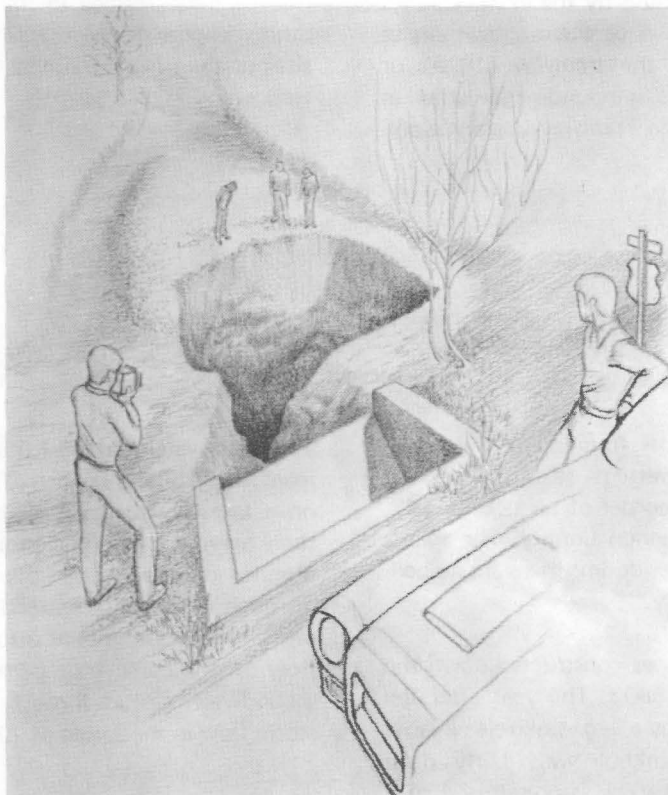
Figure 7

The Buckhorn collapse, Sec. 7, T. 35 N., R. 12 W., in Pulaski County, Missouri formed in spring, 1967 at the end of a box culvert under the westbound lane of Interstate 44 (fig. 7). At this point the highway crosses an intermittent stream valley underlain by Roubidoux residuum. The Buckhorn collapse was induced by runoff from the culvert.

When first inspected in 1967, the sink was about 20 feet in diameter and 22 feet deep. At this time a small cave could be entered from the sinkhole, and this led to a debris chamber in the residuum directly beneath the 45-foot high highway fill. Collapse of the highway in this area is a distinct possibility; the collapse which occurred in 1967 was induced by changes in the water regimen of the valley.

Catastrophic collapse occurred near Buckhorn, in the streambed of Collie Hollow, at the north end of a box culvert beneath Interstate 44. The resulting sinkhole was about 30 feet deep and accepted the entire flow of the stream until filled by the Missouri State Highway Department. Drawing by Douglas R. Stark, from a photograph by Jerry D. Vineyard.

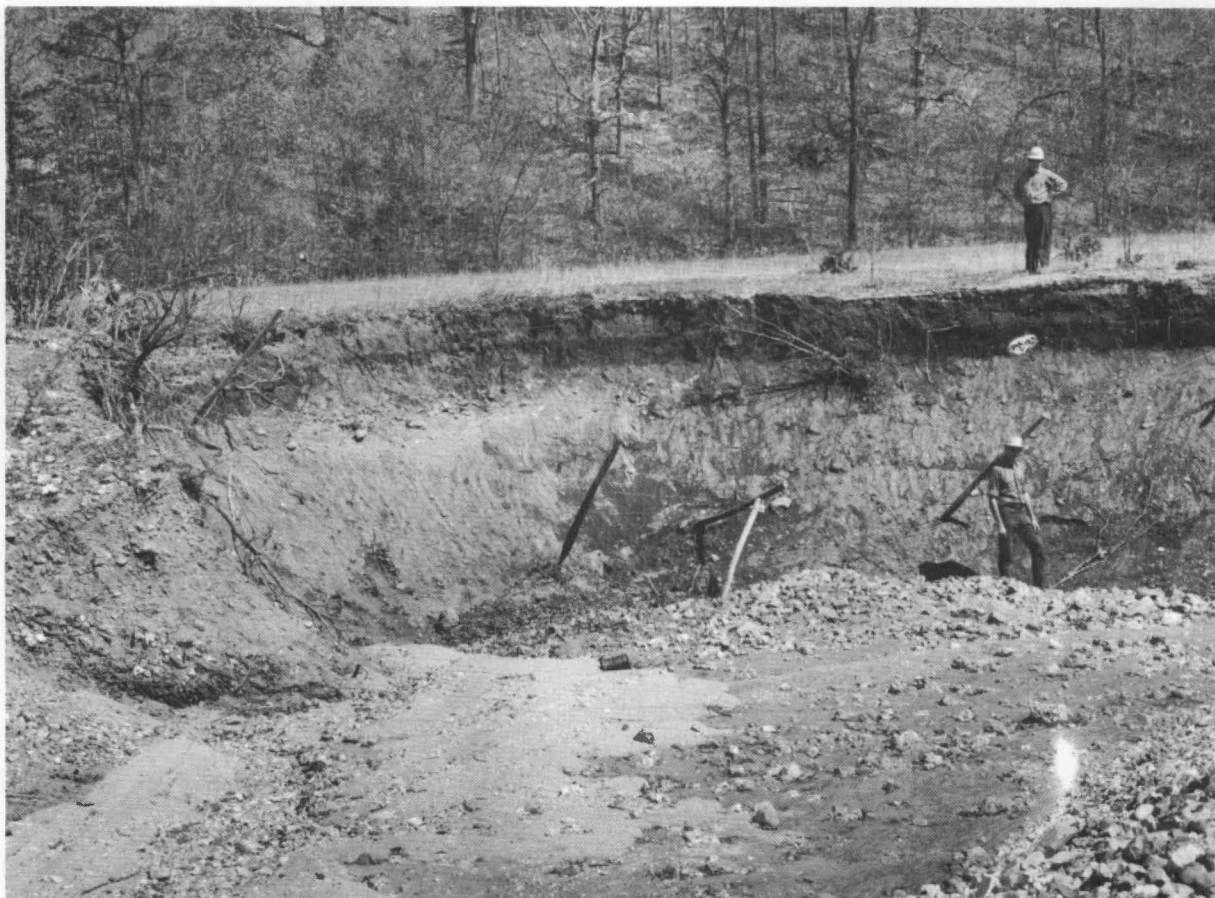
**Figure 8**

The sink was visited about two weeks after it formed, and at that time it was about 25 feet in diameter, 60 feet deep, and nearly cylindrical in shape. By 1968 (fig. 8) stream gravels had nearly filled the sink; in a few years most, if not all, of the topographic expression of the sink will have disappeared.

Sycamore Creek Sink two years after its formation. The sinkhole has been nearly filled with sand and gravel transported by Sycamore Creek. Photo by James W. Massello.

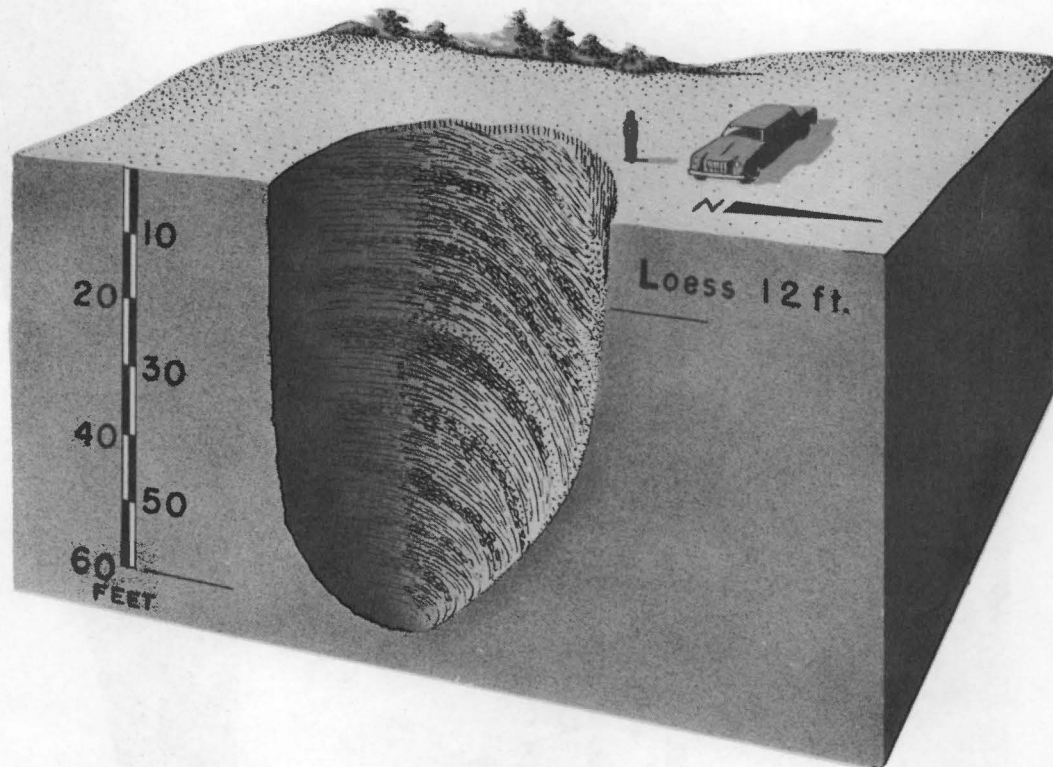
Figure 9

When the sink was first visited on April 10, 1964 it was 42 feet in diameter and 60 to 65 feet deep. The sink was cylindrical and had 10 to 15 feet

of water in the bottom (fig. 9). Vineyard and Williams (1964) suggested that the sinkhole collapse may have been triggered by the Alaskan earthquake of March 27, 1964.

Block diagram of a collapse sink that formed near Lebanon, Mo. contemporaneously with the Alaskan earthquake in March 1964. Apparent bedding is in residuum of the Roubidoux Formation. Drawing by Douglas R. Stark.

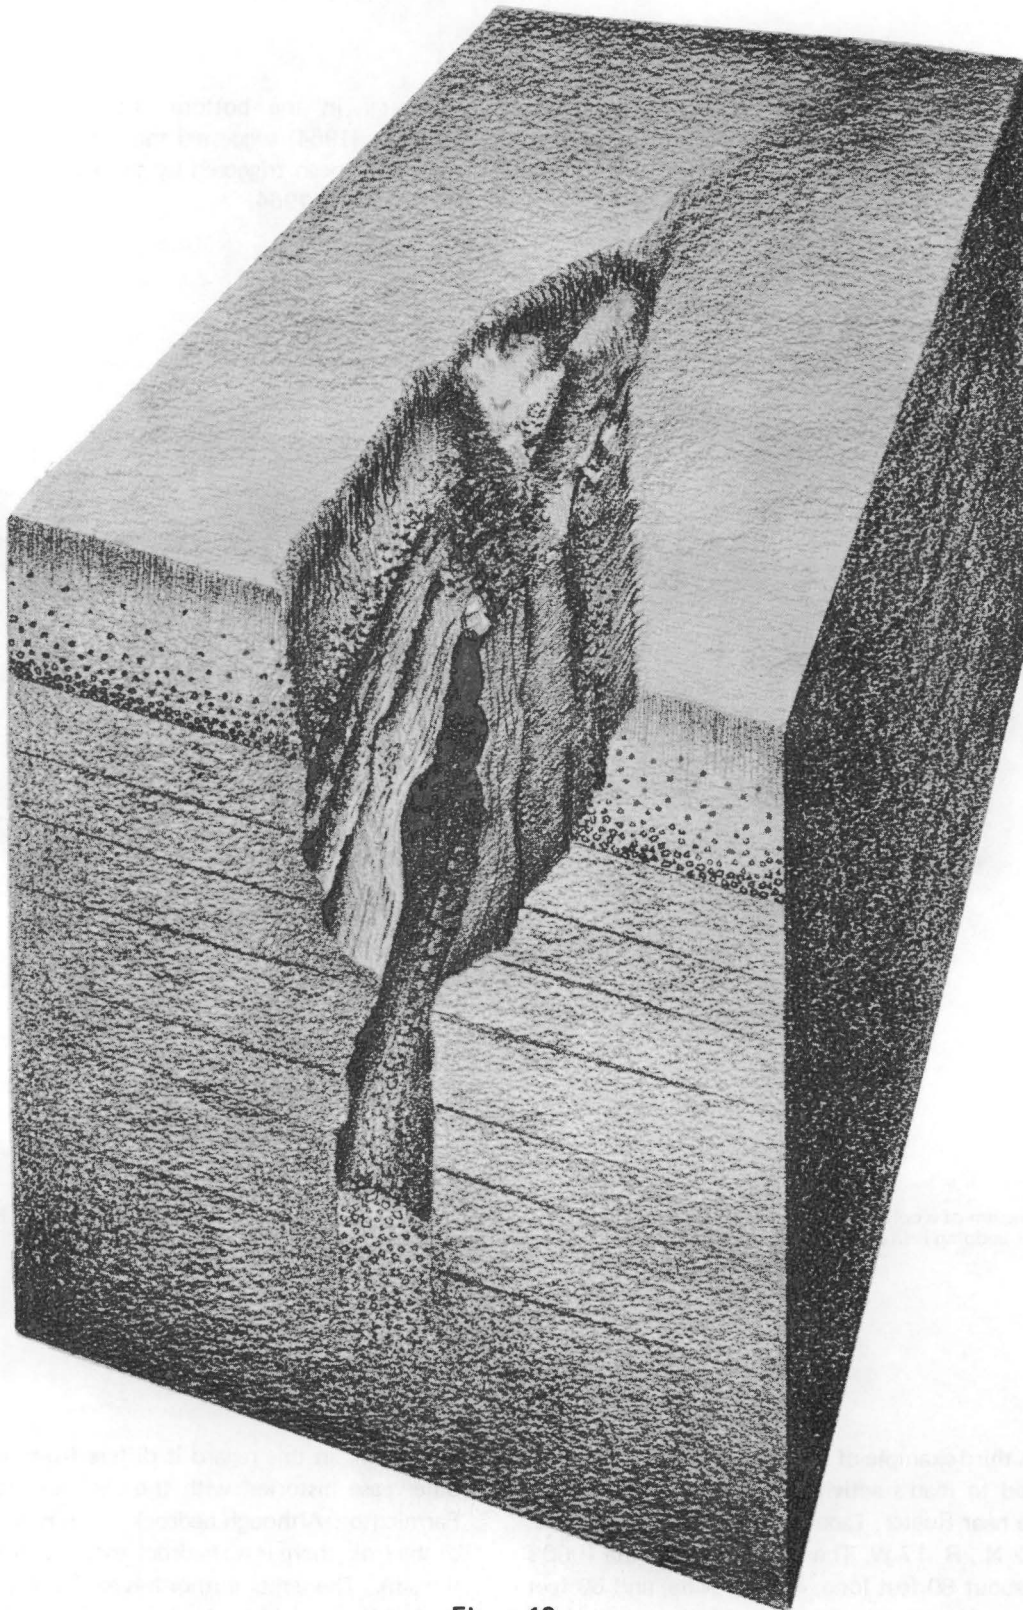
**Figure 10**

formation; in this regard it differs from most of our other case histories, with the exception of those at Farmington. Although bedrock is exposed on the sides of the sink, there is no bedrock exposed at the ends of the sink. The senior author has explored several caves in the vicinity which also have residuum ceilings. The caves are typically narrow, vertical passages 2 to 20 feet wide and up to 60 feet high. The Racetrack Ridge sink is apparently an unroofed cave of this type.

Racetrack Ridge collapse. This sinkhole was formed by the collapse of residuum into a solutional void in the bedrock. A portion of the original void still exists and can be entered from the bottom of the sink for about 20 feet. Drawing by Douglas R. Stark from photos by Thomas J. Aley.

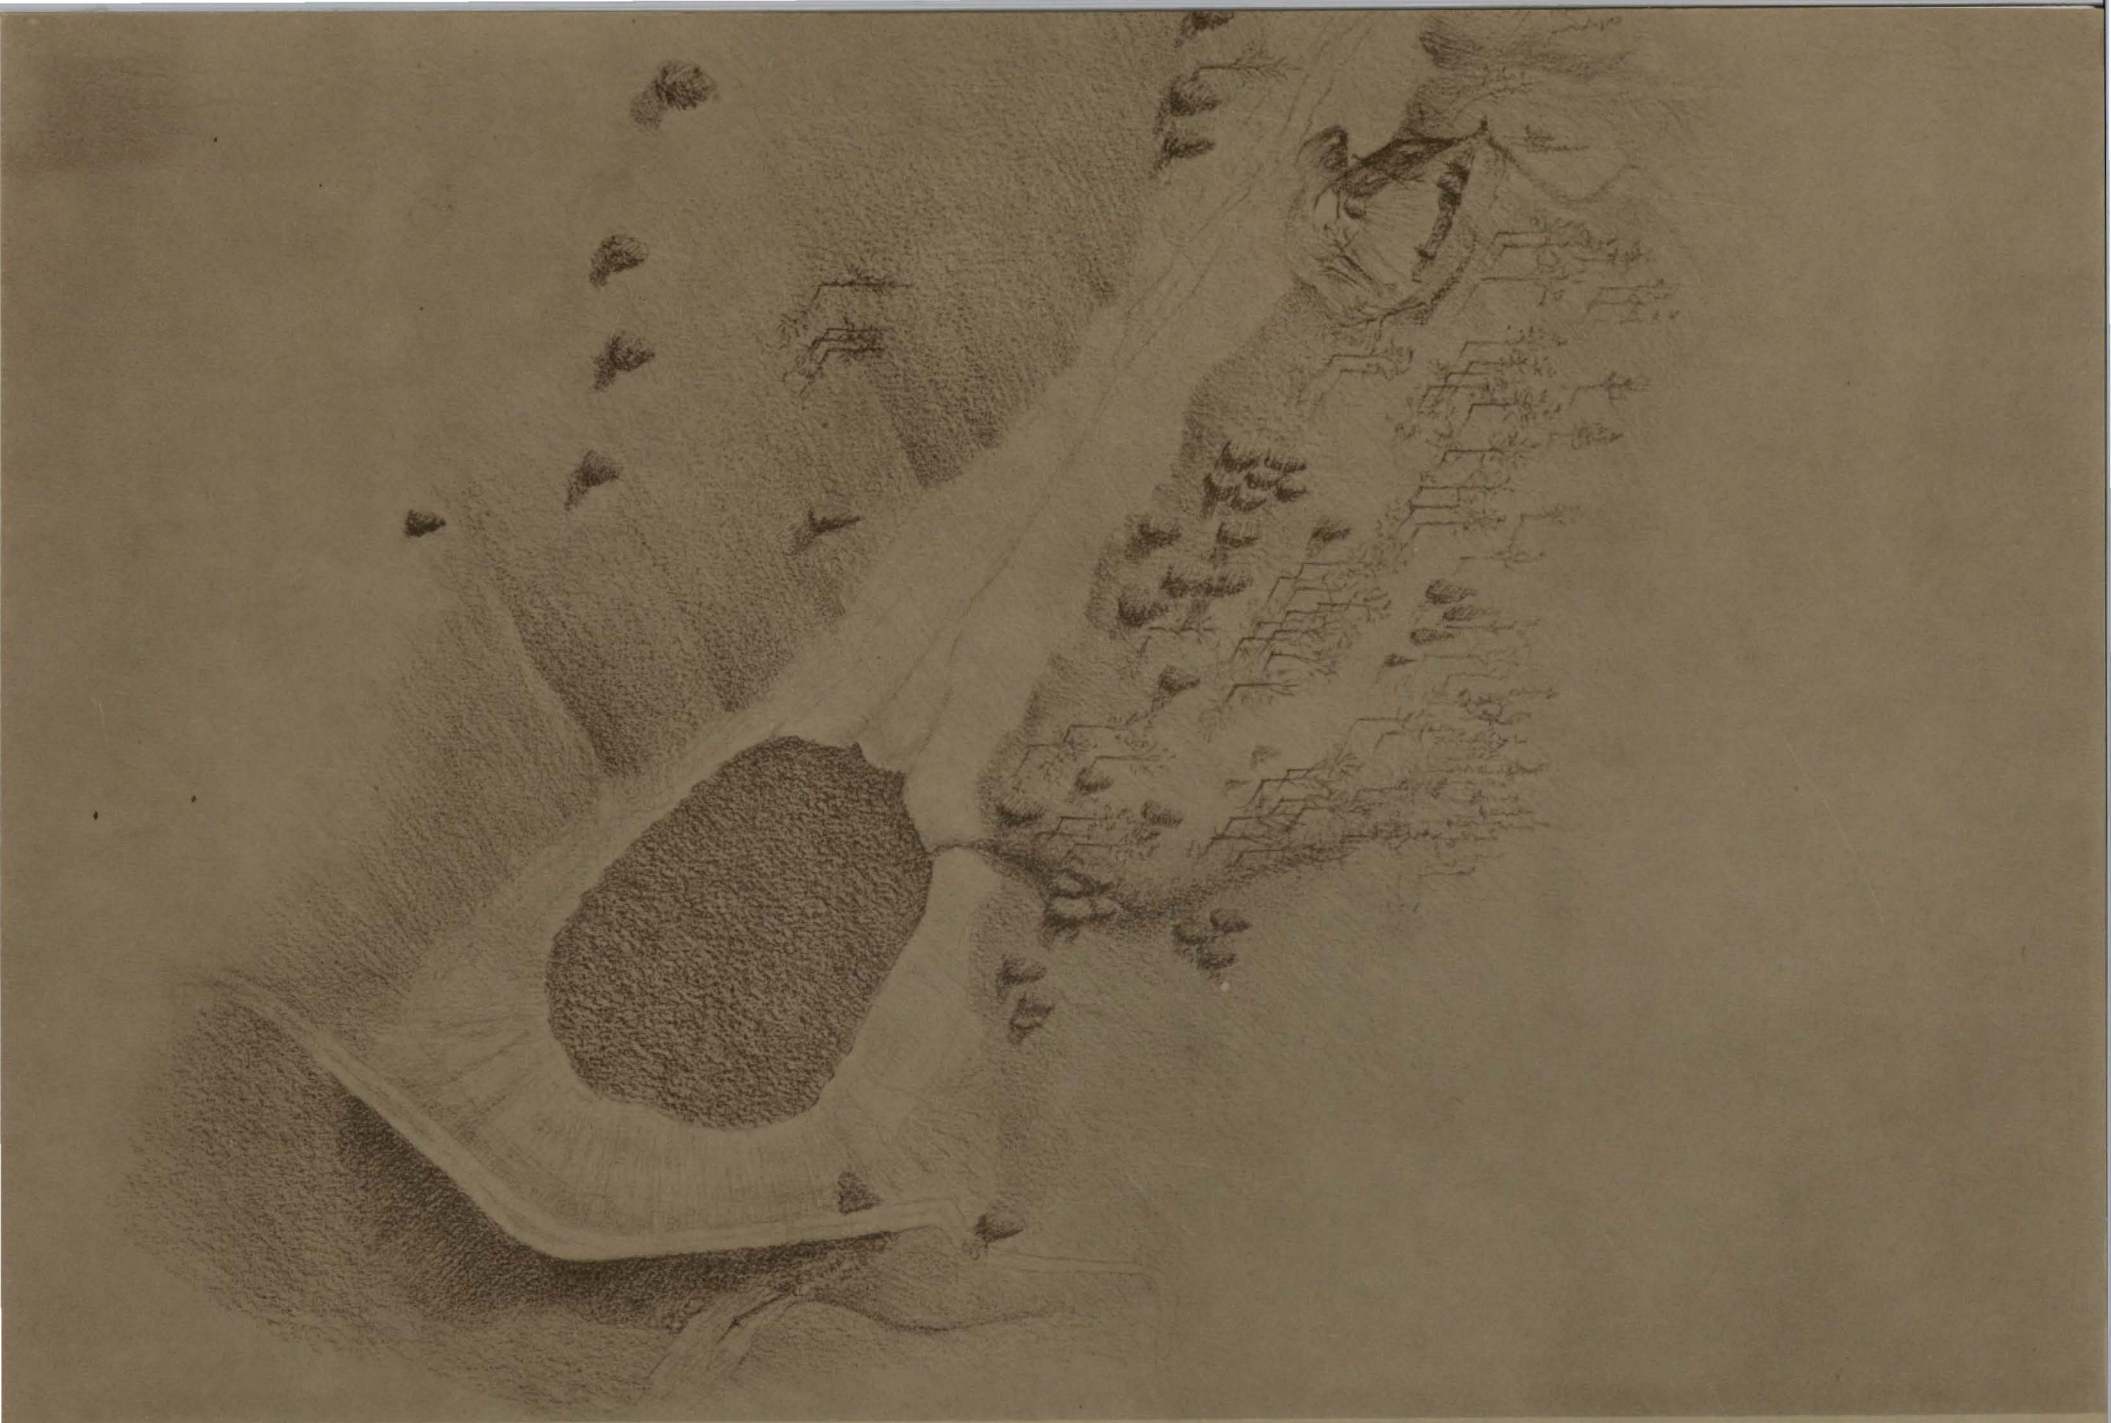
*COVER: The largest of four catastrophic sinkholes caused by Norton Dam is shown on the left of the cover illustration. Three other sinkholes lie upstream. Drawing by Douglas R. Stark.*
