# Groundwater Contamination and Sinkhole Collapse

Induced By Leaky Impoundments

In Soluble Rock Terrain

*Aley, Thomas J., James H. Williams and James W. Massello, 1972, Groundwater contamination and sinkhole collapse induced by leaky impoundments in soluble rock terrain: Mo. Geol. Survey and Water Resources, Engineering Geology Series No. 5, 40 p., 10 figs., 1 tbl.*

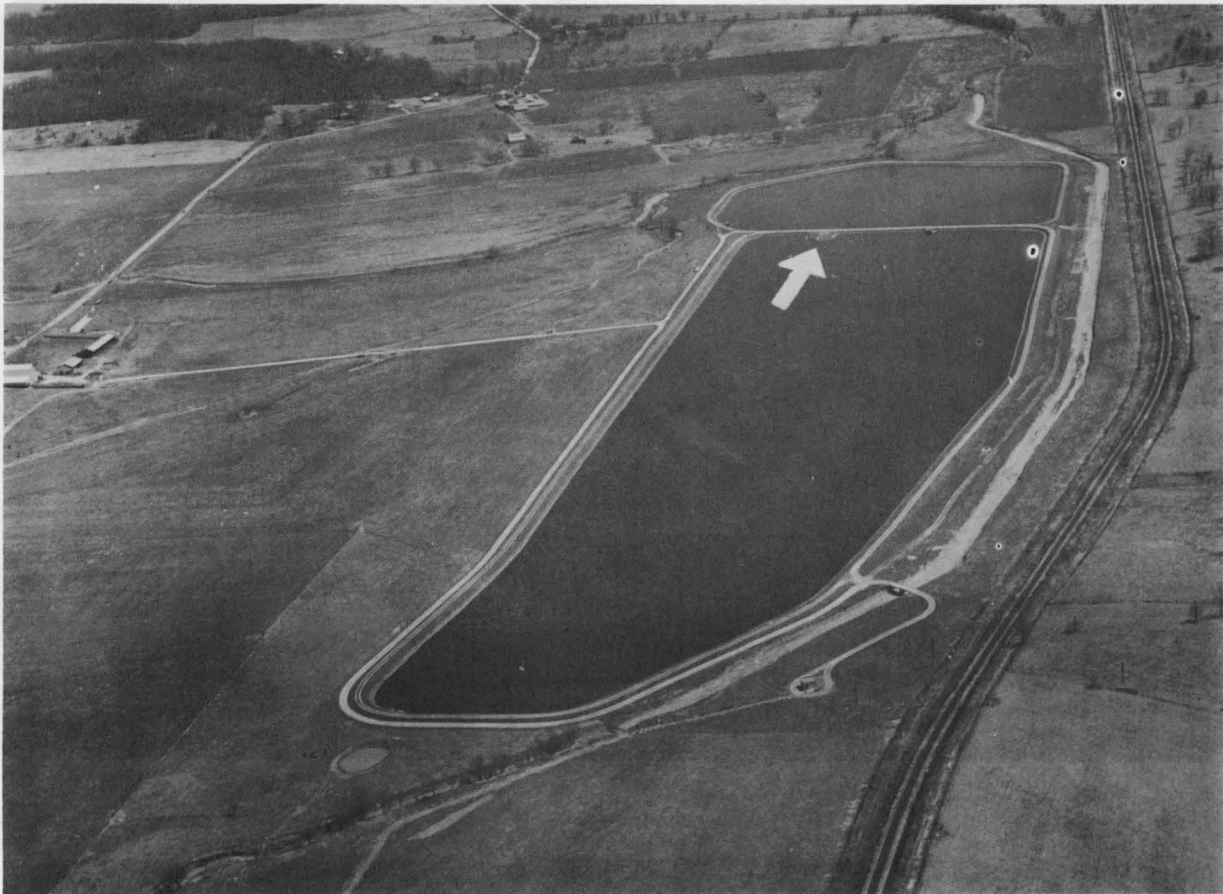
Collapse within sewage lagoons has also occurred at West Plains, Howell County, Missouri (fig. 2). The

**Figure 2**  
Aerial view of the West Plains sewage lagoon as it appeared in 1971. The area which collapsed in 1966 is shown by the arrow.  
Photo by Jerry D. Vineyard.

The 1966 collapse at the West Plains lagoon was about 34 feet in diameter, and probably 10 to 20 feet deep. This hole was filled with clay and bentonite to the level of the dike wall and the lagoon was returned to use. Mr. Renfrow, formerly Assistant City Engineer of West Plains, reported that he walked about 4 miles of the Howell Creek channel below the lagoon collapse, but found no evidence of lagoon water. There were no reports of well contamination

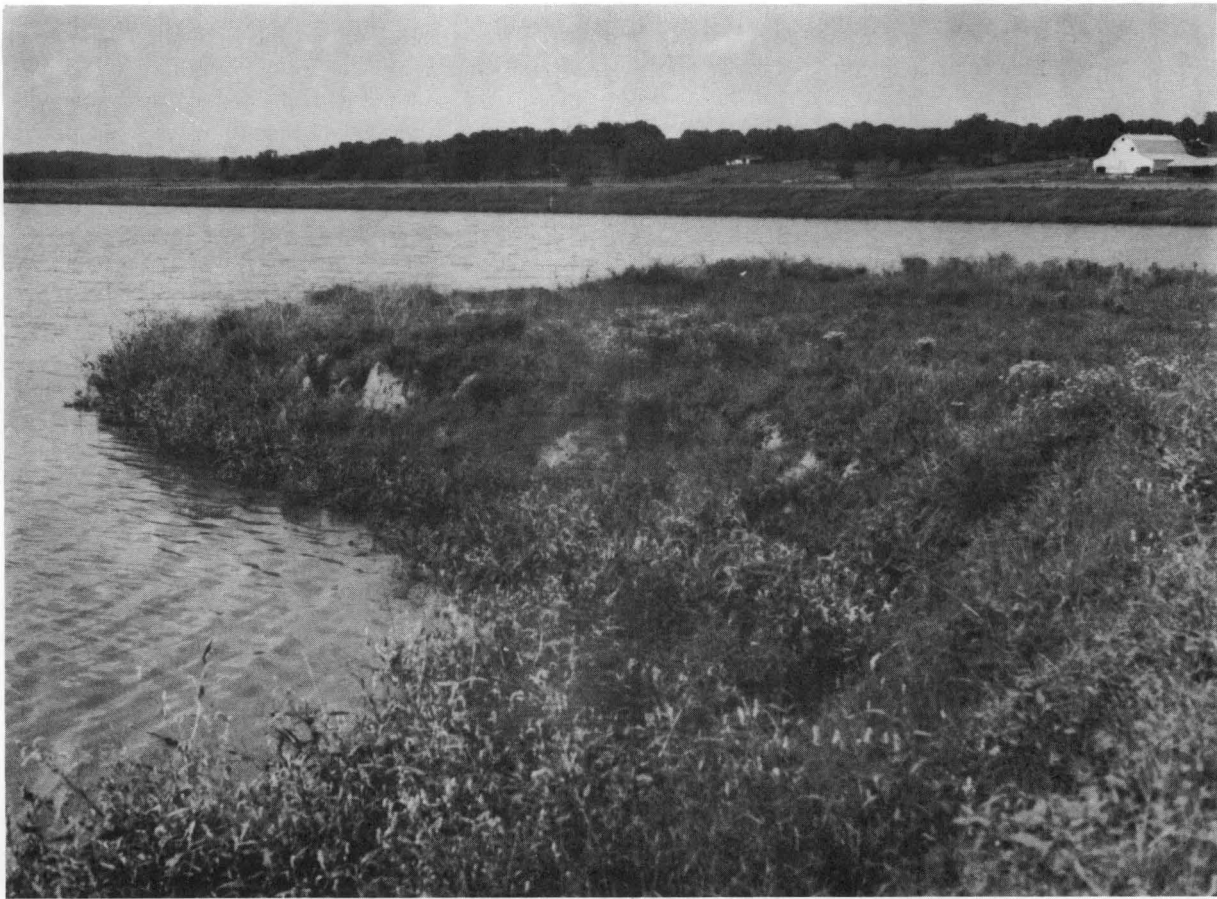
Figure 3

The large cell of the West Plains sewage lagoon. A catastrophic sink occurred in 1966 beneath the peninsula shown in the foreground. Subsequent to the collapse the sink was filled with clay and bentonite and the lagoon was returned to use. Photo by James W. Massello.

The lagoon system was constructed in 1964 and reached full operation in 1966. The smaller cell, which occupies about seven acres, collapsed in two points in 1964. The larger of these collapses was about 17 feet in diameter and probably 10 to 20 feet deep; the sinks were plugged with cement, clay, and bentonite and reportedly no longer leak.

about 136 acre-feet of effluent at the time of collapse; all the water drained out within 52 hours. Mr. Pace, City of West Plains, reports that the collapse and leakage created a vortex of such size that he was unwilling to get close to it with a boat. This is hardly surprising; the average leakage rate for the 52 hours was 29 cubic feet per second.

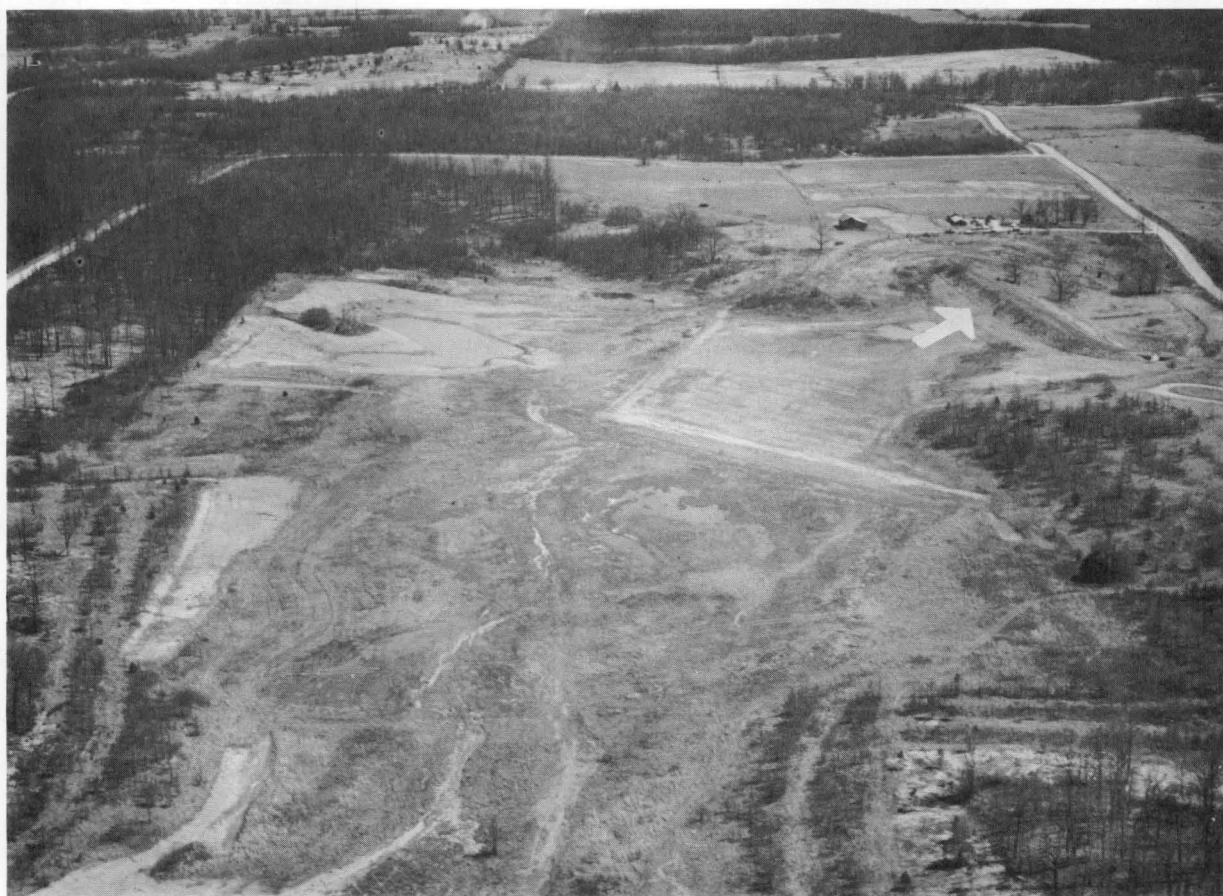
**Figure 4**

impoundment held a substantial volume of water. Unfortunately, a sinkhole suddenly formed in the floor of the impoundment and drained all the water from the reservoir. Substantial efforts were made to stop the leakage, but they have failed. Personnel of the Missouri Geological Survey report seeing flows of 10 cubic feet per second disappearing underground within the impoundment area.

Aerial view of a portion of the planned impoundment area of the Dean W. Davis Reservoir near Pomona. The arrow indicates the dam. A catastrophic sink formed within 75 yards of the dam and totally drained the impoundment overnight. Extensive attempts to seal the impoundment were unsuccessful. Photo by Jerry D. Vineyard.

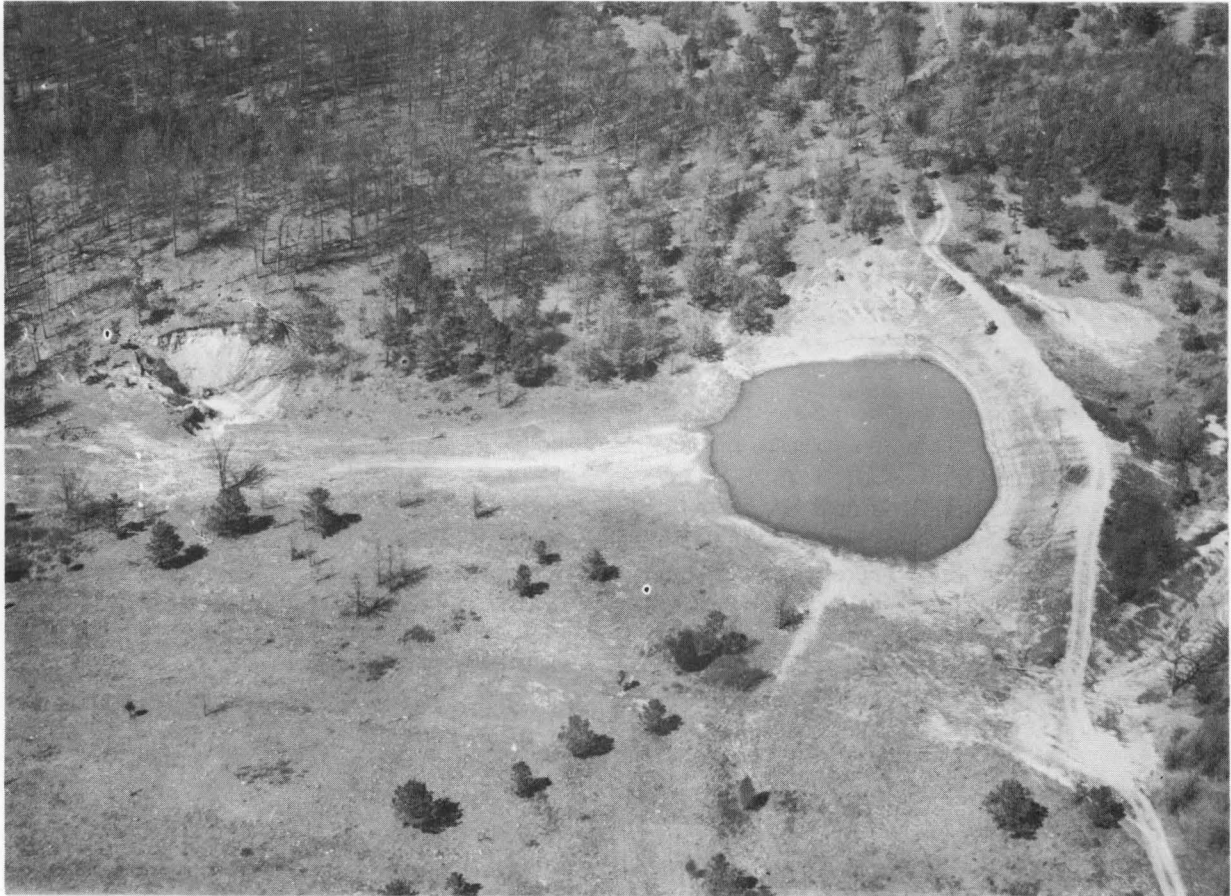
Figure 5

A most spectacular group of collapses induced by construction of an impoundment is found at Norton Dam, 2 miles south of Winona in Sec. 30, T. 27 N., R. 3 W., Shannon County, Missouri (fig. 5). The dam was built on an intermittent stream tributary to Pike Creek. The impoundment site is underlain by deep Roubidoux residuum; there are no bedrock exposures near the impoundment site.

The Norton Dam has been unsuccessful in producing a permanent lake. During storm periods the impoundment will temporarily fill, but the water level falls rapidly to about the original stream

Aerial view of Norton Dam and a portion of the impoundment area. The largest of the four catastrophic sinkholes induced by this impoundment is shown above, in the left-center of the photo. The other three sinkholes lie upstream of the area pictured. Photo by Jerry D. Vineyard.

We are convinced that the Norton impoundment led to the formation of the sinks. The dam has had four effects on water regimens in the valley. The first effect has been to spread flood water over the entire valley floor. The second effect, since the impoundment site leaks, is to induce recharge of groundwater from the impoundment area. This recharge tends to be localized in the more permeable areas, which in turn tends to move fine materials into underlying solution channels and voids. The third effect of the dam has been to make the residuum in

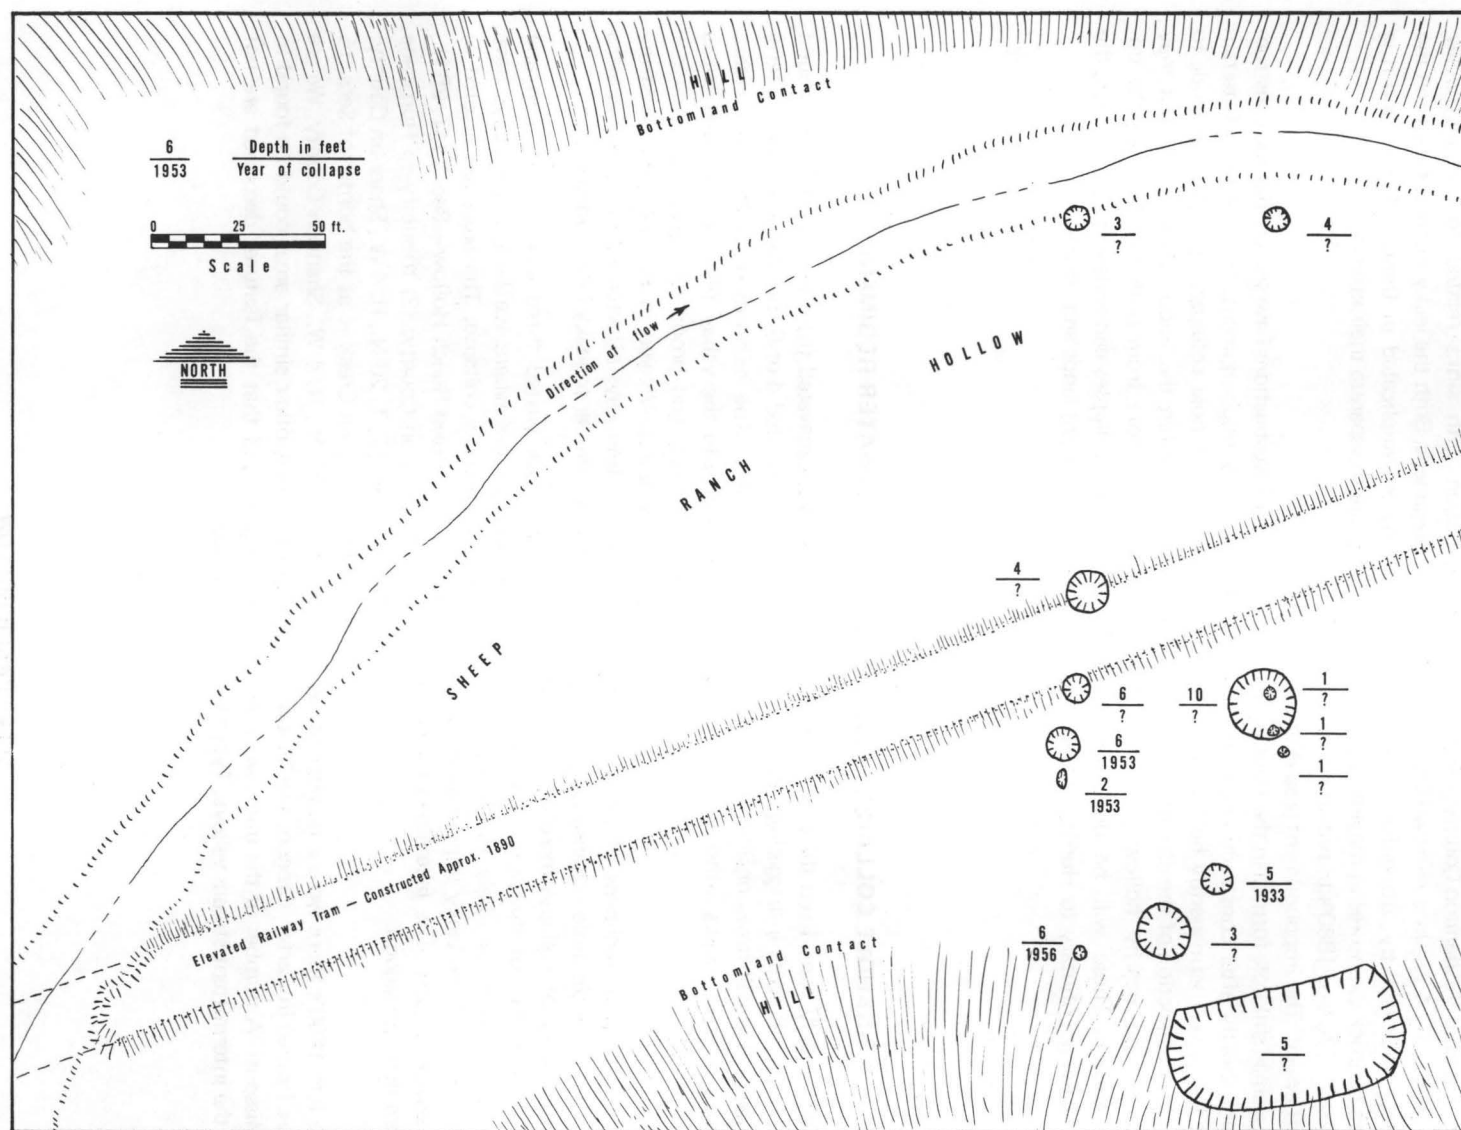
Figure 6

The catastrophic sinkhole collapses which have occurred in Sheep Ranch Hollow (fig. 6) provide an

Sinkhole collapses in Sheep Ranch Hollow induced by construction of a logging tramway in about 1890. Sinkhole sizes were measured in January 1971.  
(Illustration courtesy of Mark Twain National Forest)

The sinks are found in two clusters within a ten-acre area. The illustration (fig. 6) shows only the downstream cluster consisting of 13 sinks of recent origin. The upstream cluster includes five recent sinks. Not all of the sinks formed immediately after construction of the tramway. One formed in 1933, two

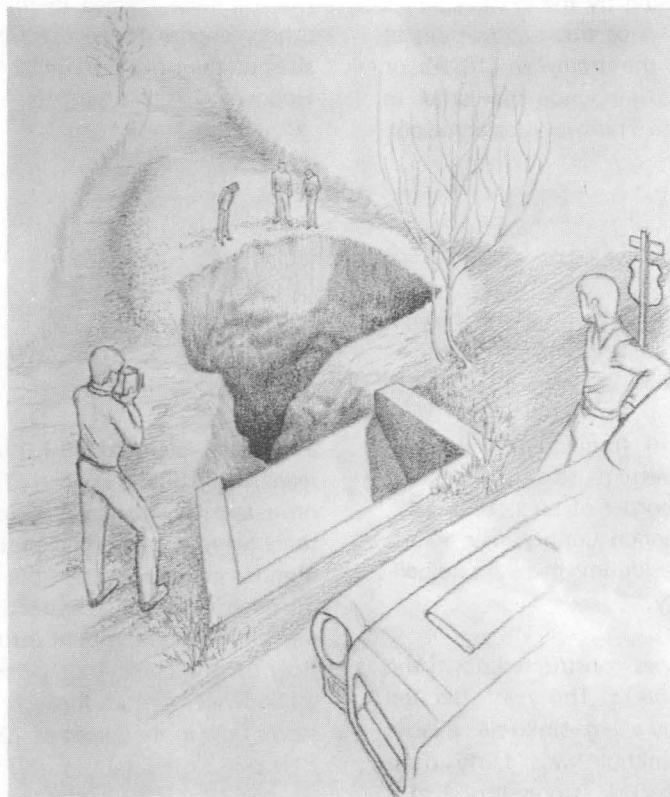
Figure 7

The Buckhorn collapse, Sec. 7, T. 35 N., R. 12 W., in Pulaski County, Missouri formed in spring, 1967 at the end of a box culvert under the westbound lane of Interstate 44 (fig. 7). At this point the highway crosses an intermittent stream valley underlain by Roubidoux residuum. The Buckhorn collapse was induced by runoff from the culvert.

When first inspected in 1967, the sink was about 20 feet in diameter and 22 feet deep. At this time a small cave could be entered from the sinkhole, and this led to a debris chamber in the residuum directly beneath the 45-foot high highway fill. Collapse of the highway in this area is a distinct possibility; the collapse which occurred in 1967 was induced by changes in the water regimen of the valley.

Catastrophic collapse occurred near Buckhorn, in the streambed of Collie Hollow, at the north end of a box culvert beneath Interstate 44. The resulting sinkhole was about 30 feet deep and accepted the entire flow of the stream until filled by the Missouri State Highway Department. Drawing by Douglas R. Stark, from a photograph by Jerry D. Vineyard.

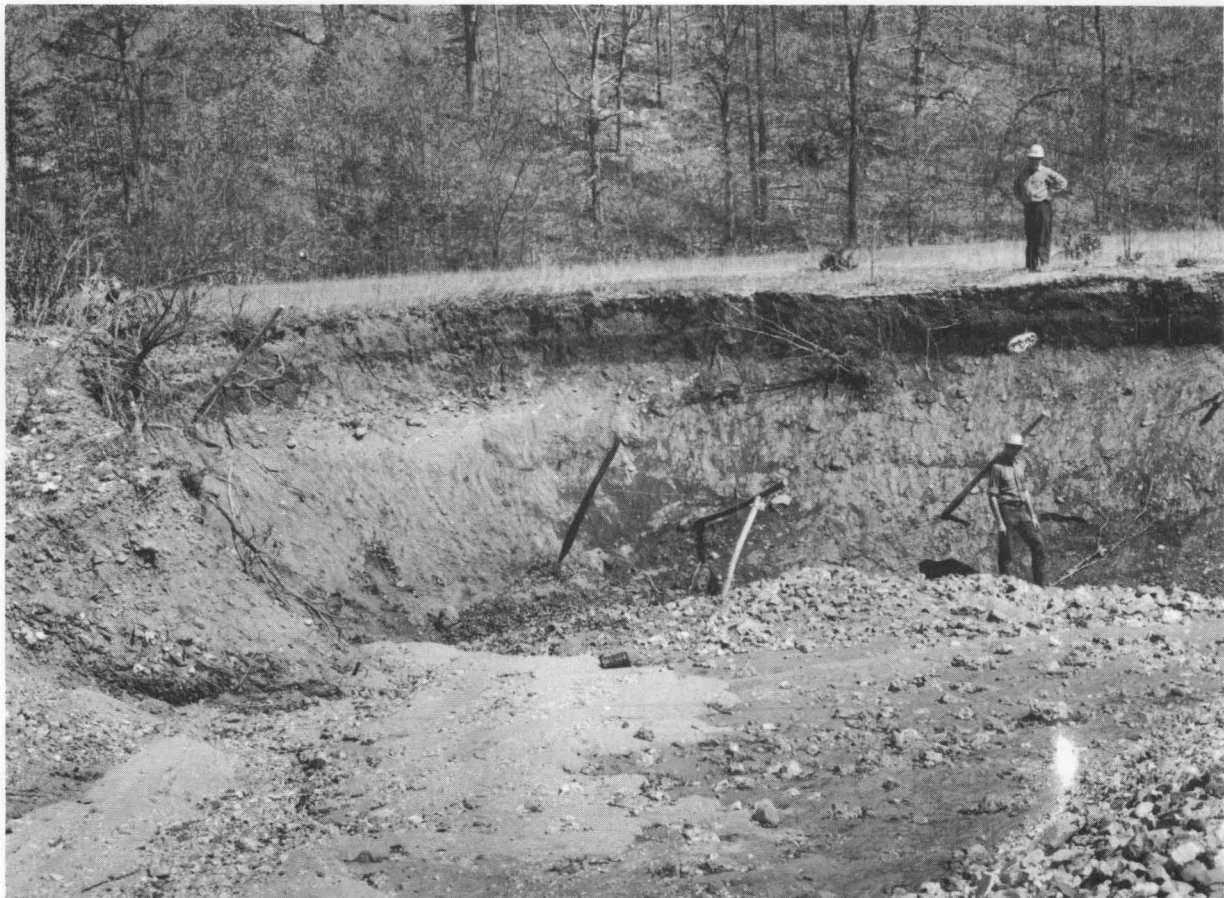
**Figure 8**

The sink was visited about two weeks after it formed, and at that time it was about 25 feet in diameter, 60 feet deep, and nearly cylindrical in shape. By 1968 (fig. 8) stream gravels had nearly filled the sink; in a few years most, if not all, of the topographic expression of the sink will have disappeared.

Sycamore Creek Sink two years after its formation. The sinkhole has been nearly filled with sand and gravel transported by Sycamore Creek. Photo by James W. Massello.

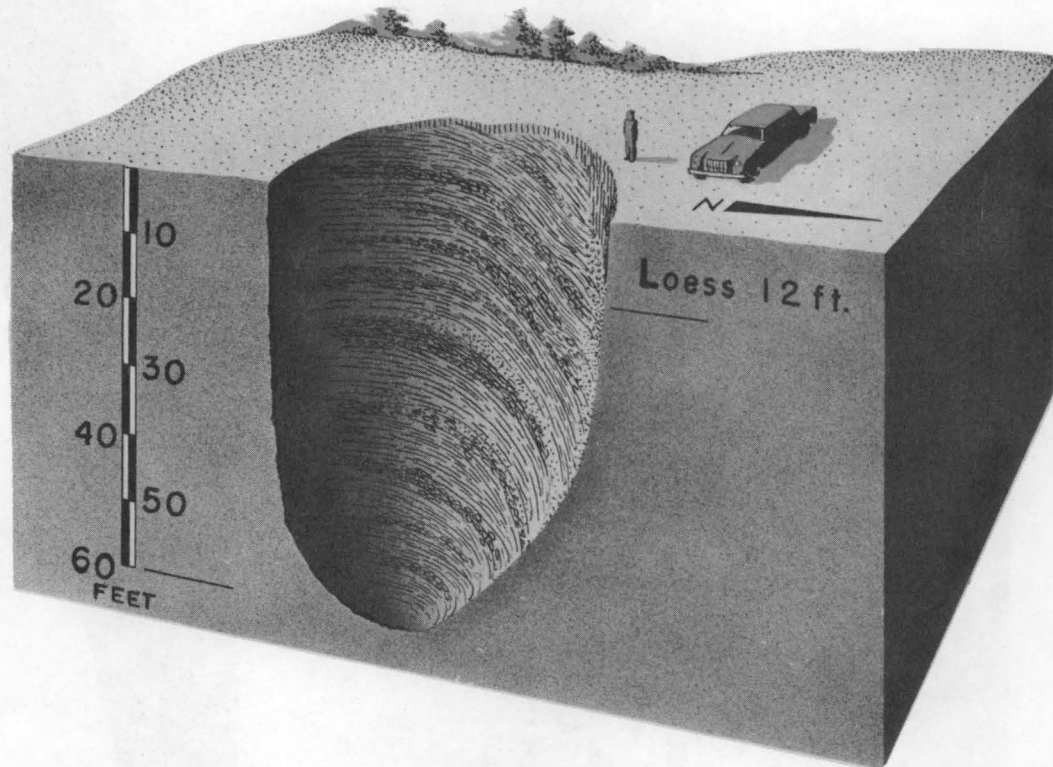
Figure 9

When the sink was first visited on April 10, 1964 it was 42 feet in diameter and 60 to 65 feet deep. The sink was cylindrical and had 10 to 15 feet

of water in the bottom (fig. 9). Vineyard and Williams (1964) suggested that the sinkhole collapse may have been triggered by the Alaskan earthquake of March 27, 1964.

Block diagram of a collapse sink that formed near Lebanon, Mo. contemporaneously with the Alaskan earthquake in March 1964. Apparent bedding is in residuum of the Roubidoux Formation. Drawing by Douglas R. Stark.

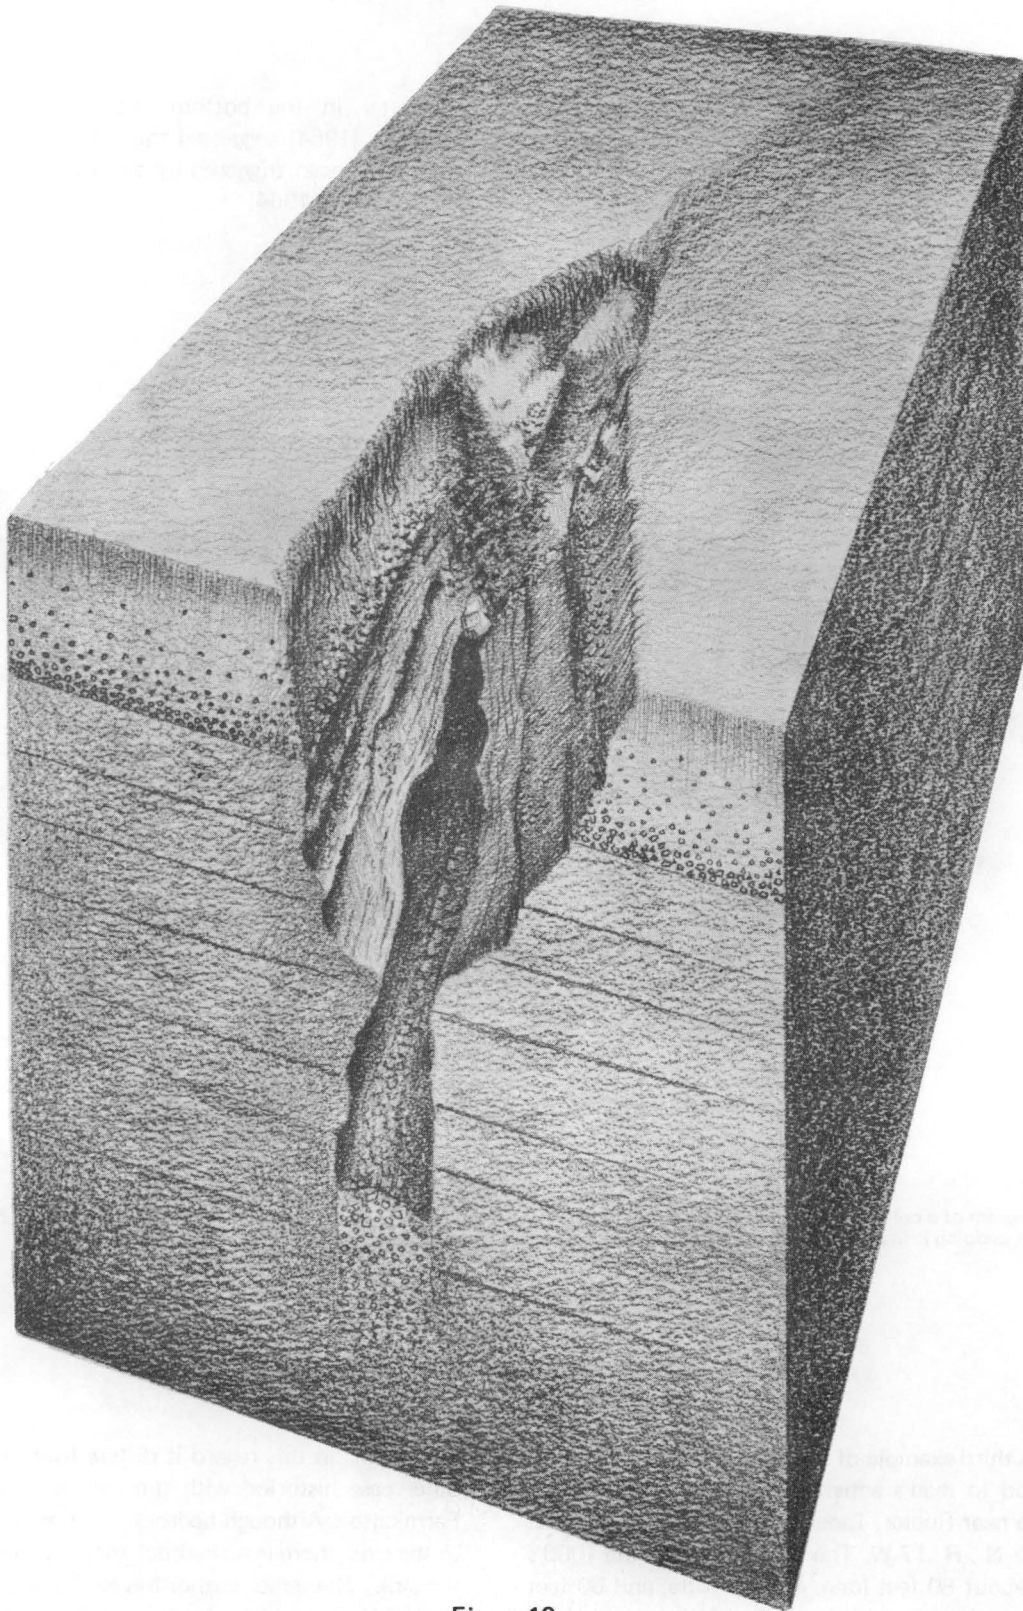
Figure 10

A third example of sinkhole collapse apparently unrelated to man's activities is the Racetrack Ridge collapse near Rueter, Taney County, Missouri, in Sec. 8, T. 22 N., R. 17 W. The sink formed in the 1960's and is about 80 feet long, 40 feet wide, and 60 feet deep. Its orientation is identical with the trend of the losing stream beneath which it has formed (fig. 10). The sink is in an area with shallow soils and numerous rock outcrops assigned to the Jefferson City-Cotter

formation; in this regard it differs from most of our other case histories, with the exception of those at Farmington. Although bedrock is exposed on the sides of the sink, there is no bedrock exposed at the ends of the sink. The senior author has explored several caves in the vicinity which also have residuum ceilings. The caves are typically narrow, vertical passages 2 to 20 feet wide and up to 60 feet high. The Racetrack Ridge sink is apparently an unroofed cave of this type.

Racetrack Ridge collapse. This sinkhole was formed by the collapse of residuum into a solutional void in the bedrock. A portion of the original void still exists and can be entered from the bottom of the sink for about 20 feet. Drawing by Douglas R. Stark from photos by Thomas J. Aley.

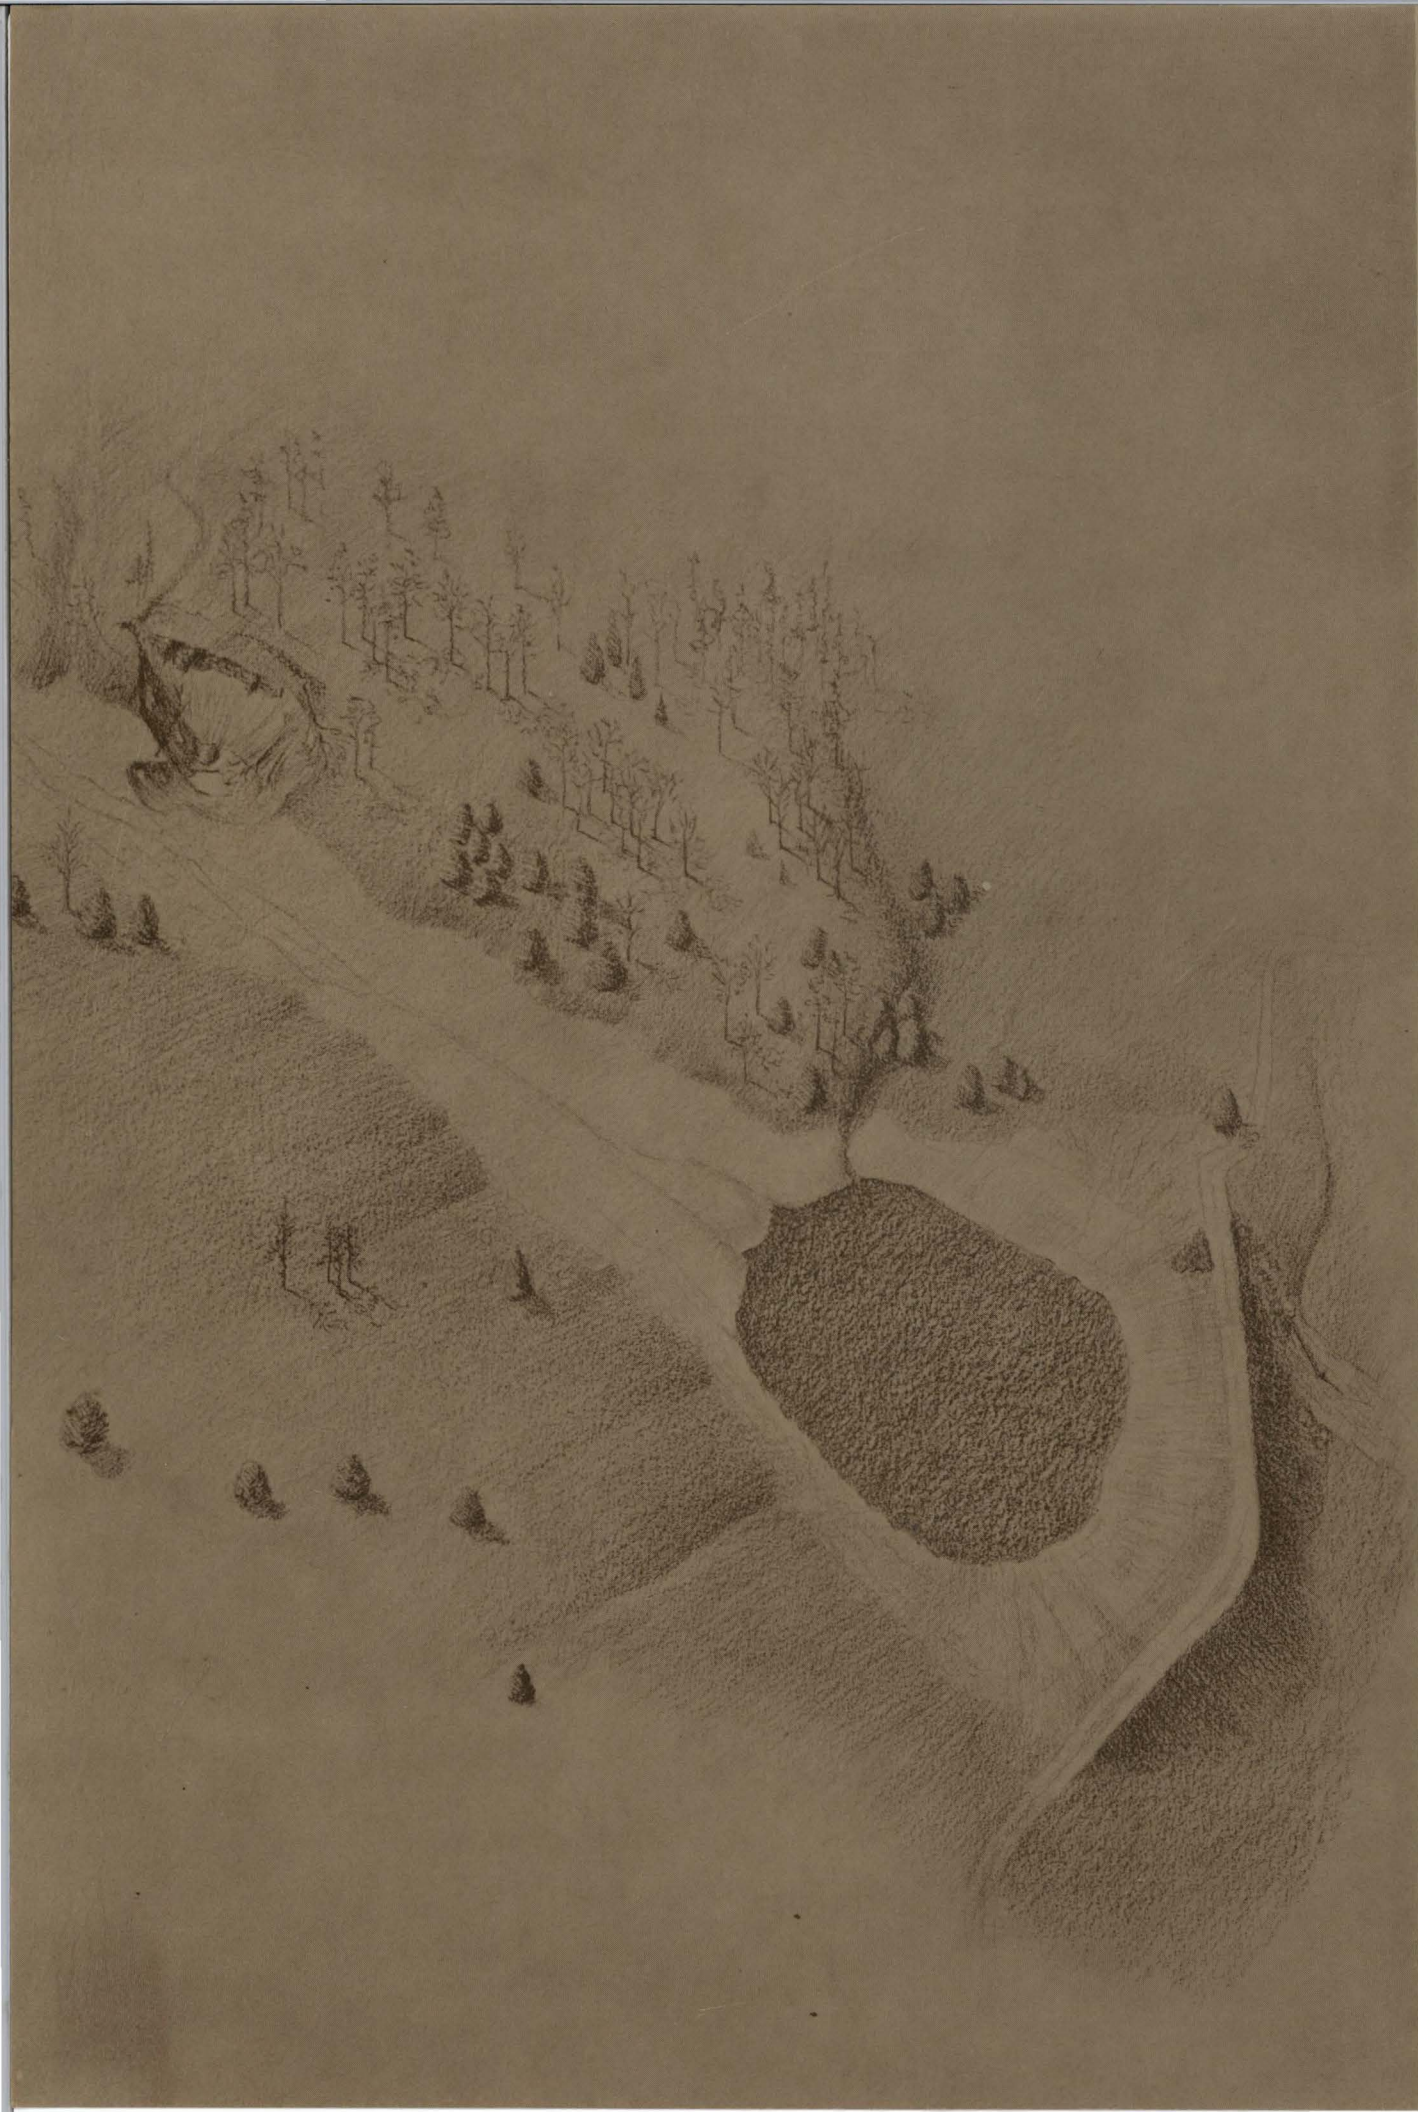
*COVER: The largest of four catastrophic sinkholes caused by Norton Dam is shown on the left of the cover illustration. Three other sinkholes lie upstream. Drawing by Douglas R. Stark.*
