## The 1977 and 1998 Brush Creek Flash Floods, Kansas City

Raymond M. Coveney, Jr.  
 Geosciences and Environmental Studies  
 University of Missouri  
 Kansas City MO 64110-2499  
 coveneyr@umkc.edu

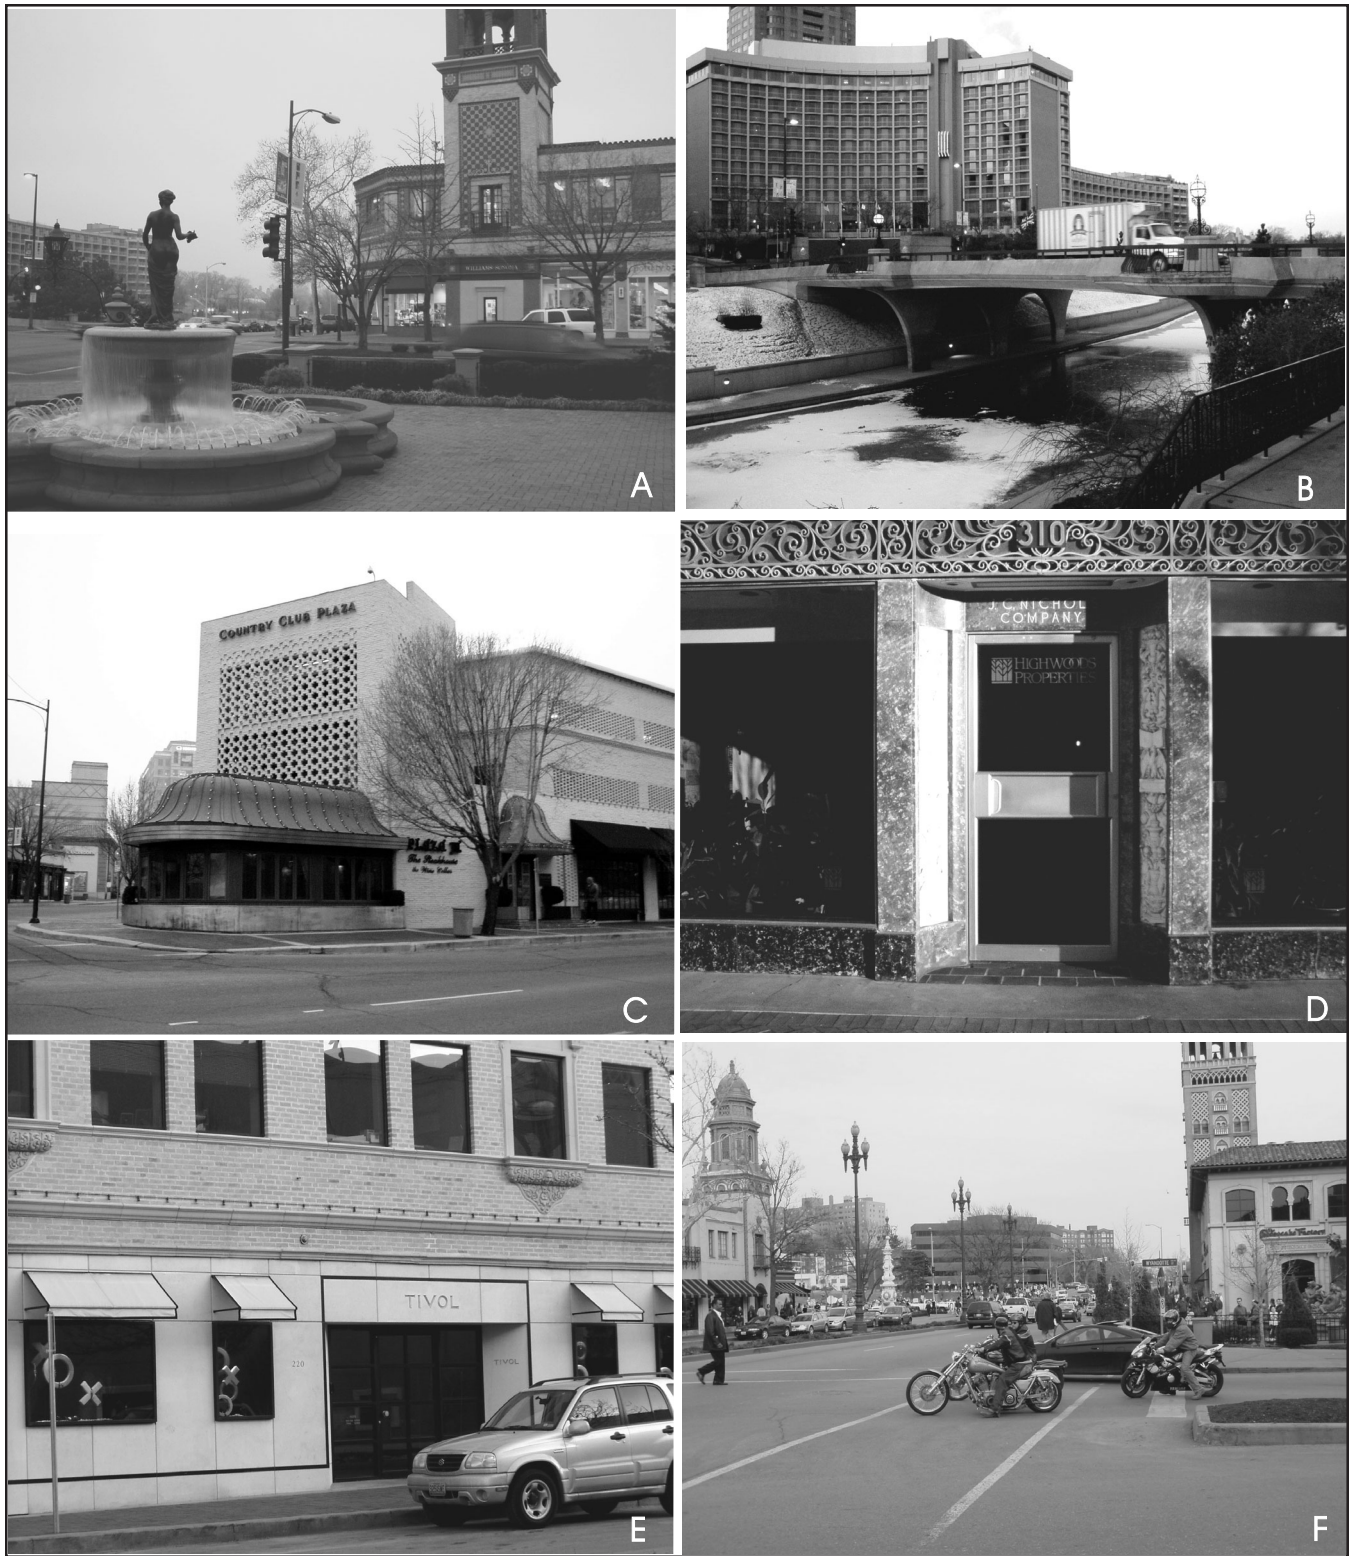
Figure 2. The Country Club Plaza, developed by the J.C. Nichols Company in the 1920s, and modeled after the architecture of Seville, Spain. A. Statue of Pomona with starting point, intersection of Broadway and Ward Parkway in background. B. Wornall-Broadway Bridge over Brush Creek, view toward southwest and Fairmont Hotel. C. Plaza III steakhouse, original west end of the Country Club Plaza District. D. Former headquarters of the J.C. Nichols Company with elaborate stone and tile work typical of the Plaza. E. Tivol Jewelry, Nichols Road on the Plaza, where employees used gold pans to recover jewelry from flood muck in 1977. F. Intersection of Emanuel Cleaver II Boulevard and J.C. Nichols Parkway with structure modeled after the Giralda Tower of Seville visible to the right. The high-water mark for 1977 flood was located near the point from which the picture was taken.

- 0.0 mi STOP 1.** Begin the trip in the County Club Plaza from the intersection of Broadway Avenue and Ward Parkway (Fig. 2A). Cross the Broadway Avenue Bridge over Brush Creek and continue south on Broadway Avenue until it becomes Wornall Road. The present bridge was built in 1980 to replace an earlier structure, which created a dam and restricted considerable downstream flow of water during the 1977 Plaza Flood (Faulkner, 1996). The high water mark at the Broadway Avenue Bridge was about 1.5 m above the level of Ward Parkway pavement at the peak of the 1977 Plaza flood. However, a previous publication issued by the Kansas City municipal government, predicted a standard, projected flood height of ca. 2.5 m (anonymous, 1970).

**5.25 mi STOP 5** Park on the right hand side and view the bridge and the channels shown on Figure 2. Continue east on Ward Parkway.

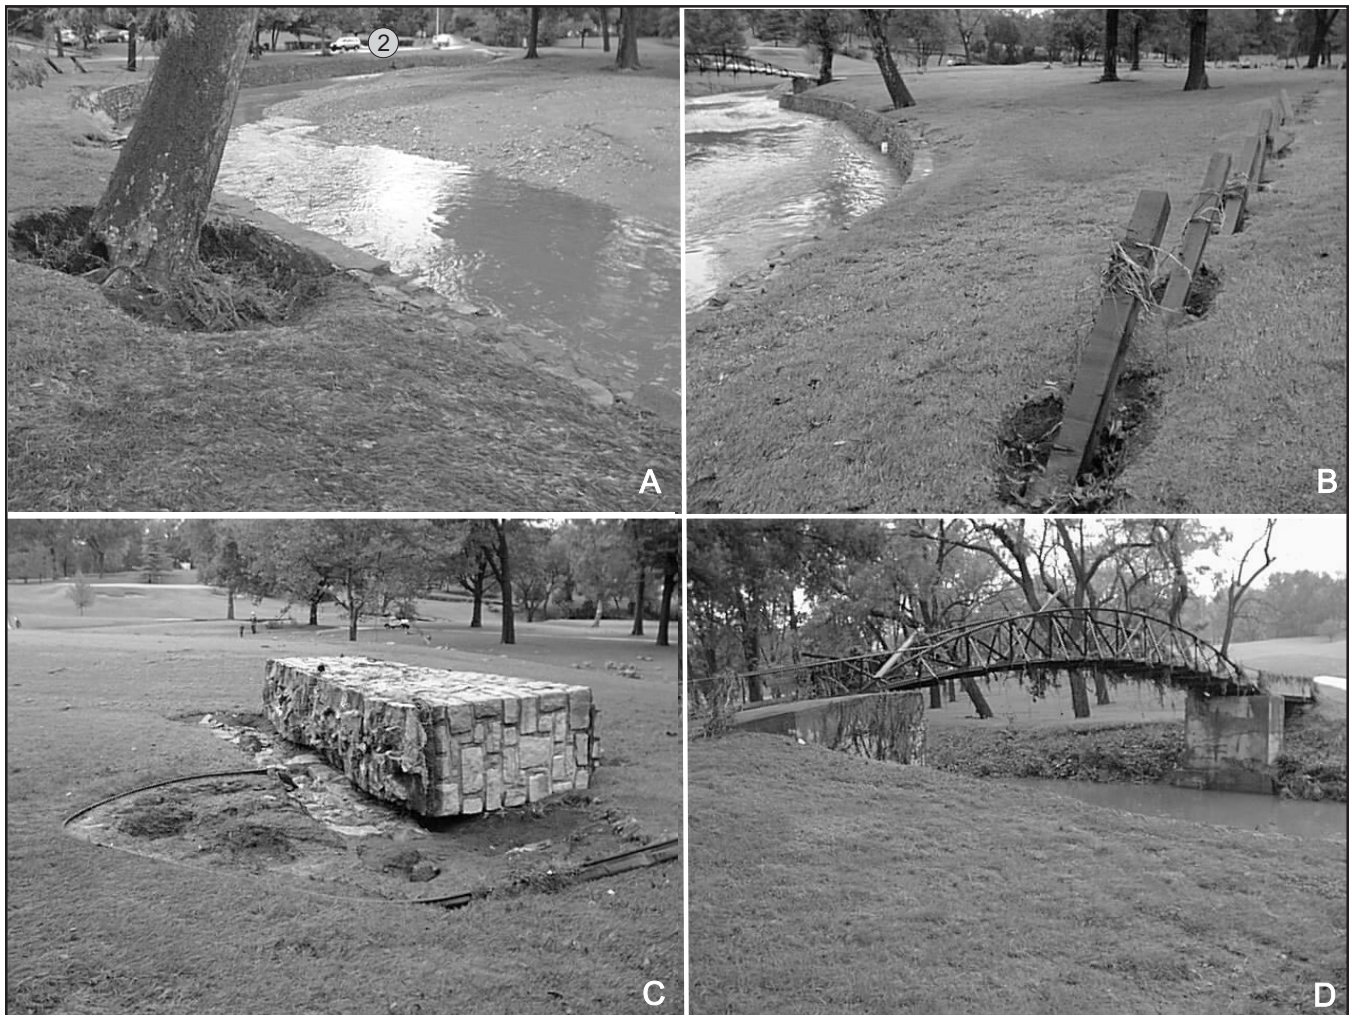
*Figure 3. Flood damage in Mission Hills, Kansas. A. View toward stop 2, stream channel and active gravel bar. Note scouring at base of sycamore, 2 m above normal stream level. Note fence posts located 3 m above normal stream a level and visible in upper left hand corner of photograph. B, C. Fence posts and toppled stonewall just downstream from stop 2. D. Pedestrian bridge on Mission Hills golf course with flood debris sitting six meters above the normal level of Brush Creek, near stop 4 on State Line Road.*

- 1.9 mi STOP 2.** On the right view house that was reconstructed after the 1998 flood. The earlier 1½ story house that was located on this property was flooded in 1998. The homeowners were rescued from the attic by firefighters who came through the roof with axes. The present house is elevated to allow water to pass readily underneath during major rain events. Fence posts, a pedestrian bridge, and a large mortared stonewall at the entrance to the Mission Hills Country Club were all flattened by the 1998 flood (Fig. 3).

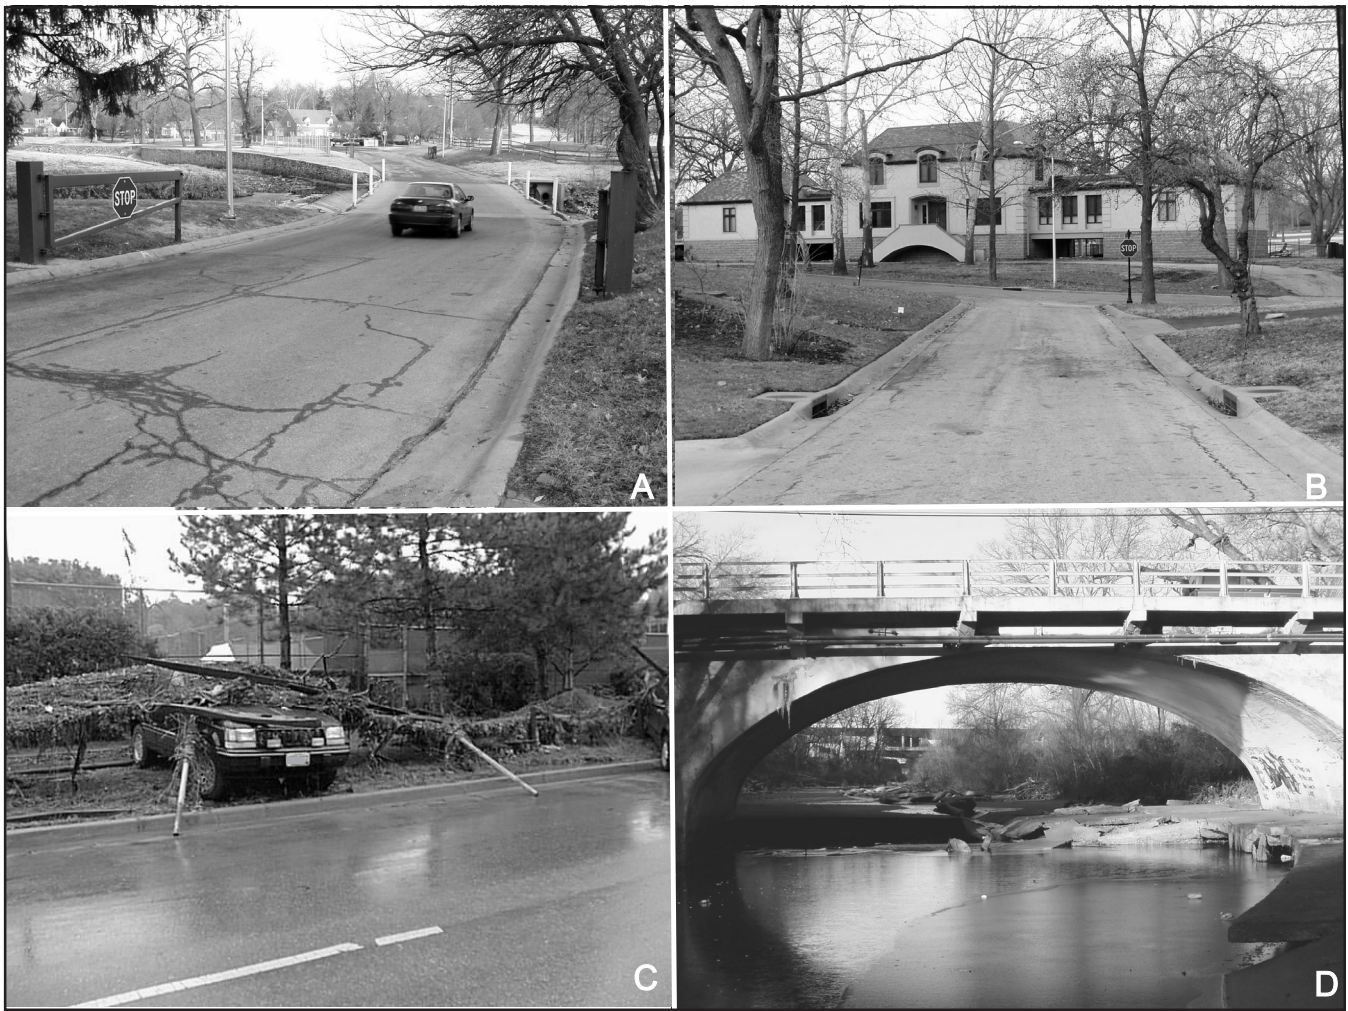
Figure 4. Hazardous sites along Brush Creek. A. Belinder road crossing at the border between Mission Hills and Fairway Kansas, where two individuals died in their car when they attempted to cross Brush Creek during the 1977 flood. Note wooden gate that is closed during major rainfalls in an effort to prevent the occurrence of such tragic events in the future. B. Home just west of Stop 2 on Mission Parkway replacing house that was flooded in 1977 and 1998. The new house was built after the 1998 flood and is elevated to permit the flow of storm water. Two residents were trapped in the attic of the original house in 1998, and had to be rescued by firefighters who came through the roof with axes. C. SRV whose driver perished on State Line Road during the 1998 flood. D. Prospect Avenue Bridge, 2003, from which seven individuals were swept away during the 1998 flood. An inexpensive solution, such as the wooden gate depicted in Fig. 5A, may have prevented such a tragedy. The bridge is slated for demolition in 2003. Note disrupted and undermined Pendergast-era concrete to lower right and also beneath the bridge.

- 2.3 mi Turn right on Belinder Avenue and keep to the left and park on Brookbank Lane.
- 2.35 mi STOP 3.** Belinder Avenue crosses Brush Creek through a gate that can be closed during major rainfalls to prevent people from attempting to pass over Brush Creek. Two individuals were killed in 1977 as they attempted to cross the creek in their car. Continue north on Belinder Avenue past the Mission Hills Country Club. After crossing Brush Creek, the route leads into Fairway, Kansas.

- 3.5 mi STOP 4.** The State Line Bridge and the Ward Parkway Bridge visible about 50 m downstream were both overtopped by the 1977 and the 1998 floods. Across Brush Creek on the east side of State Line Road is a low spot where the driver of a sports utility vehicle (depicted in Fig. 4C) was killed during the 1998 flood.

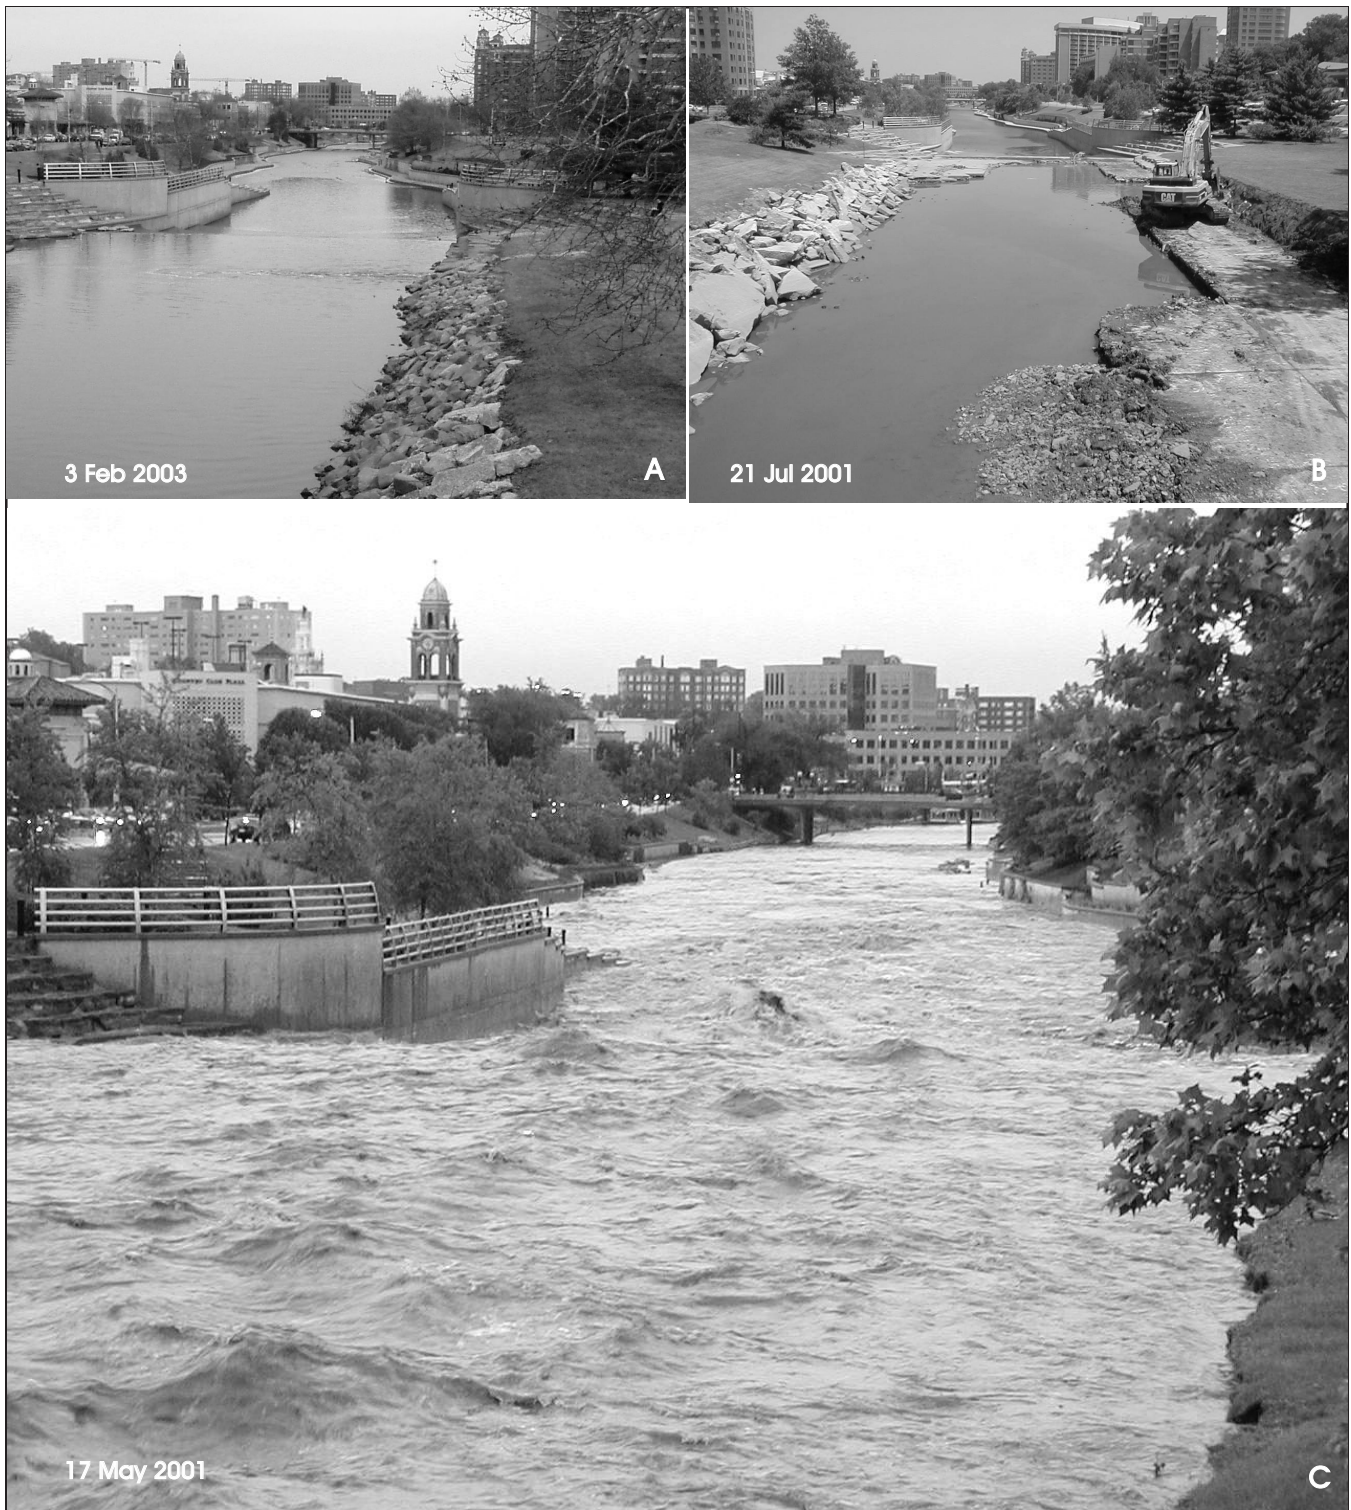
Figure 5. Brush Creek and Country Club Plaza, viewed toward the east from Roanoke Parkway Bridge. A. on a dry day after a prolonged drought in February 2003. B. During July 2001 when the channel was stripped of a concrete liner and deepened by about 2 m to facilitate flow and lessen the impact of rain events and flooding. C. After rainfall of several inches on 17 May 2001. The tower visible in the distance in all three photographs is located at the starting point of the trip.

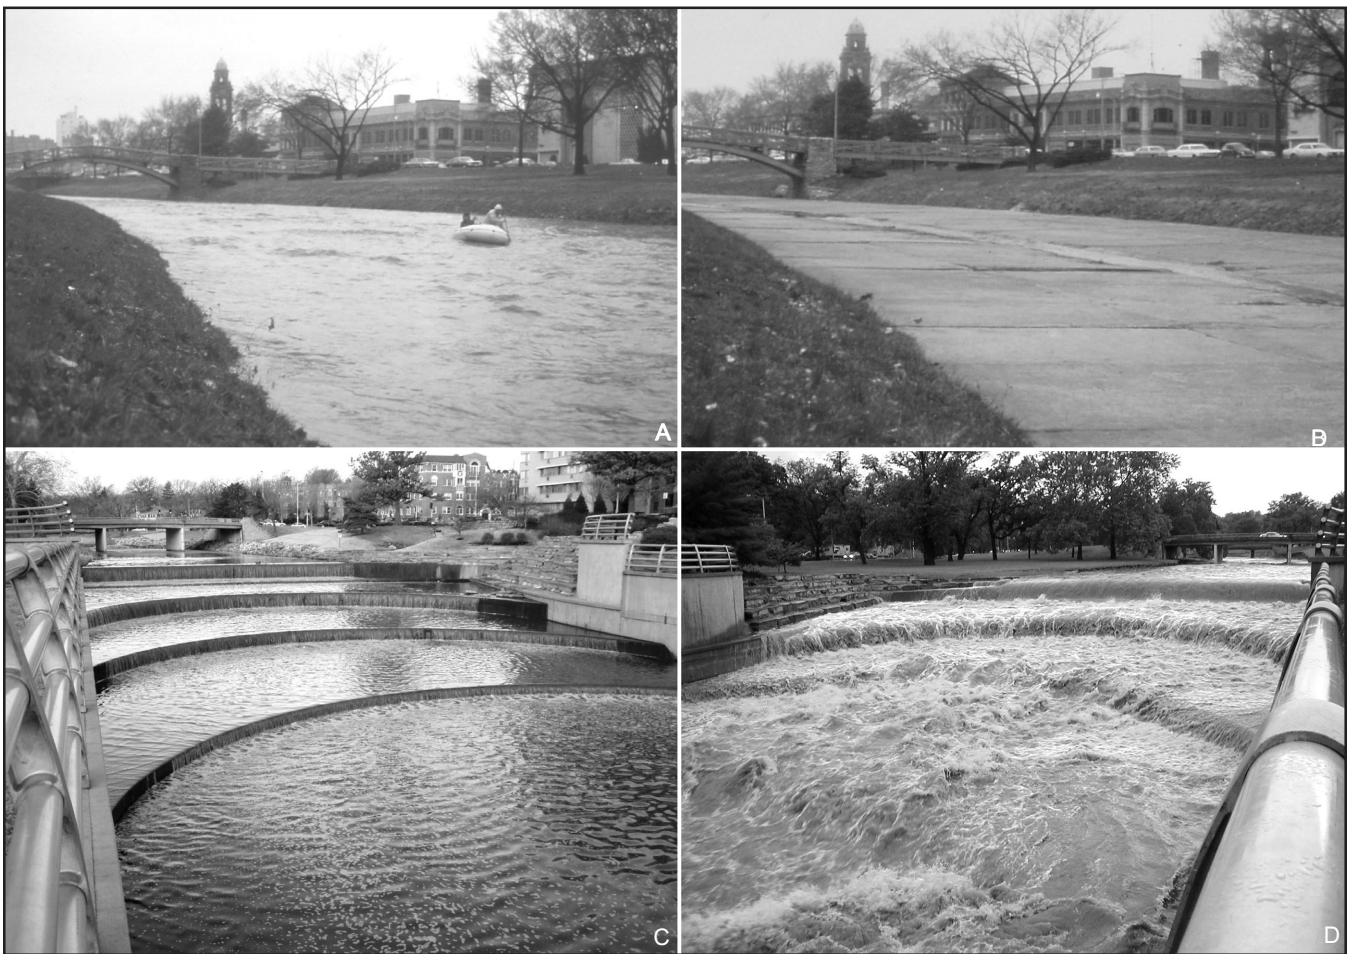
Figure 6. Pre-1977 and 2001 Views of Brush Creek flow rates.

A. Brush Creek after 9 cm rainfall ca. 1974. B. Same scene as 6A on normal day ca. 1974. Note Pendergast-era concrete pavement. C. July 2001 view of stepped waterfall built when the Brush Creek channel was modified after the 1977 flood. The water flow results from recirculation of water by pumping from the east end of the Country Club Plaza to the south bank near Roanoke Parkway (Stop 5). D. Flowage of Brush Creek and standing wave at Stop 5 resulting after 10-15 cm of rain on 17 May 2001.
