Water Resources Report Number 76

Revised Recharge Areas of Selected Large Springs in the Big Four Region of the Ozarks

By
James W. Duley and Cecil Boswell

Missouri Department of Natural Resources, Missouri Geological Survey 2017
Revised Recharge Areas of Selected Large Springs in the Big Four Region of the Ozarks
Water Resources Report Number 76, 155 pages, 110 figures, 10 tables.

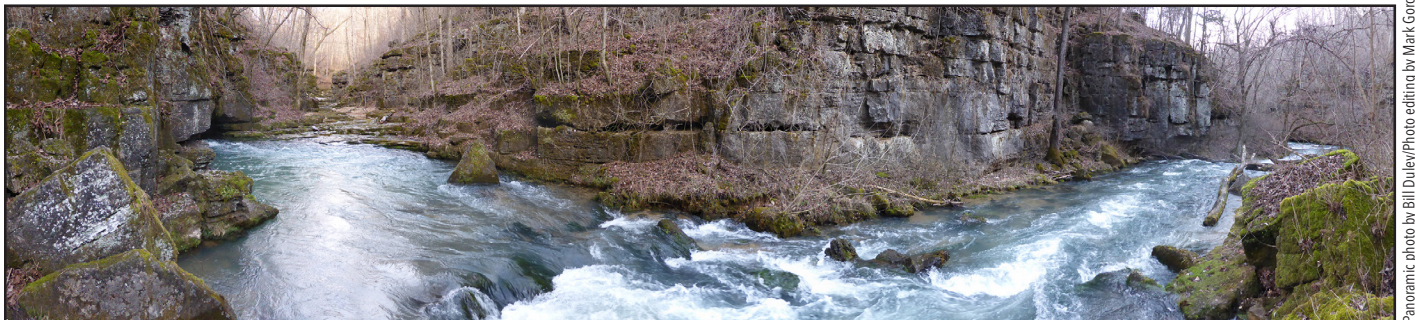
Figure 1. Panoramic view of upper Greer Spring (left) and the spring branch leading to lower Greer Spring.

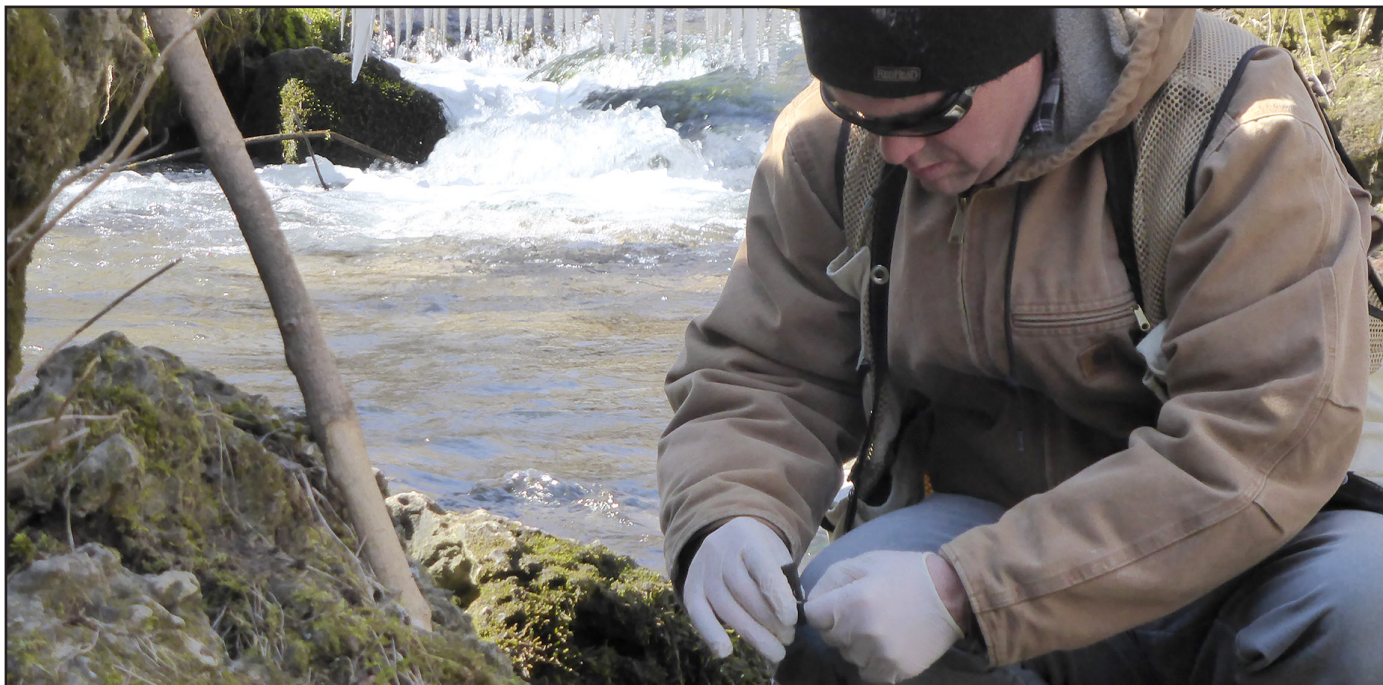
Figure 6. Coauthor replacing a carbon packet at upper Greer Spring.

MGS staff compared two protocols for collecting and detecting fluorescent tracers during this study. The standard protocol (Protocol 1) used by MGS in recent years involves use of activated coconut charcoal (6 to 12 mesh) to collect fluorescent tracers in the field. Charcoal (about 9.5 grams) is placed in packets constructed of common nylon window screen. Packets are then secured in the water at the monitoring point for periods ranging from days to weeks (Figure 6). They are replaced on a regular basis and analyzed in the MGS Water Tracing Laboratory using fluorescence spectrometry techniques. Background packets are normally collected and analyzed for periods ranging from weeks to months prior to dye injection to assure that the impact of other fluorescent compounds can be minimized.

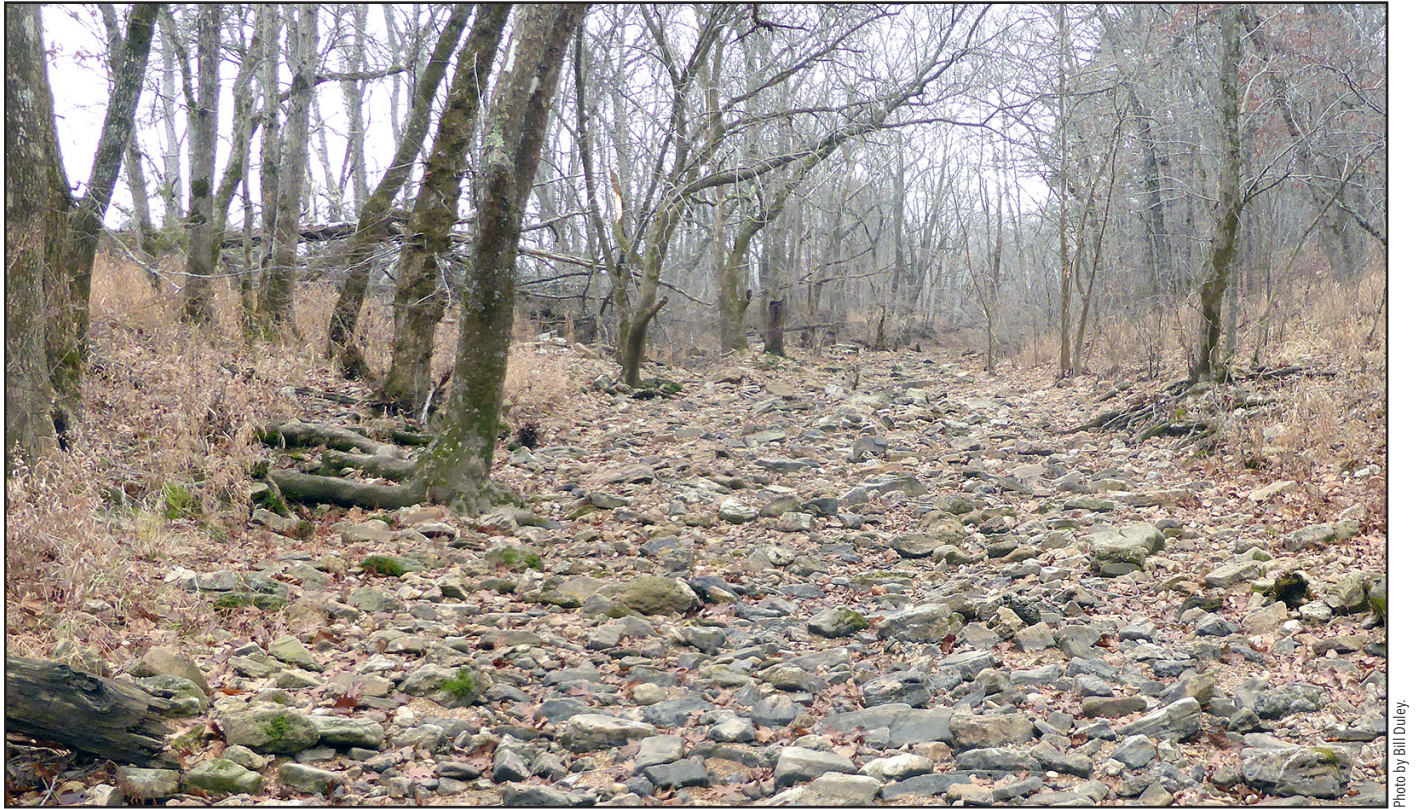
Figure 10. Losing stream - Middle Fork of the Eleven Point River downstream of a gaining segment.

Due to budget limitations and access issues, it was not possible to view more than a small percentage of streams in the study area. Nevertheless, by observing stream crossings it is possible to get a reasonable approximation of where losing and gaining stream reaches are present (Figure 10). Large areas in the region are essentially devoid of flowing streams, or even pools of water, during dry periods. Documented gaining stream reaches are much rarer than losing streams within the recharge areas of major springs in the region. Numerous gaining stream reaches are discontinuous and can be observed flowing

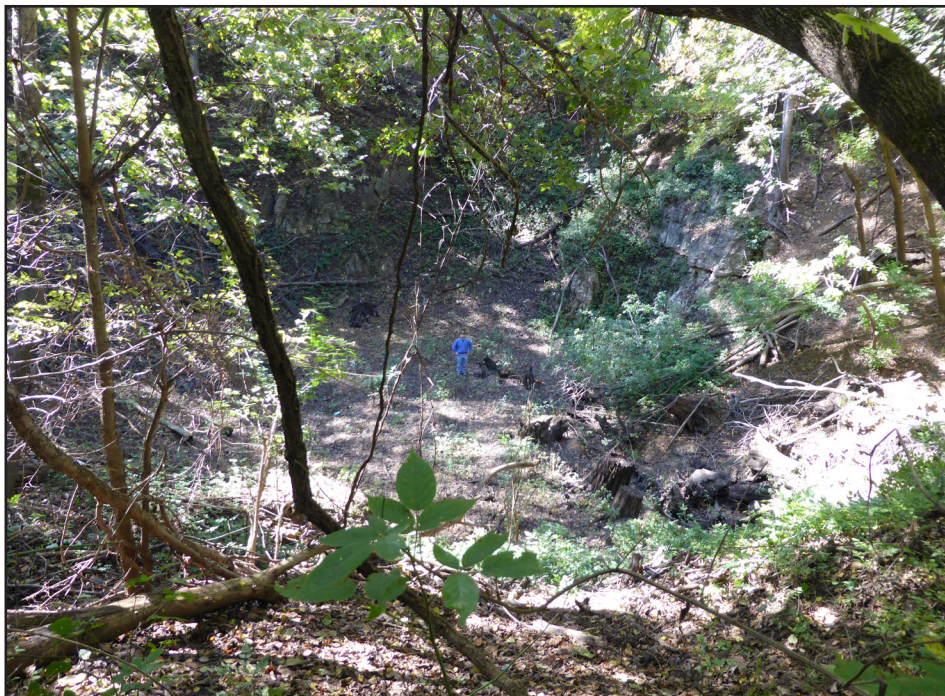
Figure 11. Sinkhole north of Alton once used as a dye injection point (IP4 - Aley, 1972).

Disseminated sinkholes are found throughout the region (Figure 11). They rarely are provided with a continuous flow of water to carry a tracer significant distances into the subsurface. The largest sinkhole plains in the region are included in recharge areas of springs. However, limited trace information exists with respect

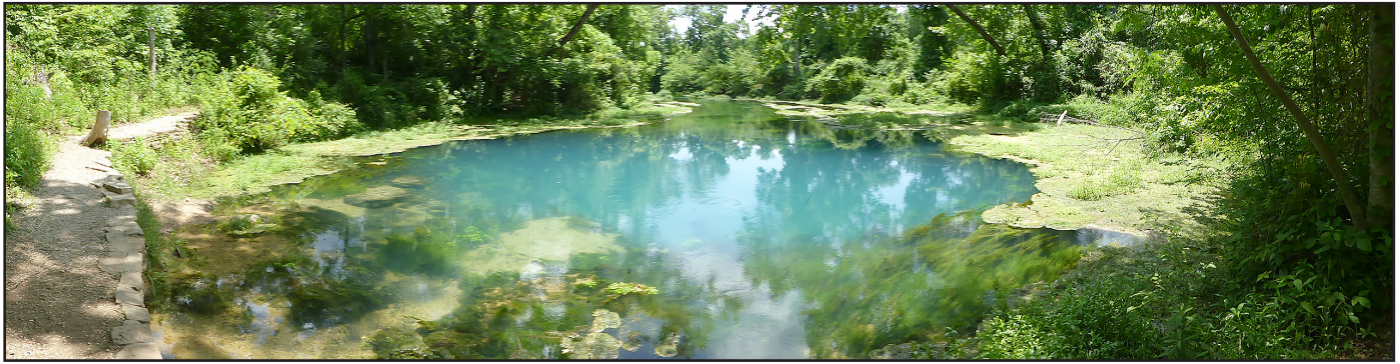
Figure 18. Boze Mill Spring orifice looking downstream.

Boze Mill Spring (Figure 18) issues from a bedrock opening at floodplain elevation on the east side of the Eleven Point River. A rock dam was constructed across the spring branch in the past to provide power to Boze Mill. The mill is gone but some associated machinery remains near the dam (Figure 19). Vineyard and Feder (1974) summarized discharge measurements of Boze Mill as a maximum of 46.0 ft³/s, a minimum of 13.0 ft³/s and an average of 23.0 ft³/s (10 measurements).

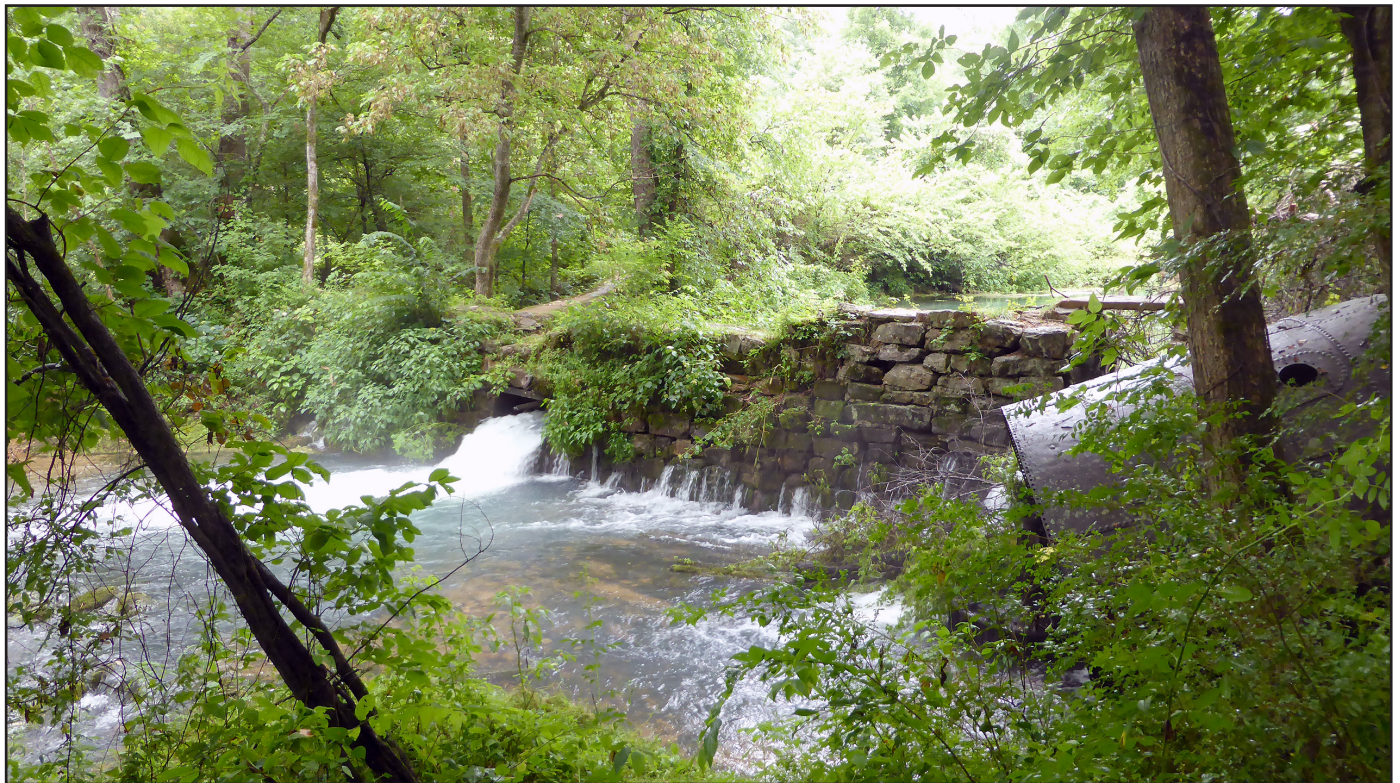
Figure 19. Boze Mill dam with associated machinery.

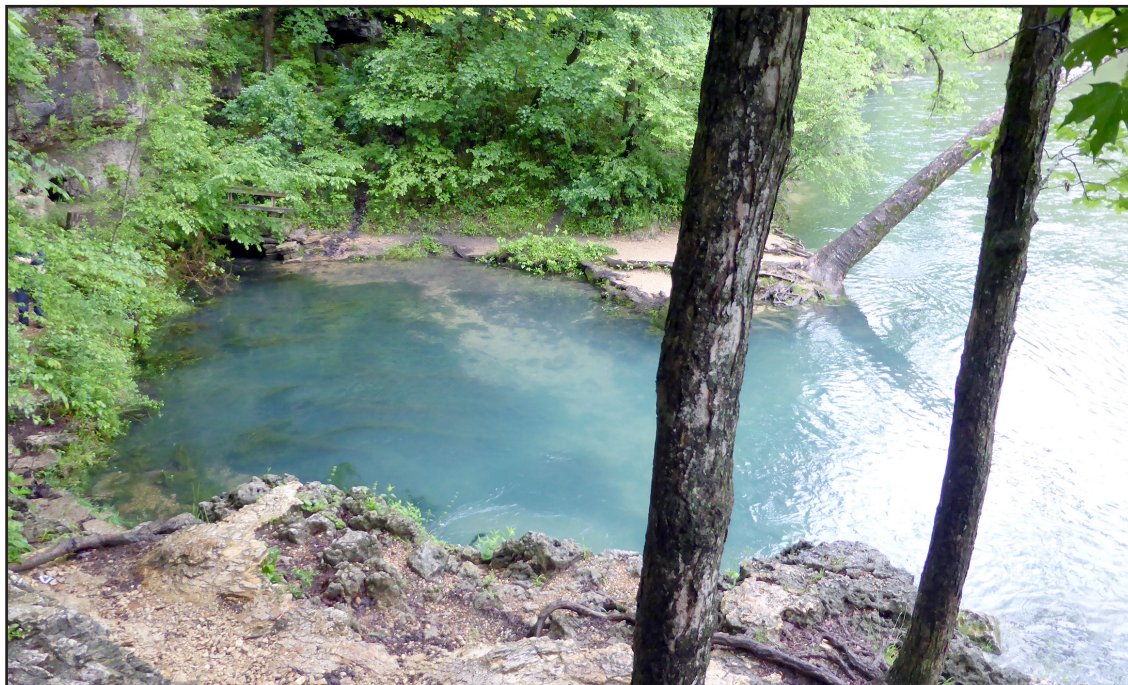
Figure 24. Blue Spring (Ozark County) on the North Fork.

Blue Spring (Ozark County) is located on the east bank of the North Fork River. It rises in a small boil in a bedrock lined recess in the North Fork River bluff. Blue Spring is an attraction at a USFS day use and camping area located off Missouri Route CC. Hammond Mill, now gone, was once located upstream of Blue Spring on the North Fork. Blue Spring is inundated when the North Fork is in flood, but the spring can still be viewed from a trail and an overlook atop a small bluff just east of the river (Figure 24). Blue Spring issues from the lower part of the Gasconade Dolomite. Six flow measurements ranging between 9.5 and 30 ft³/s, with most of the measurements in the 10 to 12 ft³/s range, are recorded in Vineyard and Feder (1974).

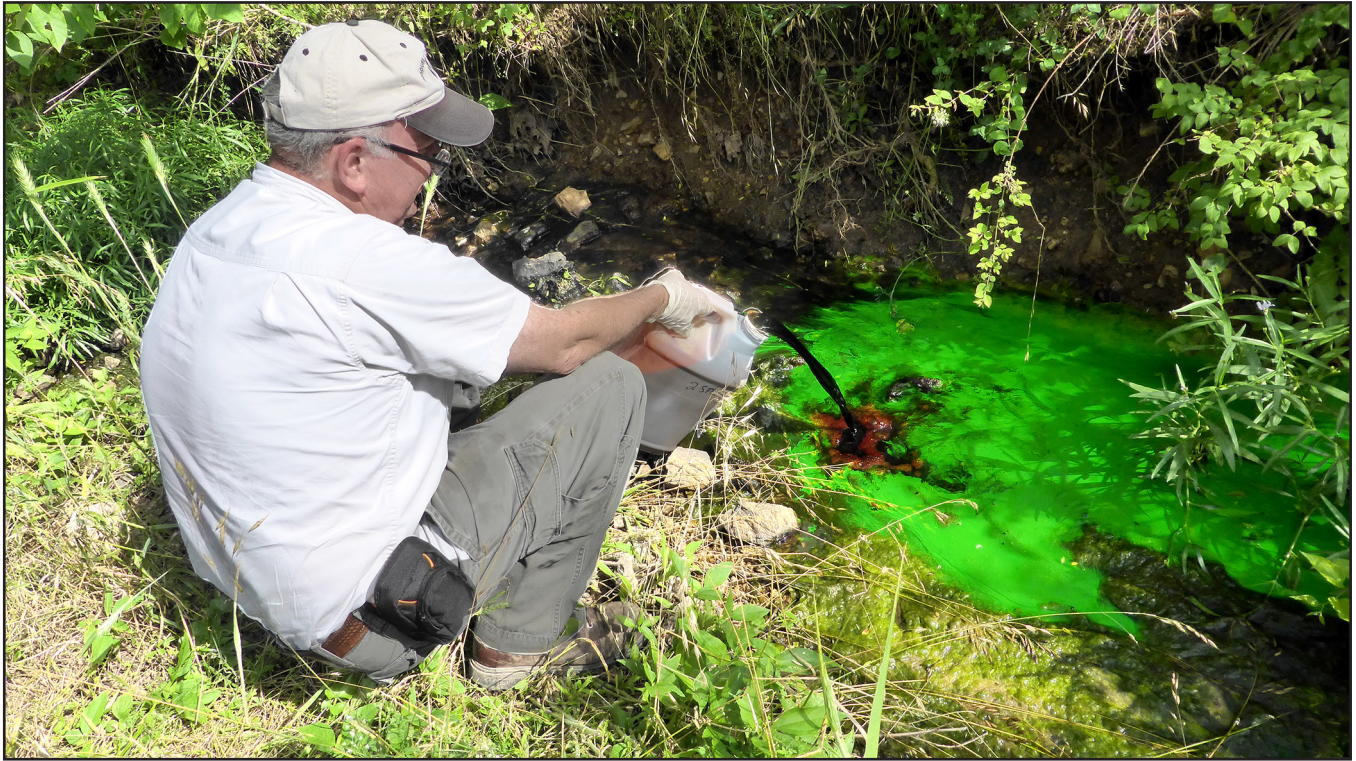
Figure 25. Fluorescein injection into upper Tabor Creek.

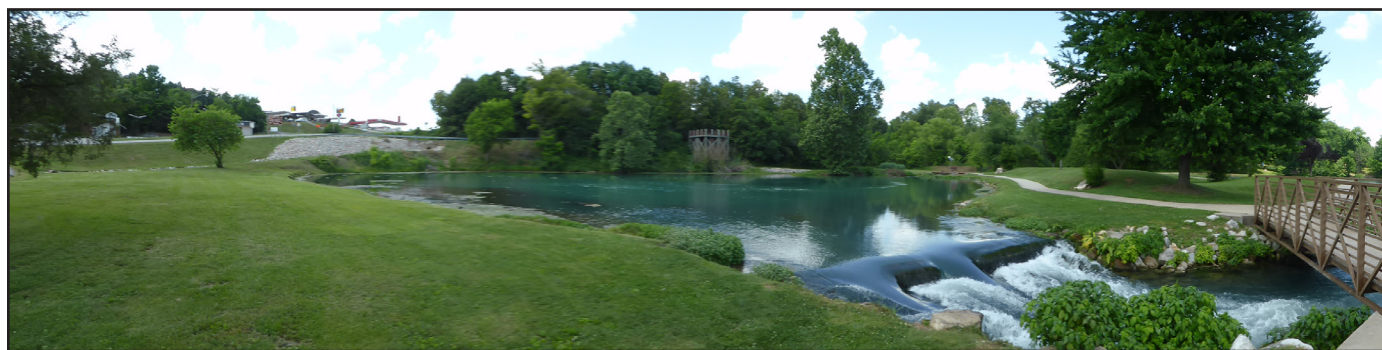
Figure 29. Panoramic view of Mammoth Spring in Mammoth Spring State Park, Arkansas.

Mammoth Spring issues from a single steeply inclined conduit into an artificial reservoir several hundred feet south of the Missouri state line (Figure 29). It is the major feature of Mammoth Spring State Park in Arkansas and is the largest spring in that state. For many years it was considered to be the second largest spring in the Ozarks, having been gaged continuously since 1981 with a mean discharge of approximately 351 ft³/s over that period. However, a comparison with Greer Spring (water years 1982 to 2015) suggests that Greer Spring is larger (see discussion below). Continuous gaging at Greer Spring and Big Spring (Carter County) in Missouri collected over the same time period shows that

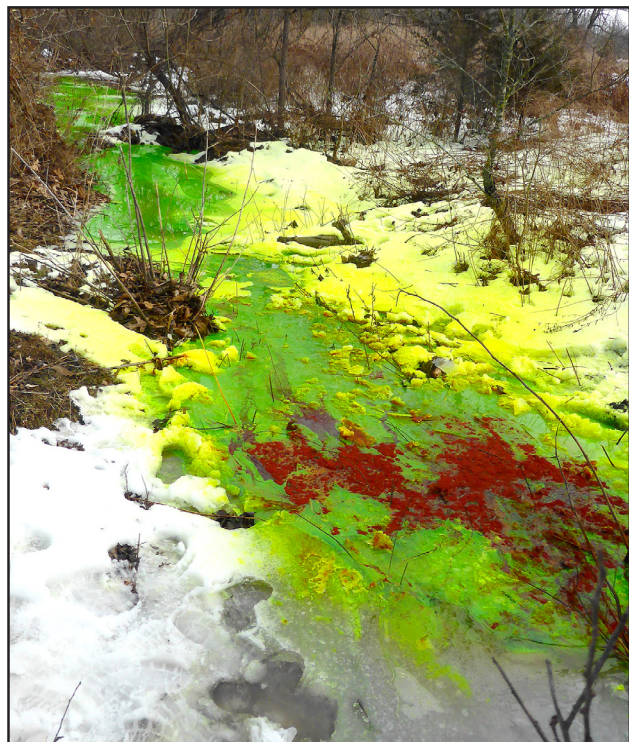
Figure 42. Mustion Creek injection.

uppermost reach of this particular branch of Mustion Creek is gaining with about 10 gpm flowing into a small series of pools where all surface flow is lost (Figure 42). Ten pounds of fluorescein were injected just upstream of these pools at 1:00 p.m. on Feb. 14, 2014. No flow was observed in Mustion Creek for more than five miles downstream during the study.

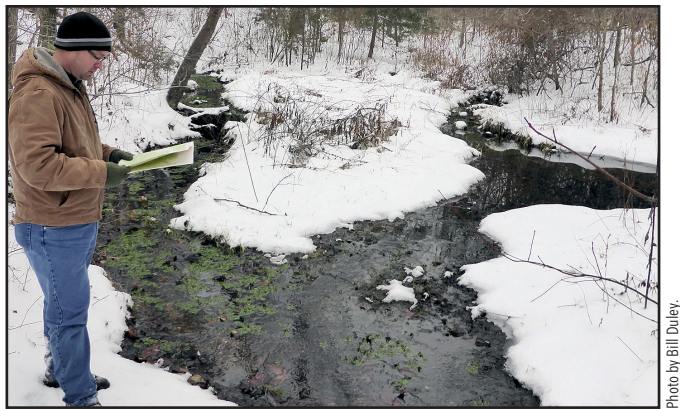
Figure 44. Rattlesnake Spring with its characteristic “fangs.”

Rattlesnake Spring is a small spring (IP84) at an altitude of about 990 feet with a normal flow of about 15 gpm (Figure 44). During dry periods all flow is lost from the spring branch within 300 yards downstream. This branch was used as a fluorescein injection site on May 7, 1978. Vandike (1979) reported dye recovery at two locations, Big Spring (Douglas County, NF6) and Rainbow Spring (NF1). Via personal communication, Vandike (retired MGS, 2014) expressed reservations about visual methodologies in general of legacy traces such as this one and specifically about the recovery at Rainbow Spring. He also noted that he did not monitor Mammoth Spring or Greer Spring during the original trace.

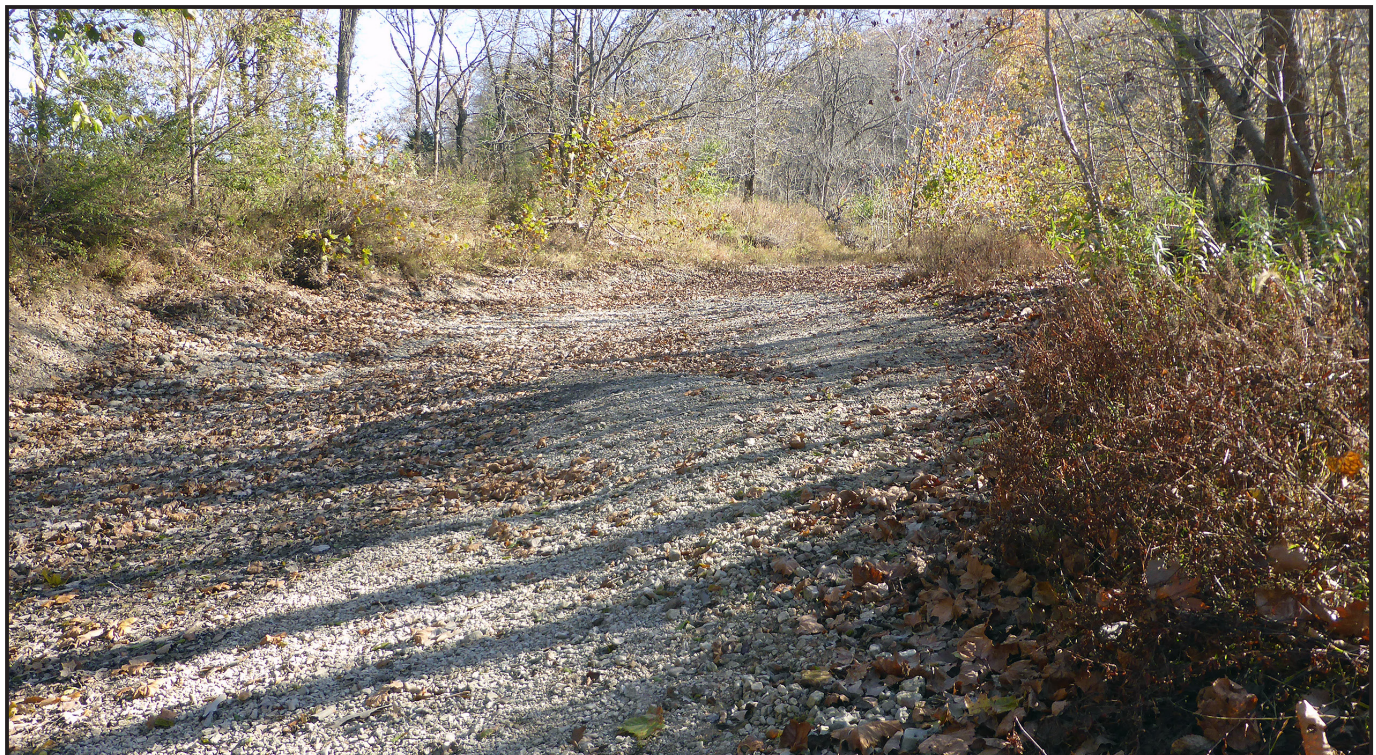
Figure 49. Eleven Point River at Lost Hill injection pool one week after the injection.

Five pounds of eosine were injected into the losing reach of the Eleven Point River channel about three miles downstream of Missouri Route W (IP46). The injection was conducted by MGS staff at 5:00 p.m. on Oct. 28, 2014, into a moderate sized pool about 150 feet long by 10 feet wide and two to three feet deep. Flow into the pool on the date of injection was estimated at 50 gpm with no significant surface flow occurring downstream for at least a mile. When the injection site was revisited on Nov. 4, 2015, this pool was completely dry and the water loss point had migrated upstream about 100 yards (Figure 49).

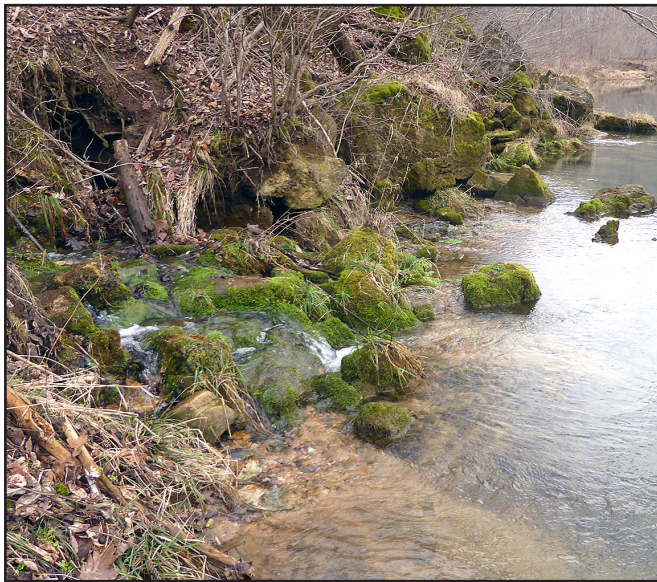
Figure 55. Most of the flow of Bill Mac Spring rises in a pool of the Eleven Point River, but numerous outlets can be observed at or below river level during high spring-flow events,.

Bill Mac Spring is normally the largest spring in the Eleven Point River upstream of Thomasville. It issues from a pile of huge boulders at the base of a sandstone and dolomite bluff of the Roubidoux Formation and flows directly into the Eleven Point (Figure 55). During dry periods, the Eleven Point River displays no flow just

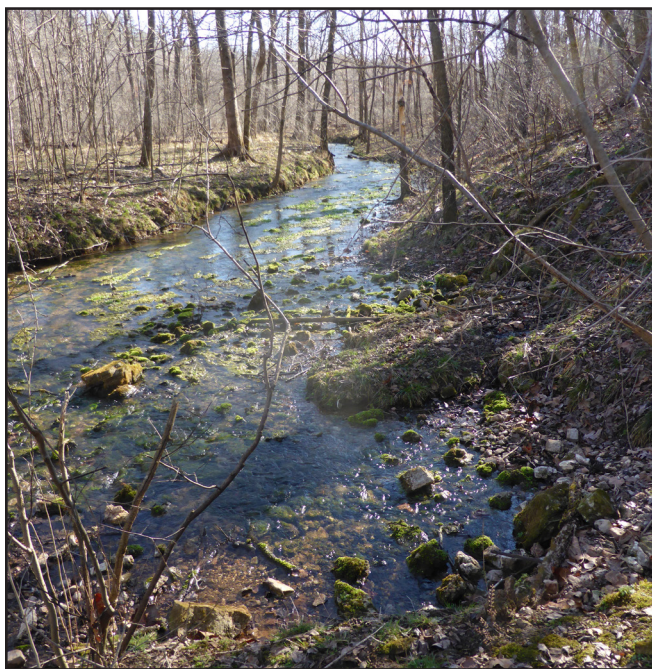
Figure 57. Rookery Tree Spring.

Rookery Tree Complex is a group of springs on the Middle Fork of the Eleven Point River that have not been thoroughly evaluated. During this study, three springs (Rookery Tree, Steepshead and Bluff: Figures 57-59) were observed to issue from the Roubidoux Formation on a

Rookery Tree Spring had no flow on Nov. 2, 2015 while both Steepshead and Bluff springs had small flows (estimated at 0.25 ft³/s each) on that date. Upstream of Bluff Spring, the Middle Fork also had no flow on that date, which suggests that either the other upstream spring is a wet weather spring like Rookery Tree, or the Middle Fork has another losing reach upstream from the main part of the complex.

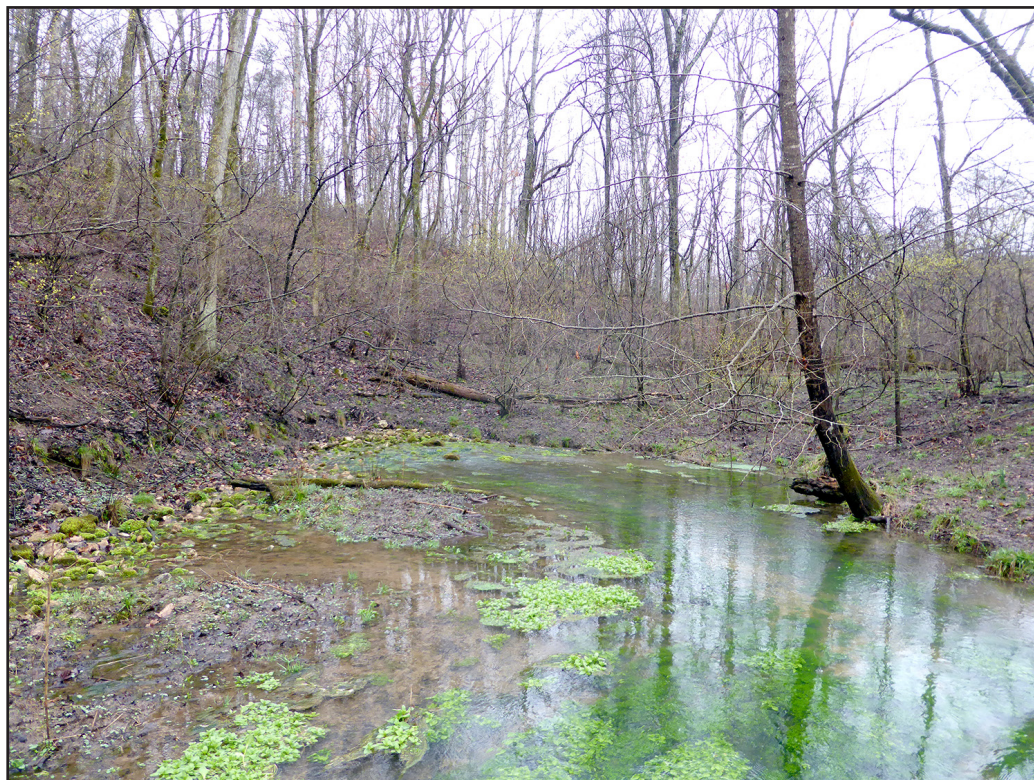
Figure 58. Steepshead Spring.

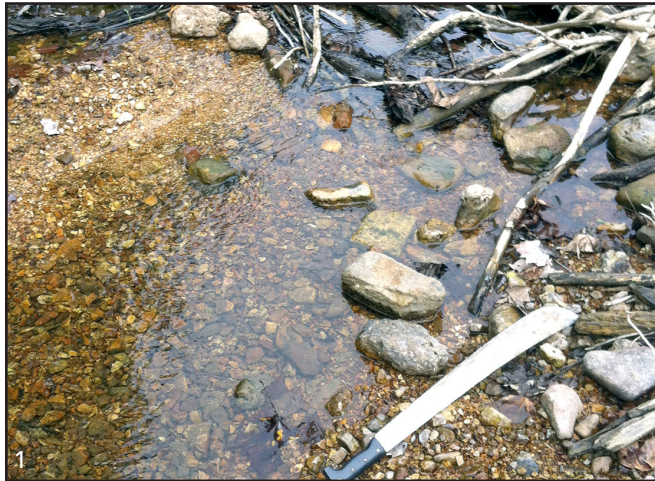
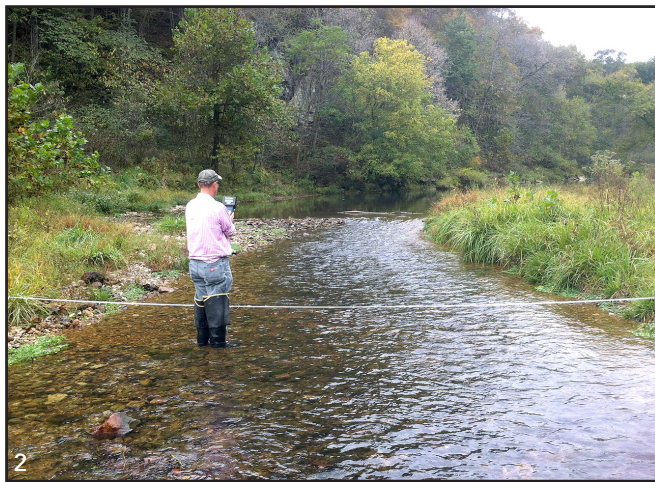
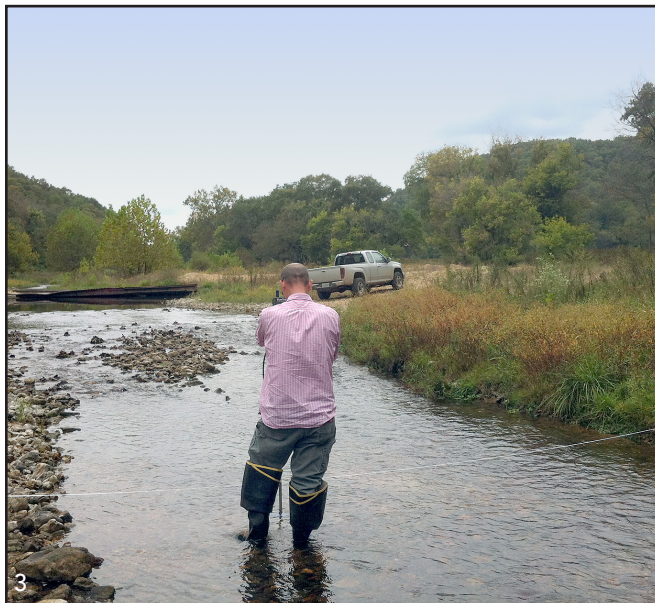
Figure 65. Three views of the Eleven Point River on October 7, 2015-Top to Bottom: 1. Upstream of Bill Mac Spring (Note: 27 inch machete for scale). 2. Measuring stream flow downstream of Bill Mac Spring and 3. Below the losing segment.

Dye was first recovered at Bill Mac Spring and downstream in packets in place Oct. 7 to Oct. 14, 2015. The small recovery is shown on Figure 64 along with the earlier recovery (January through April) from the replication injection downstream in the Middle Fork (Or 043). Due to the small size of the recovery, additional investigations were undertaken to help determine

Beginning with the first packets removed from these locations, degraded Rhodamine WT™ was found at all four of these monitoring points. Degraded Rhodamine WT™ was also recovered at Bill Mac Spring in packets in place during approximately the same time period (Dec. 9 to Dec. 16, 2015).

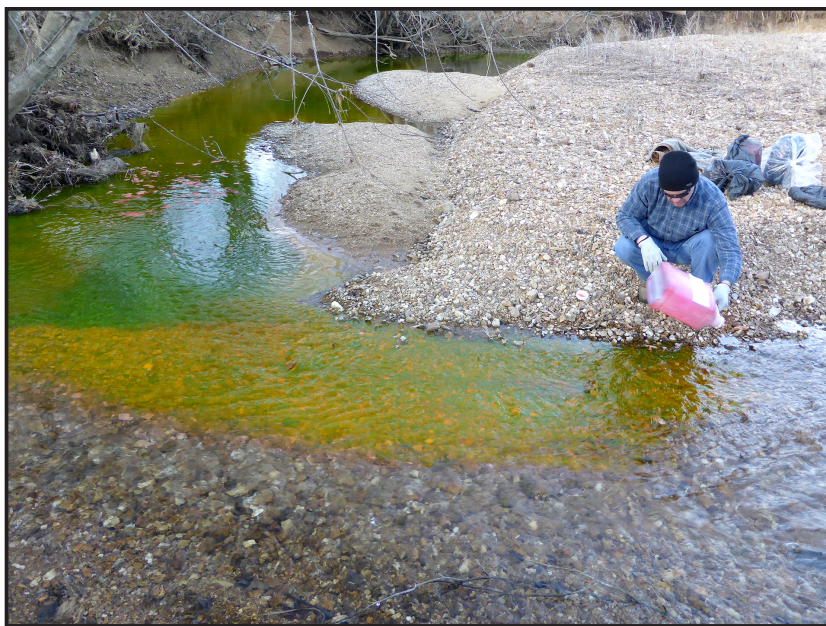
Figure 66. Second injection upstream of Fanchon at IP73.

Because of questions raised during earlier work, MGS staff injected 10 pounds of eosine into the Middle Fork losing segment upstream of Fanchon (IP73) at 4 p.m. on Feb. 9, 2016. Due to greater flow in the Middle Fork of the Eleven Point River, than was the case during the previous injection, the new injection point was moved downstream several hundred feet. About 0.25 ft³/sec was lost to the subsurface within 0.25 mile of the injection on that date (Figure 66).

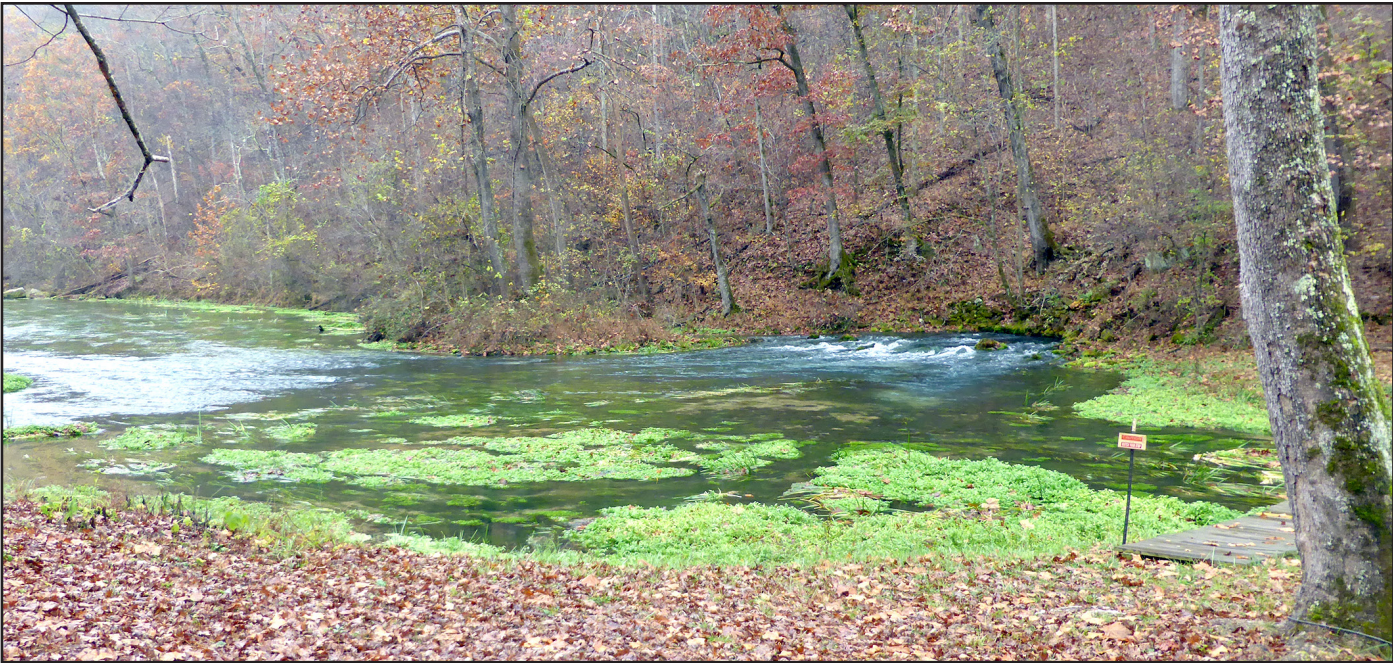
Figure 69. Rainbow Spring.

Rainbow Spring, also known as Double Spring, rises from a conduit on private property on the west side of the North Fork River at the base of a bluff composed of Roubidoux Formation sandstone (Figure 69). The discharge splits and flows through two channels to the

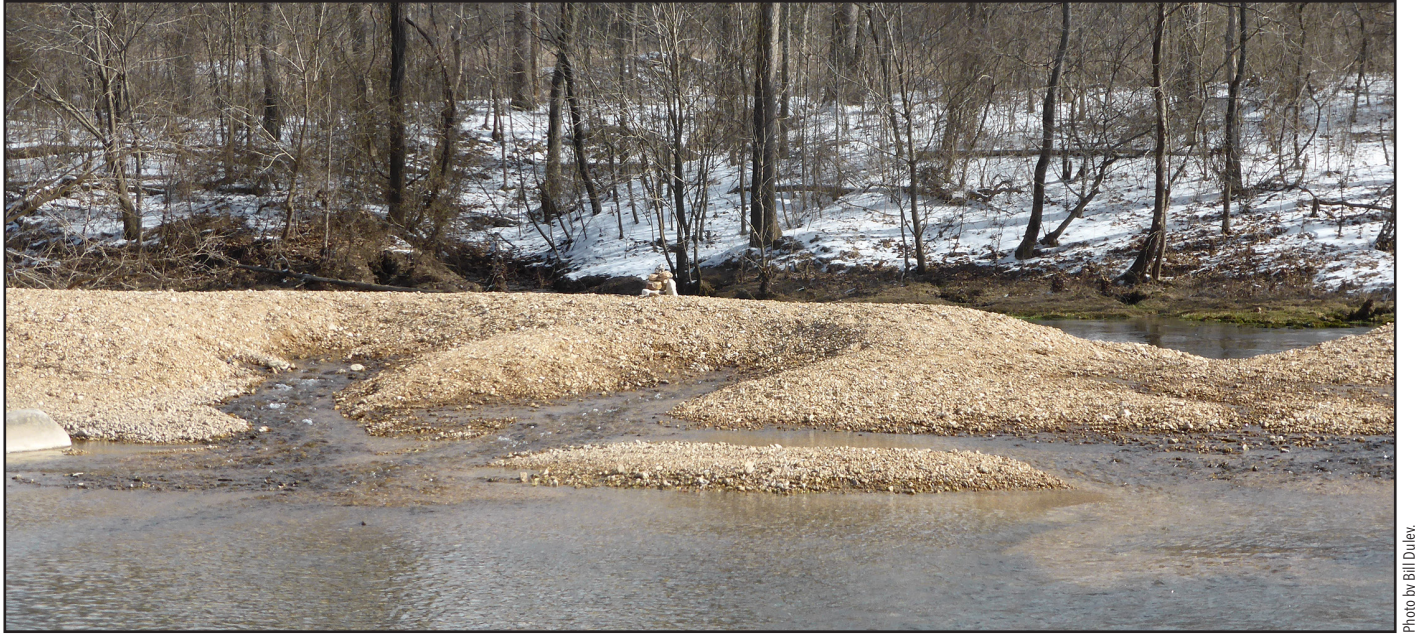
Figure 71. North Fork Spring rises in a gravel bar in the North Fork River.

North Fork, hence the alias Double Spring. Figure 70 shows the relationship of all springs in the complex. North Fork Spring, sometimes called Gravel Spring, rises from dissolution-enlarged joints or fractures in the channel of the North Fork several hundred yards upstream from Rainbow Spring (Figure 71). Interaction between the spring and the river has produced a sizable gravel bar from which much of the flow emerges.

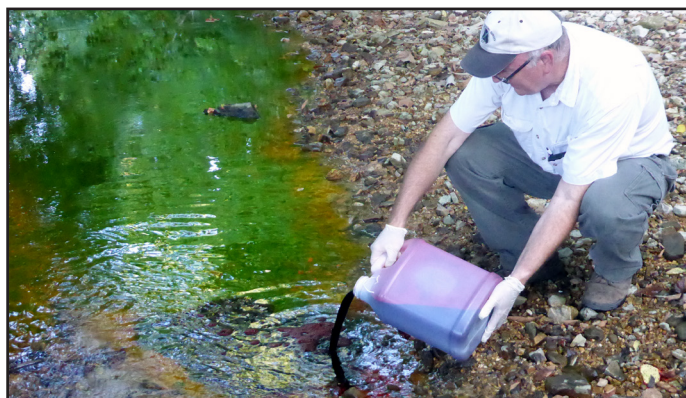
Figure 75. The senior author injecting eosine in upper Fox Creek.

First dye recovery from the Fox Creek injection was eight to 14 days later at all three springs of the Rainbow/North Fork/Hodgson Mill Complex in packets in place between Aug. 27 and Sept. 2, 2014. Large amounts of dye were recovered at Rainbow and Hodgson Mill springs with smaller recoveries at North Fork Spring. North Fork Spring was not monitored directly throughout most of the trace. The recovery curve (Figure 76) is from data collected downstream of the spring in the North Fork River. Packets upstream near Blue Spring did not contain dye while those downstream of North Fork Spring and upstream of Rainbow Spring did contain eosine. Peak dye recoveries occurred at all three springs in the complex between Sept. 2 and Sept. 9, 2014.

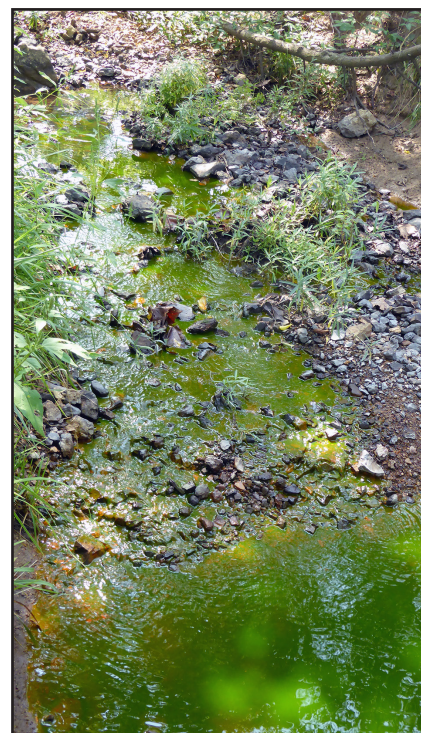
Figure 84. Spring Creek Pottersville injection.

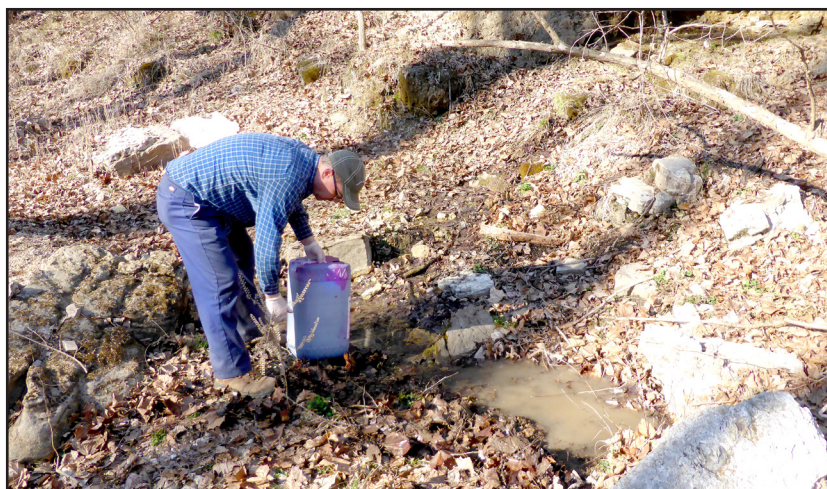
Fig 93. The coauthor during Dribble Cave Spring dye injection.

County). The new injection point (IP61) was located about 1.8 miles northwest of Rattlesnake Spring and is in the valley bottom of Dry Creek at an elevation of about 880 feet msl. A very small spring – less than one gpm discharge – issues from the mouth of a small cave in the right valley wall (looking downstream).

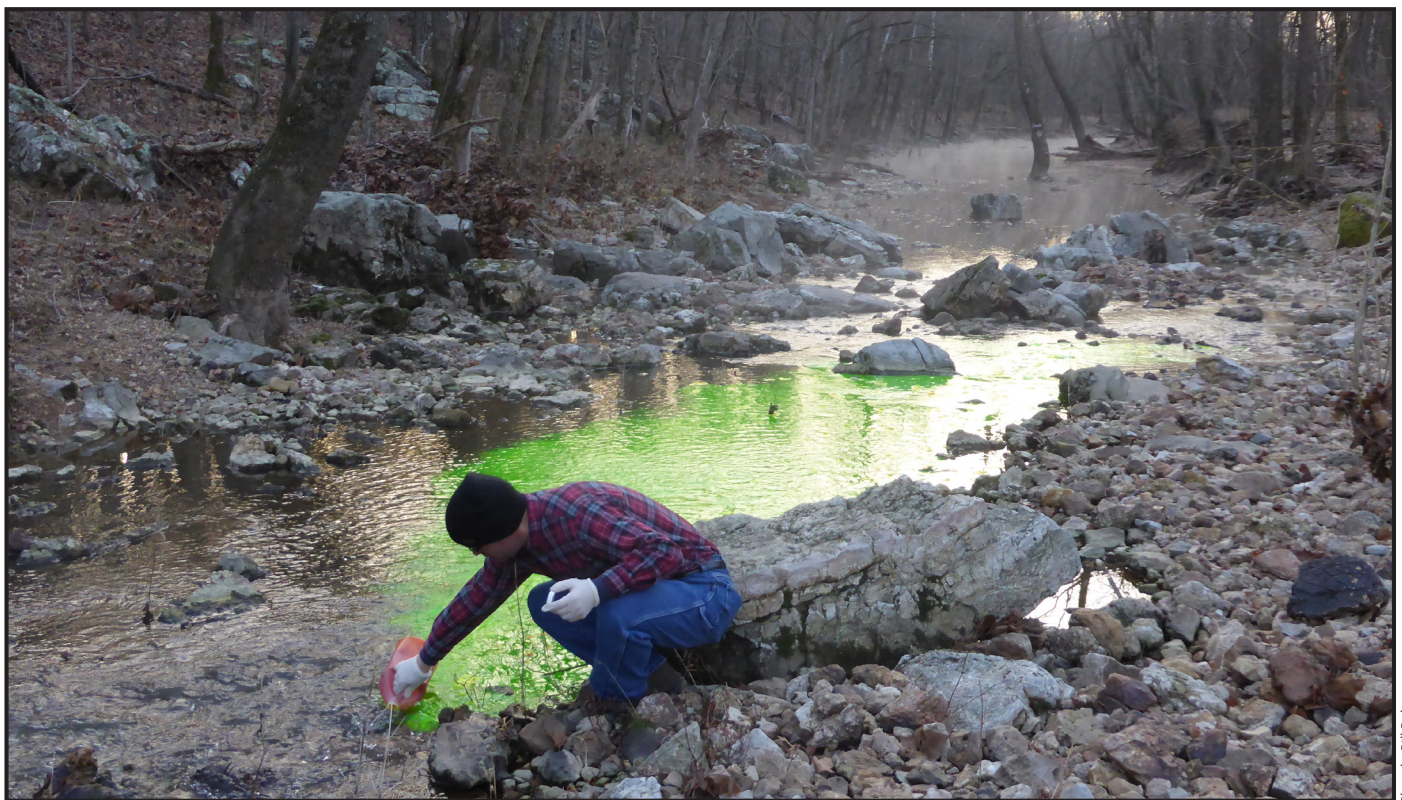
Figure 97. The coauthor injecting dye at Oregon County Road 333.

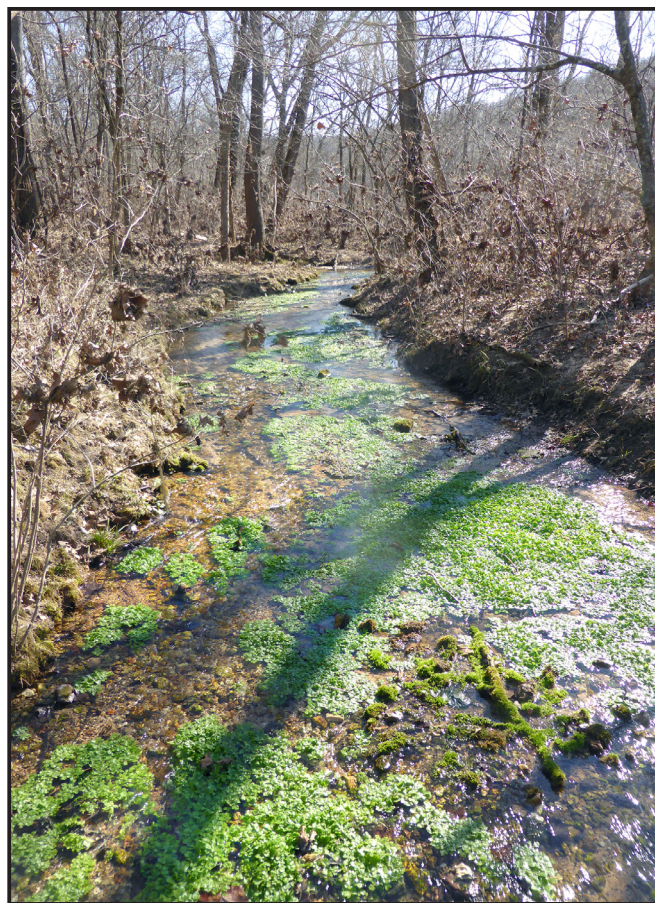
Figure 99: Perennial portion of Graveyard Complex (Graveyard - Main).

The authors of this study located two significant springs in the general area that are similar in size to the Dennig or Huff Spring of the literature. One (Figure 99) is about 100 yards downstream of the Ross Cemetery shown on the Greer USGS 7.5' quadrangle map.

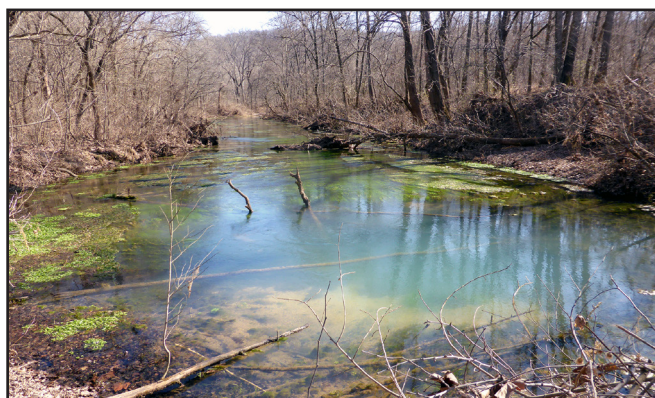
Figure 100. Dennig Complex Main spring branch.

A larger spring is located approximately 0.4 miles downstream from the spring near the cemetery (Figure 100). To further complicate the matter, each of these springs has more than one outlet with smaller rises seen as sand boils on the alluvial floodplain. In addition, the upstream complex has a wet-weather orifice located near the north edge of the alluvial valley that normally has no discharge (Figure 101).

The following descriptions are given to aid future investigators. A series of small sand boils in the alluvium mark the upstream end of Dennig Complex. Flow from the boils proceeds about 50 feet to the southeast where a large orifice discharges a large amount of flow into an alluvium-walled valley. For the purposes of this study, this large spring is termed "Dennig Complex – Main." This spring branch parallels the Eleven Point River for

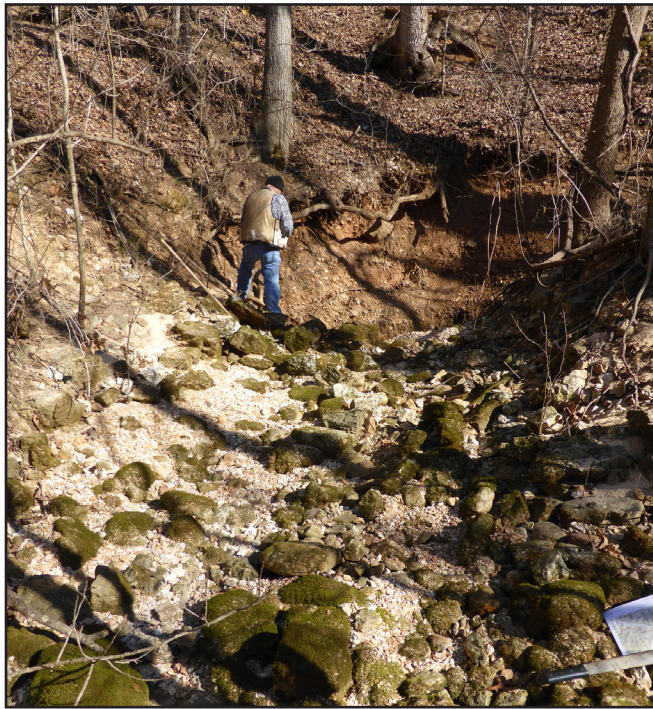
Figure 101. Wet weather orifice Graveyard Complex during low flow.

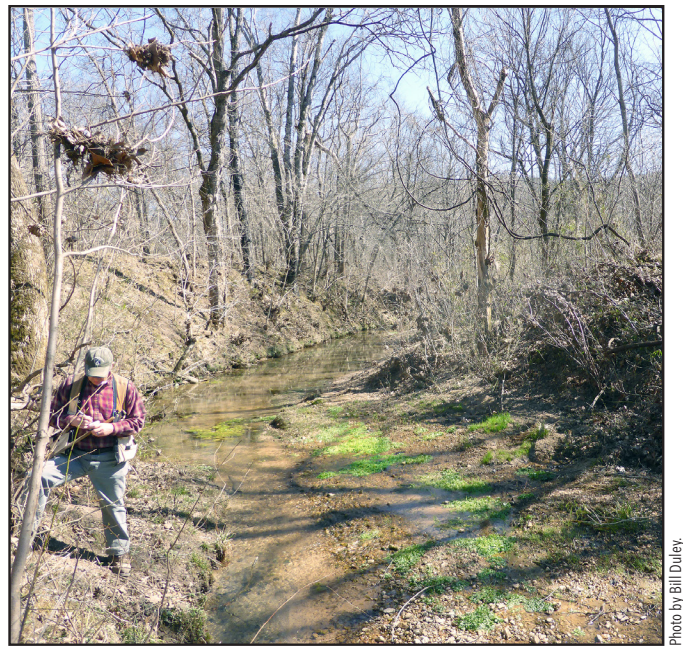
Figure 102. Changing packets at Dennig Complex – Minor.

While the springs near the graveyard could be called "upper Dennig" and the large series of springs downstream could be called "lower Dennig," there is good reason not to do so. The upstream complex near the cemetery has a distinct specific conductance signature as compared with that of the larger downstream complex. Thus, for this report, the upstream complex is termed "Graveyard" while the larger complex downstream is called "Dennig" (Figure 102).
