Water Resources Report Number 76

Revised Recharge Areas of Selected Large Springs in the Big Four Region of the Ozarks

By
James W. Duley and Cecil Boswell

Missouri Department of Natural Resources, Missouri Geological Survey 2017
Revised Recharge Areas of Selected Large Springs in the Big Four Region of the Ozarks
Water Resources Report Number 76, 155 pages, 110 figures, 10 tables.

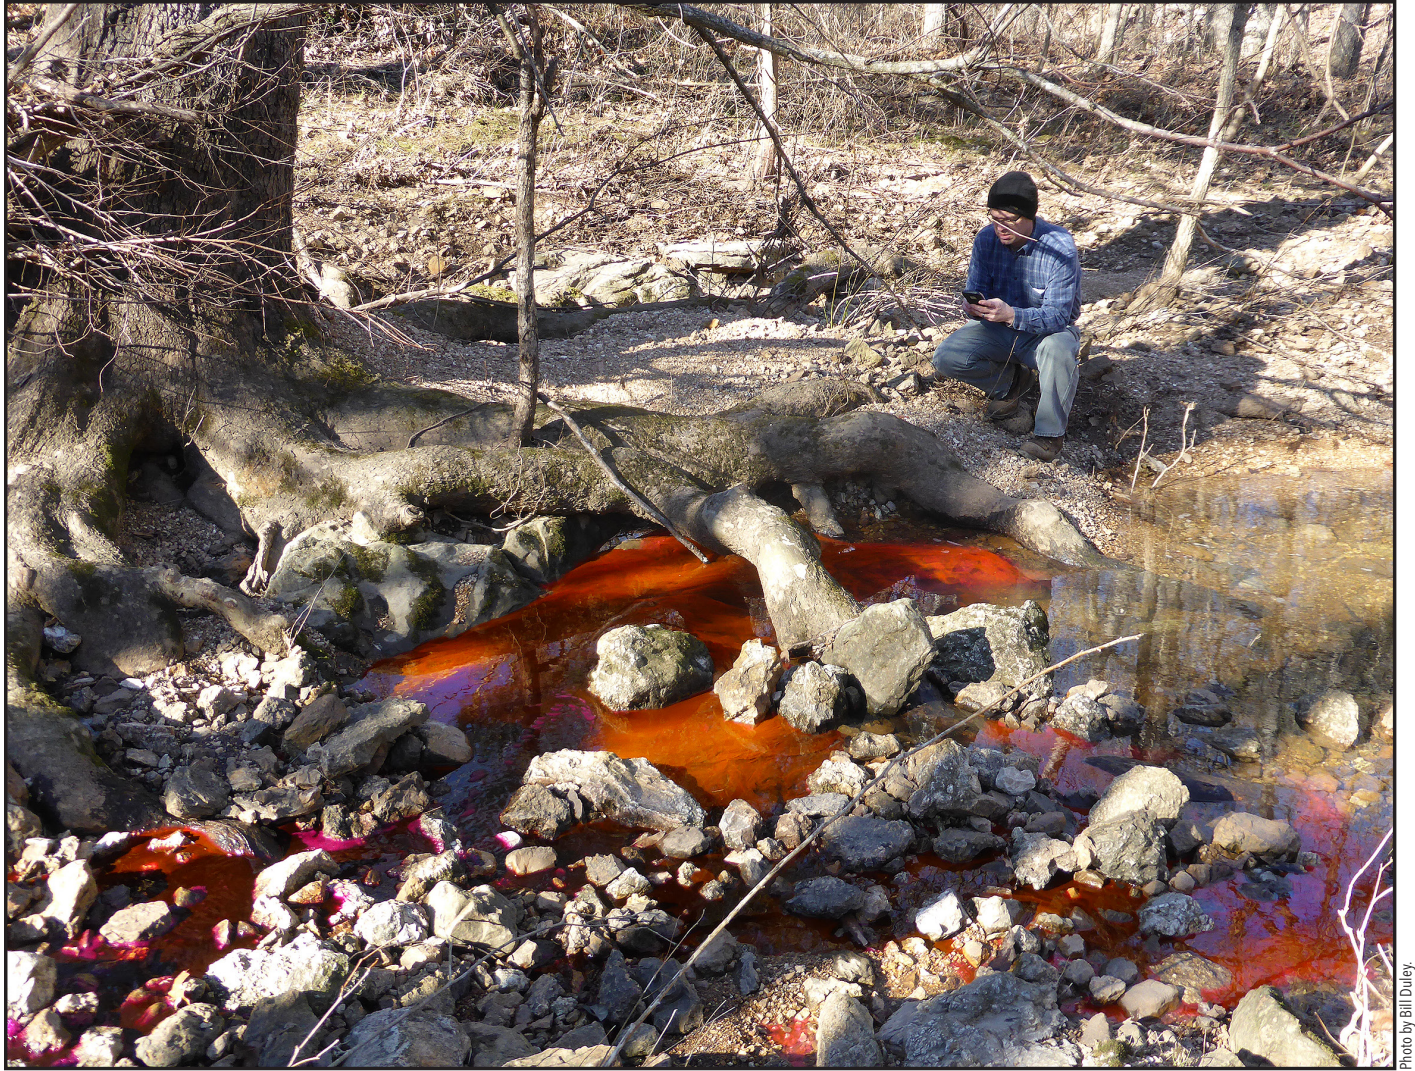
Figure 105. Dye injection in tributary to Little Hurricane Creek.

One trace was initiated during this study that was recovered at the Dennig Complex. The opportunity arose to complete a semi-replication attempt of trace Or 010. Two gallons of Rhodamine WT™ were injected into a small losing tributary to Little Hurricane Creek (Figure 105 - IP72) at 1:40 p.m. on Jan. 12, 2016. On that date, about 15 gpm were flowing into a pool that contained about 1000 gallons of water. No flow was observed downstream in limited investigations, and the landowner reported that there is normally no flow on his property when flow ceases in this part of the creek.
