Groundwater Contamination and Sinkhole Collapse

**Induced by Leaky Impoundments
in Soluble Rock Terrain**

**Missouri Department of Natural Resources
Division of Geology and Land Survey**

1972

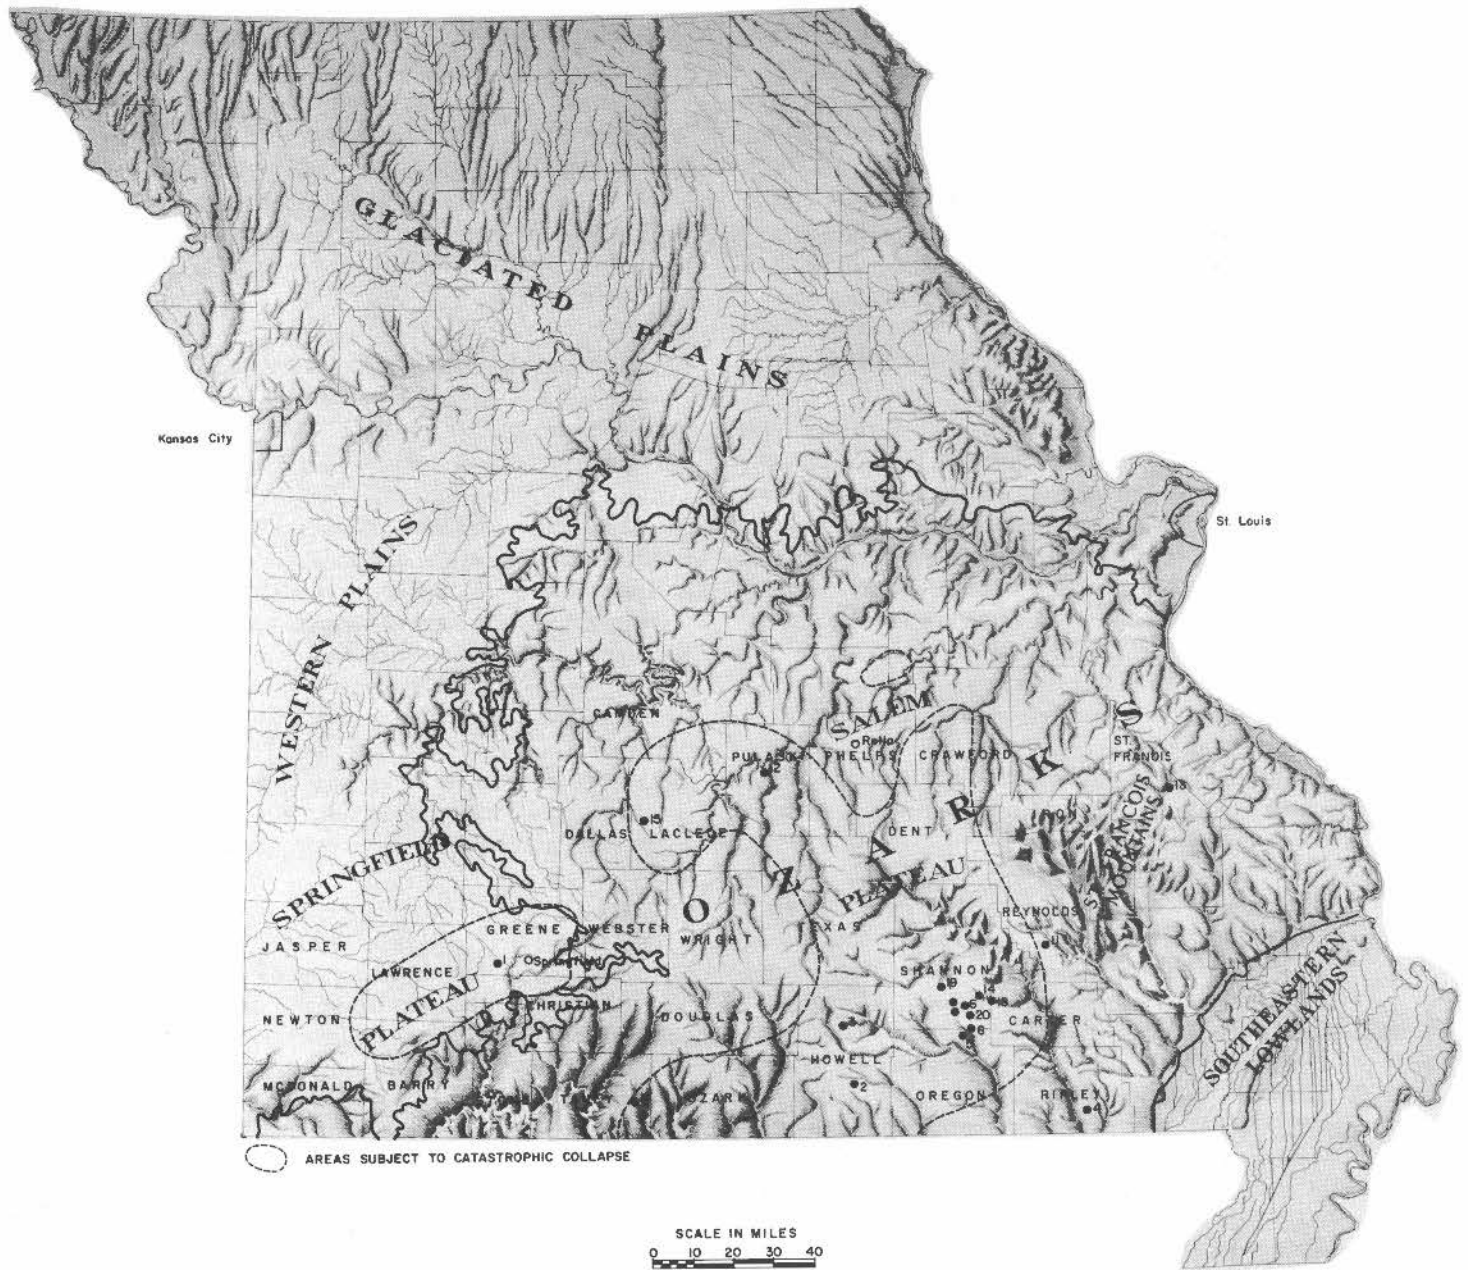
Figure 1

Areas in Missouri that are particularly subject to catastrophic sinkhole collapse. Sites of collapses and groundwater contamination investigated for case history analyses are also shown.

It is our contention that leaky impoundments in soluble rock terrain can induce sinkhole collapse and cause groundwater contamination. To support this contention, we have examined a number of sites in Missouri where these problems have occurred (fig. 1).
