# Groundwater Contamination and Sinkhole Collapse

Induced By Leaky Impoundments

In Soluble Rock Terrain

*Aley, Thomas J., James H. Williams and James W. Massello, 1972, Groundwater contamination and sinkhole collapse induced by leaky impoundments in soluble rock terrain: Mo. Geol. Survey and Water Resources, Engineering Geology Series No. 5, 40 p., 10 figs., 1 tbl.*

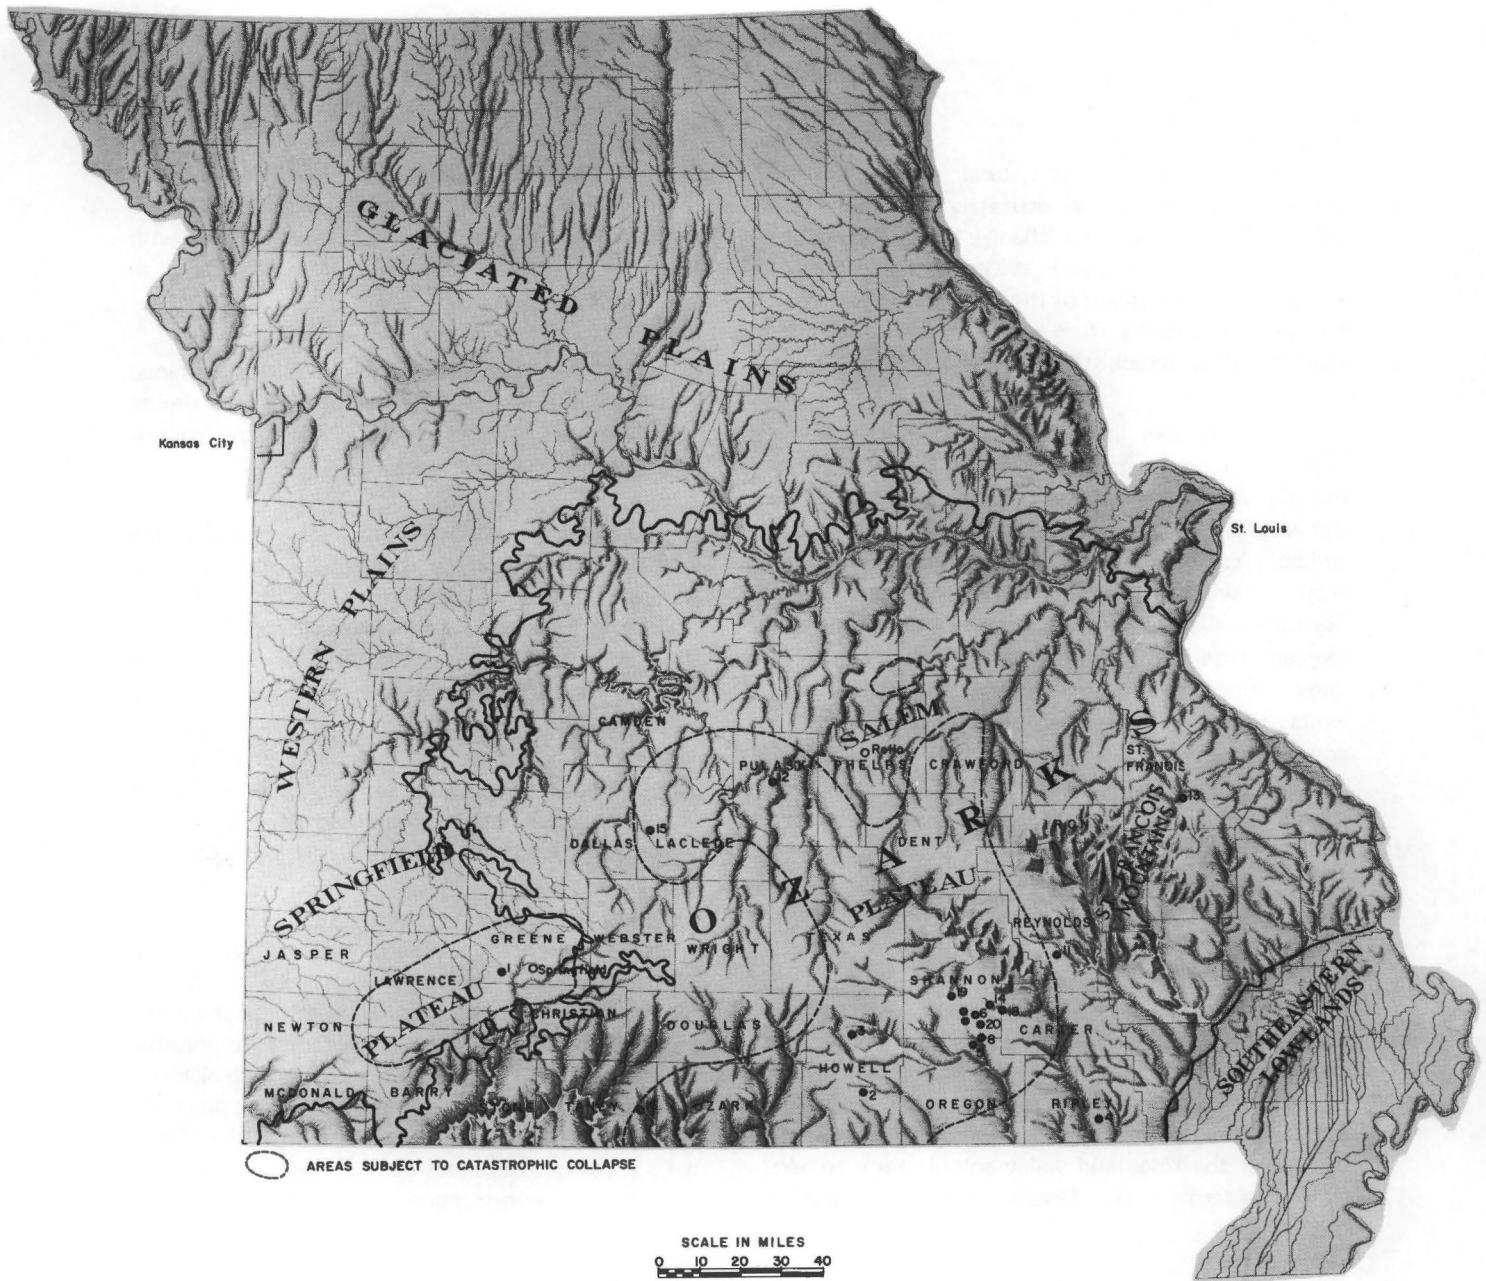
Figure 1

Areas in Missouri that are particularly subject to catastrophic sinkhole collapse. Sites of collapses and groundwater contamination investigated for case history analyses are also shown.

It is our contention that leaky impoundments in soluble rock terrain can induce sinkhole collapse and cause groundwater contamination. To support this contention, we have examined a number of sites in Missouri where these problems have occurred (fig. 1).
