a guide for the
geologic and hydrologic evaluation
of small lake sites in missouri

BY THOMAS J. DEAN
JAMES H. BARKS
JAMES H. WILLIAMS

MISSOURI DEPARTMENT OF NATURAL RESOURCES
DIVISION OF GEOLOGY AND LAND SURVEY

Dean, Thomas J., James H. Barks and James H. Williams, 1976, A GUIDE FOR THE GEOLOGIC AND HYDROLOGIC EVALUATION OF SMALL LAKE SITES IN MISSOURI: Mo. Dept. of Natural Resources, Geological Survey, WR 31, 56 p., 24 figs., 2 app.

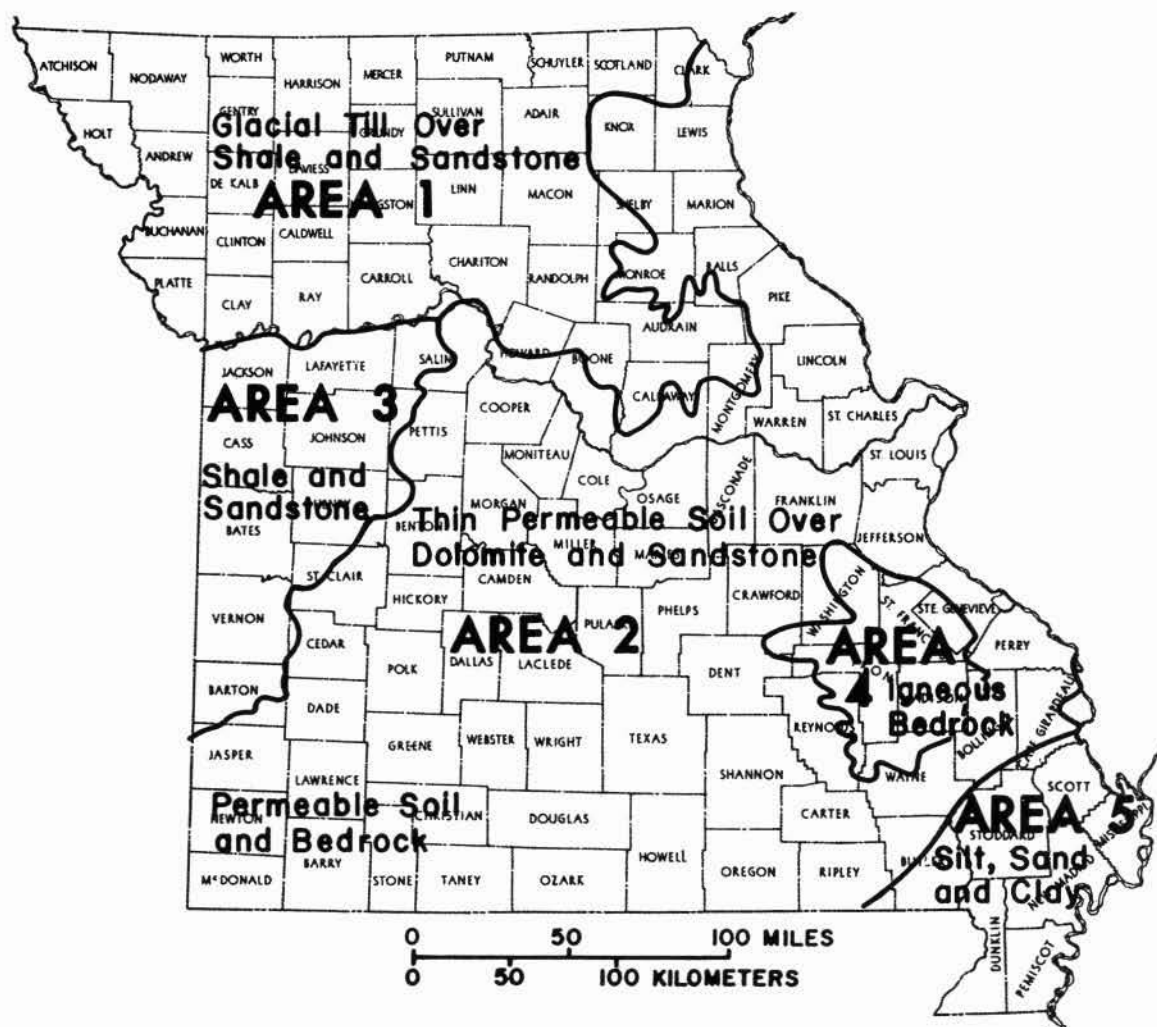
Figure 1

Generalized geologic map showing the five major geologic areas of Missouri.

As a first step in delineating typical lake settings in Missouri, the state was subdivided into five generalized areas as

shown in figure 1. The boundaries are based on geologic and hydrologic factors that influence the evaluation of a lake site.

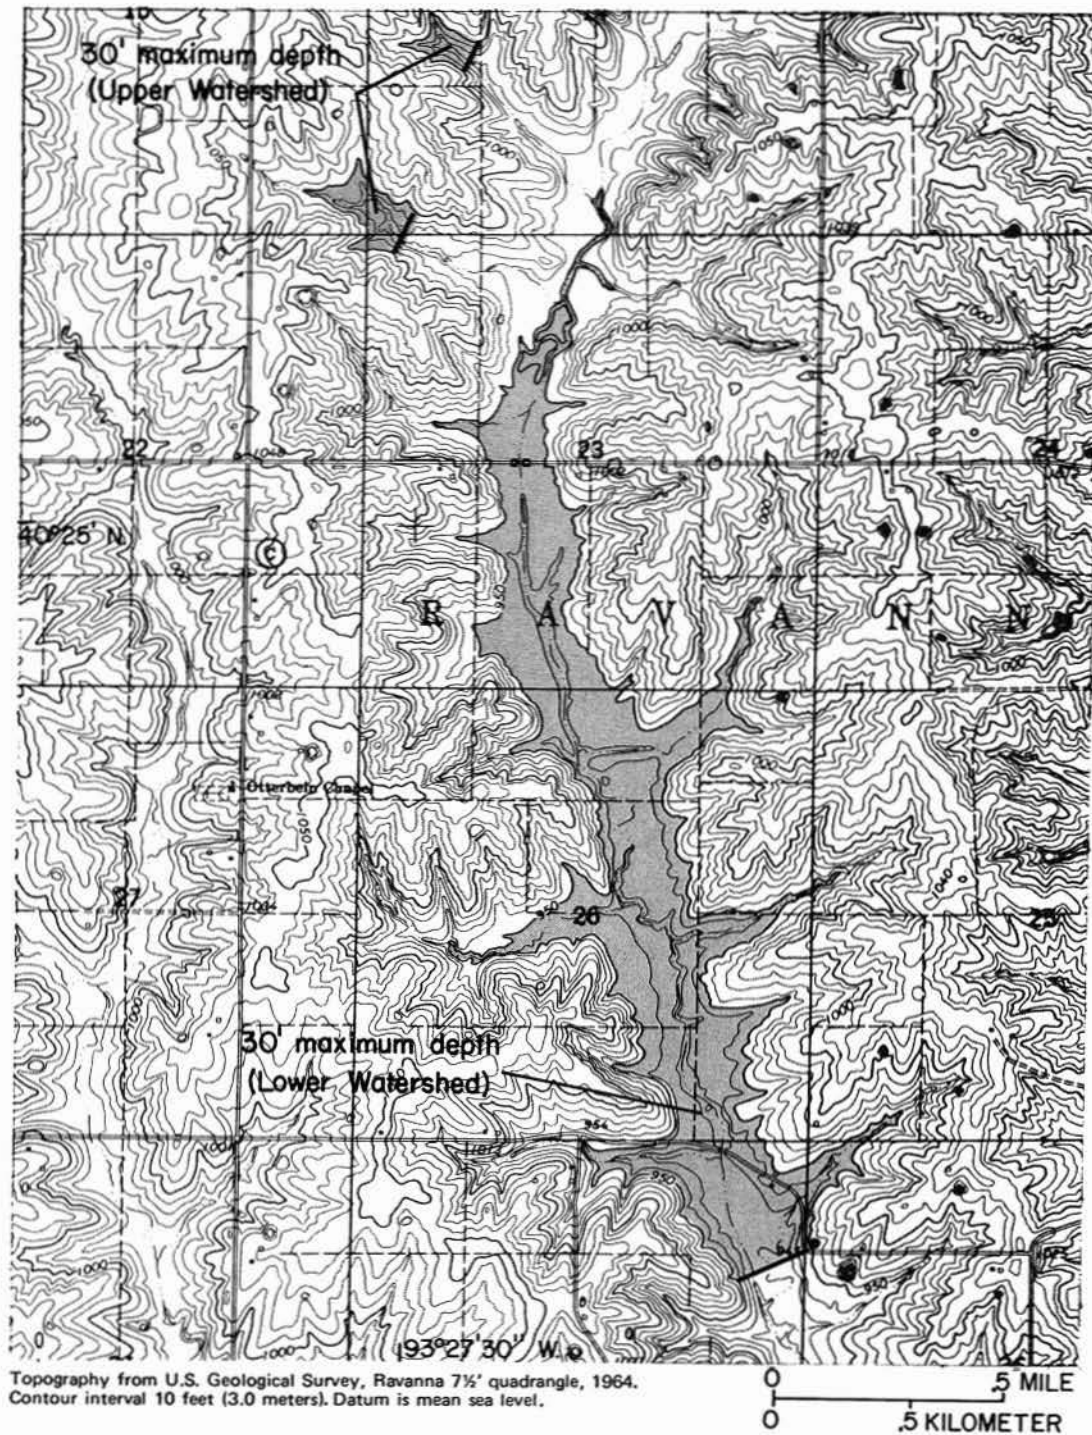
Figure 2

Topographic map showing hypothetical upper and lower watershed lakes in the glaciated area of northern Missouri.

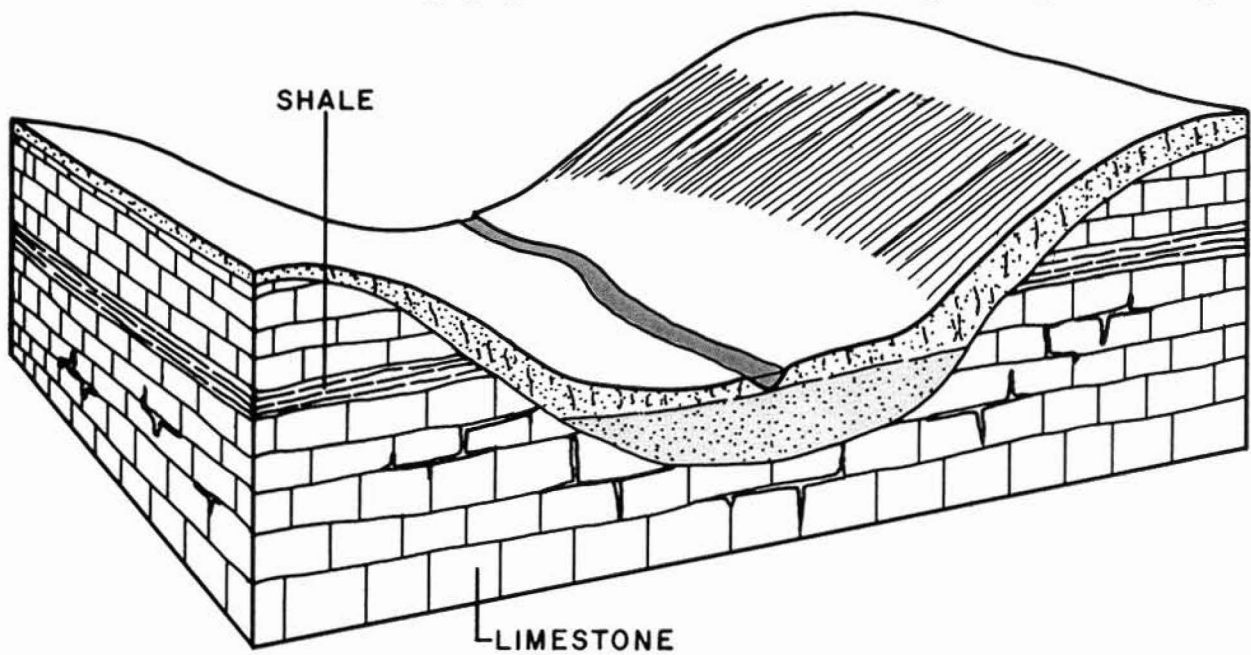
Schematic diagram of a valley cross section showing water loss through fractured or jointed limestone.

Shale or limestone bedrock is at or near the surface in some areas. Figure 3 shows how openings in fractured limestone are the major cause of leakage problems in the upper watersheds.

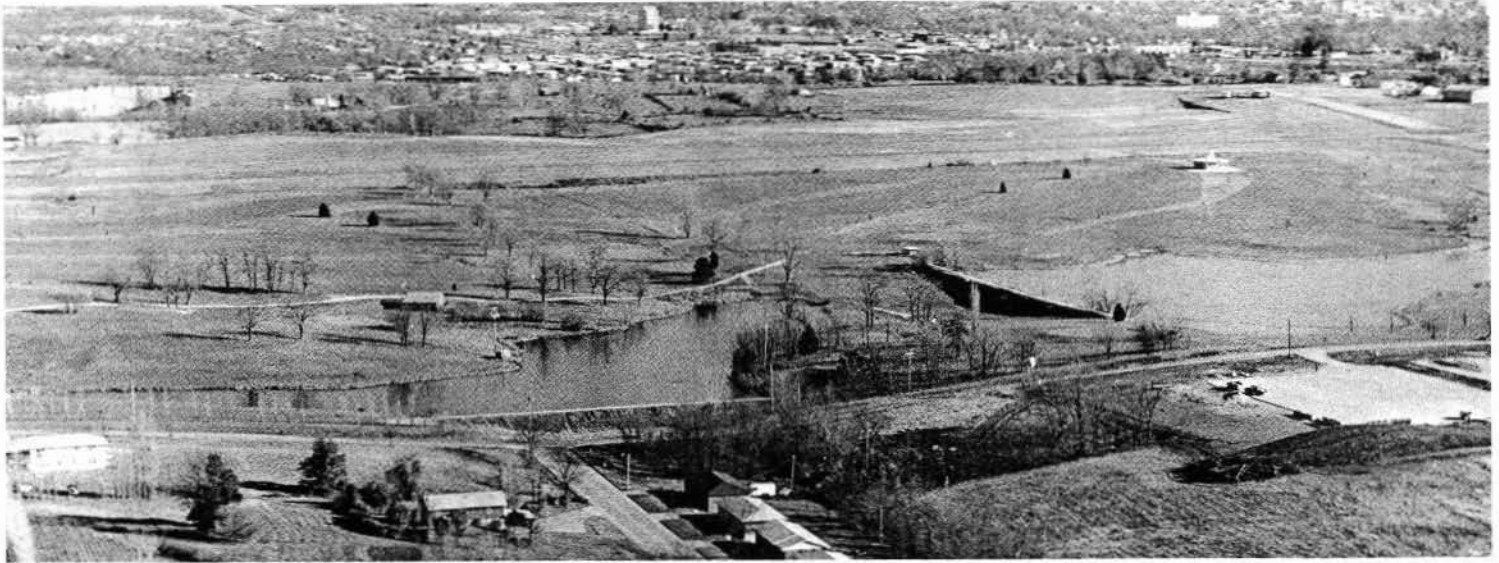
Figure 4

Construction of a low dam creates a large lake in relatively flat areas with low relief topography. Photo by David Rath.

Lakes in the upper watersheds of the Ozarks tend to be small (fig. 4) because

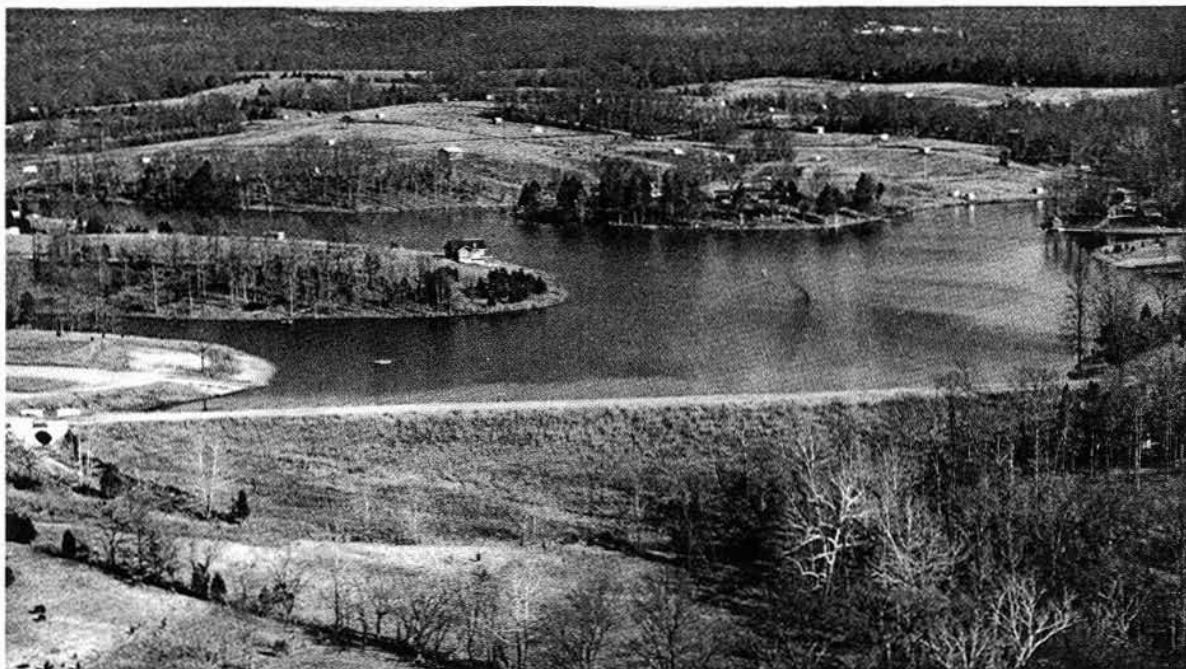
Figure 5
A typical multi-fingered lake in an Ozark setting.

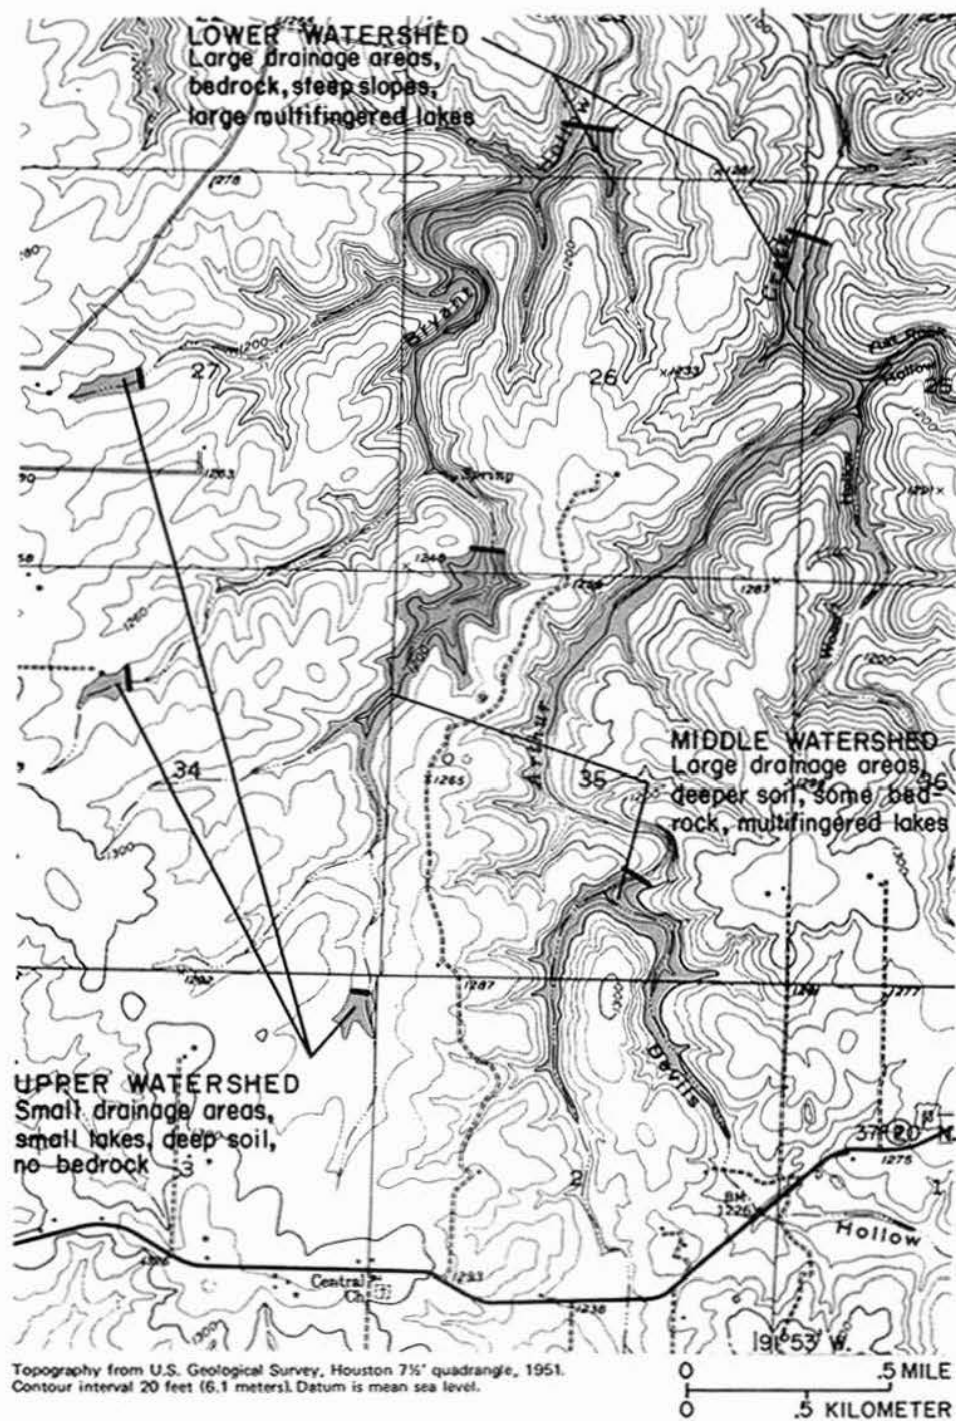
Figure 6

Topographic map showing hypothetical upper, middle, and lower watershed lakes in the Ozark carbonate area.

Topographic conditions suitable for construction of lakes exist in all parts of the Ozark watersheds, as shown in figure 6. There are, however, marked differences in the features to be found in the upper, middle and lower watersheds.

A comparison of figure 7 with figure 6 shows that much wider lakes are created in the upper watersheds of the western plains than in the Ozark carbonate area because the valleys are wider, requiring longer dams. The lakes are short due to steep stream gradients; thus, lakes in this area are often as wide as they are long.

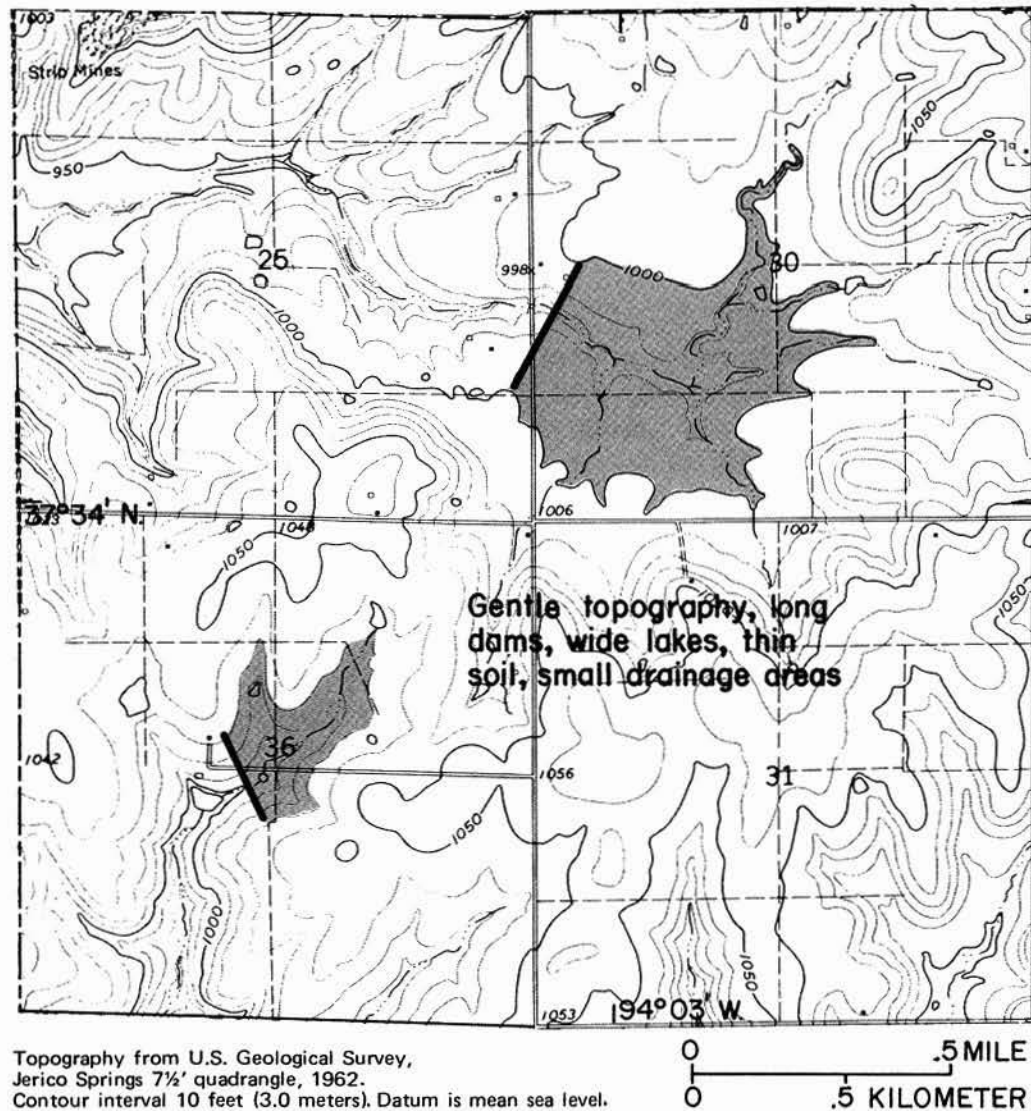
Figure 7

Topographic map showing hypothetical upper watershed lakes in the Western Plains. Lower watershed lakes (not shown) are like those in figure 2.

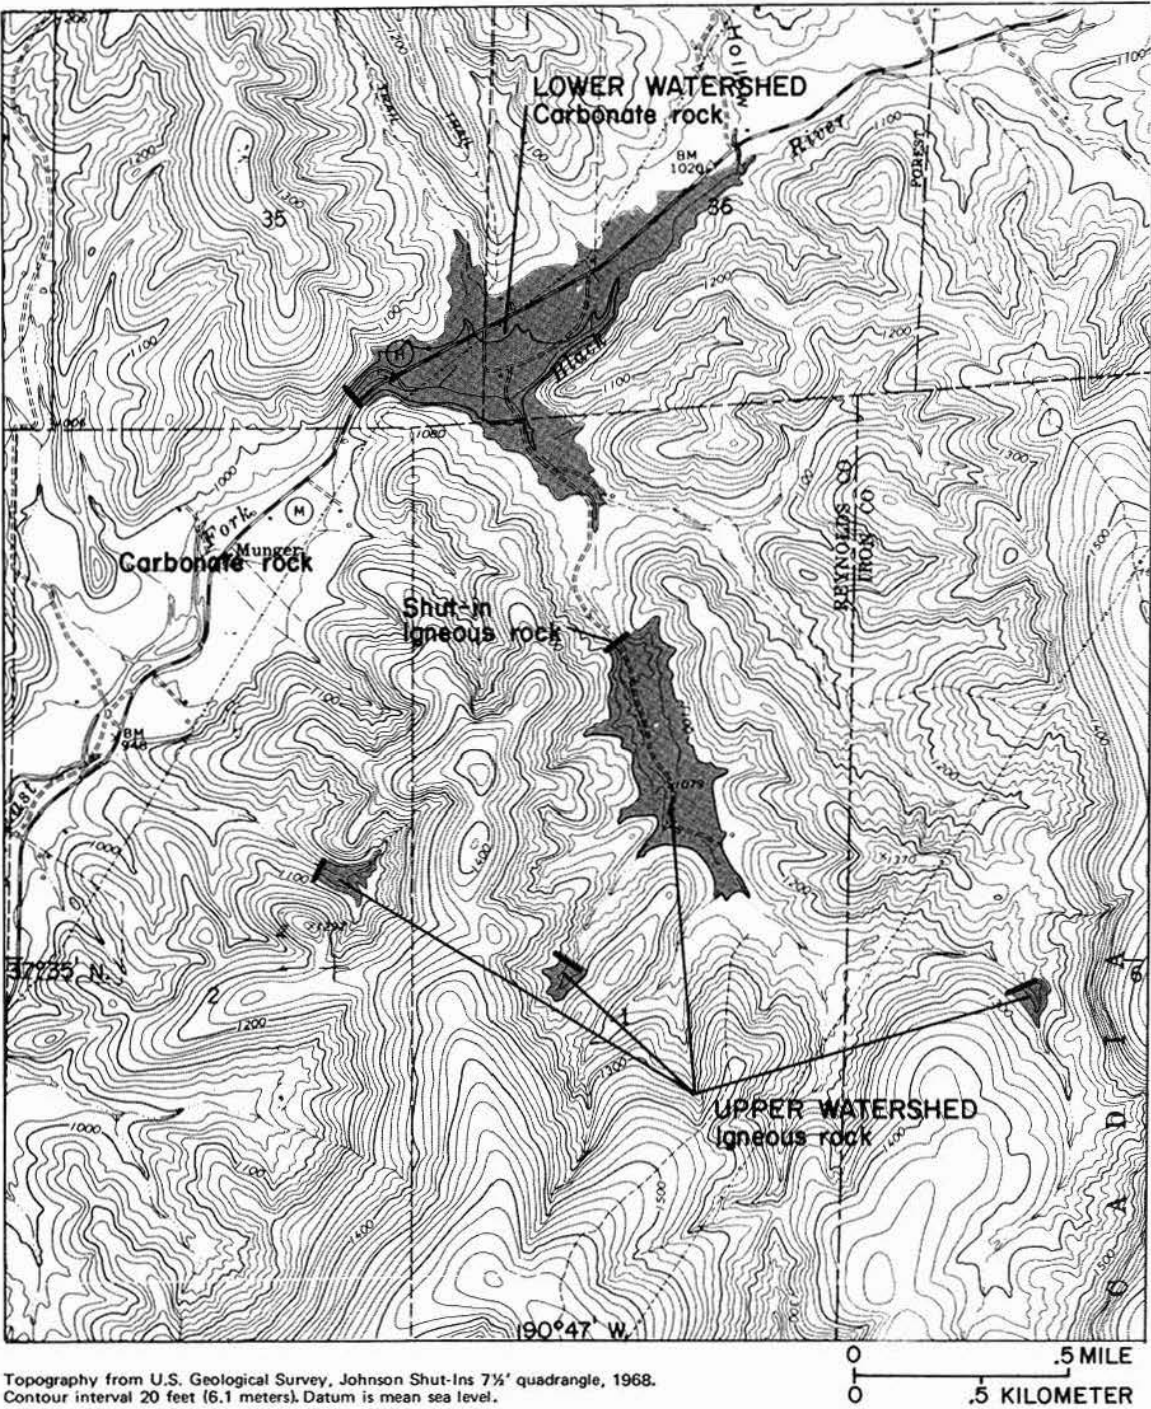
Figure 8
Topographic map showing hypothetical upper and lower watershed lakes in the St. Francois Mountains.

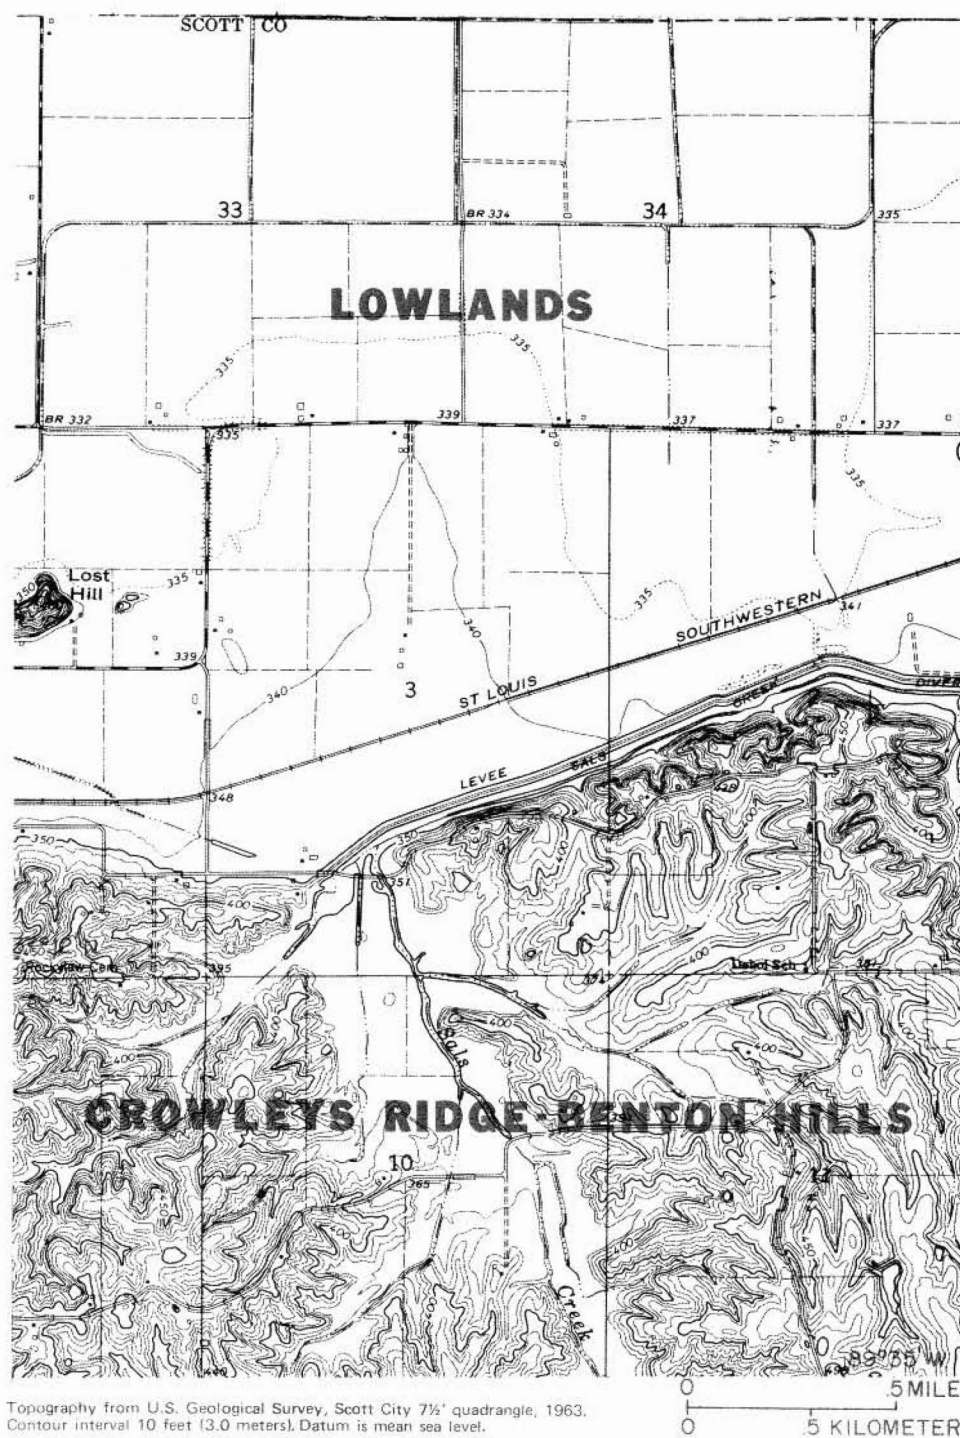
Figure 9

Topographic map showing the contrast in relief between the alluvial plains of the lowlands and the hilly topography of Crowleys Ridge-Benton Hills in the Southeastern Lowlands.

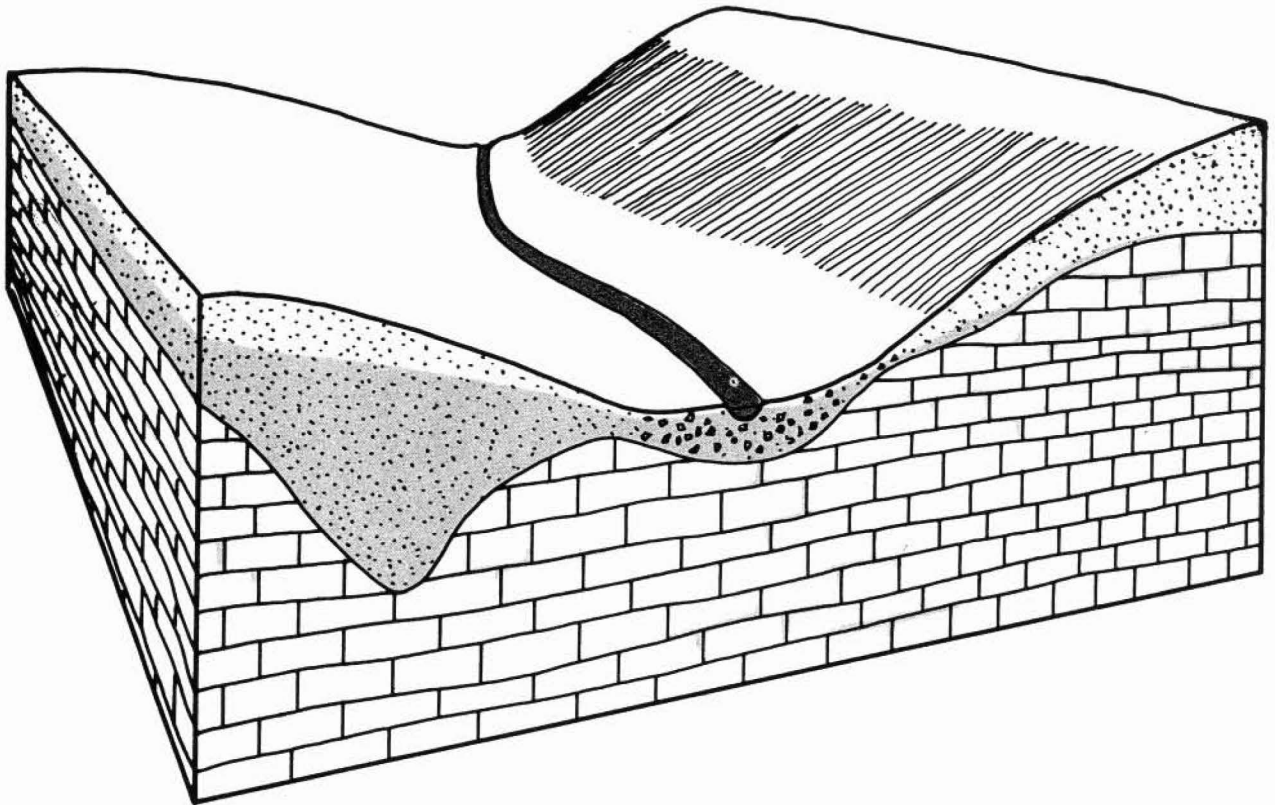
Figure 10

Schematic diagram of a valley cross section showing uneven bedrock surface.

Exploration of the valley bottom to determine shallow subsurface conditions that cannot be prejudged from surface evidence (fig. 10) can often be done inexpensively with a tractor-mounted backhoe. Several holes can be excavated on the center line of the proposed dam to determine depth to bedrock, quality of material over bedrock, the presence of water, and estimate the cost of the core. Backhoe test pits can also be used to evaluate

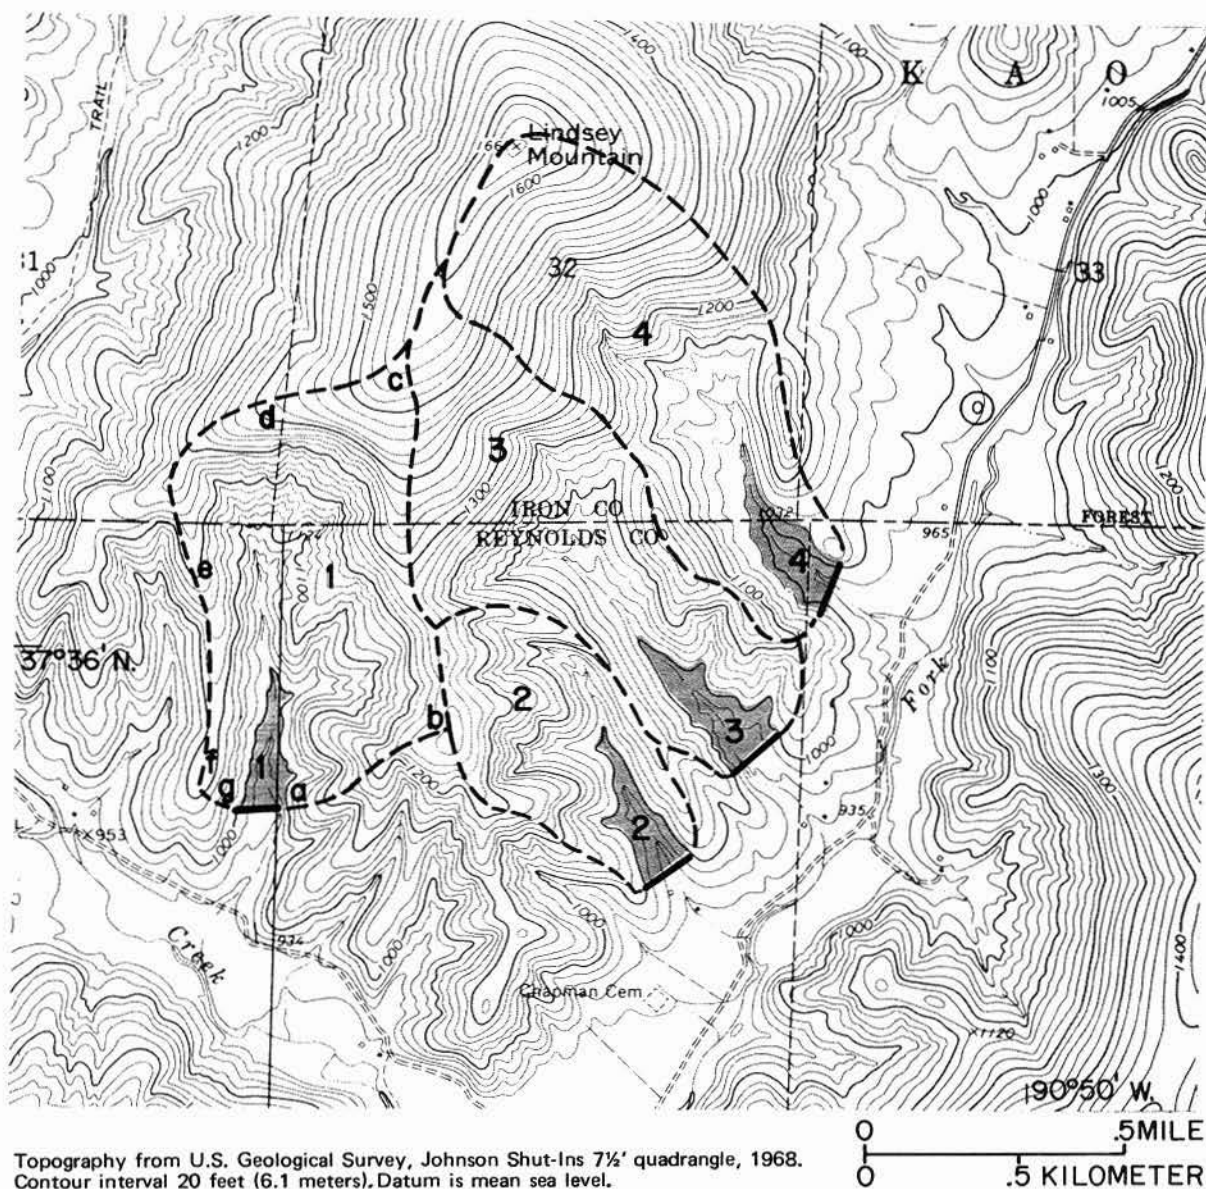
Figure 12

Computing drainage areas on topographic maps. (Numbers 1, 2, 3, and 4 represent small lakes and their corresponding drainage areas.) To draw the drainage area for lake no. 1, start at the dam at point (a), go up the valley wall to the right to the ridgetop at point (b), then go up the ridge line to point (c), follow the ridge to the left through points (d, e, and f), then drop down the valley wall to point (g), the other end of the dam. You have followed the ridge line around the lake and have outlined the drainage area. Follow the same procedure for lakes 2, 3, and 4.

On this scale map, a grid pattern of squares 5/16 inch (7.9 mm) on each side divides the area into 10-acre plots. Drainage area no. 1 has approximately 23 squares or 230 acres of drainage; no. 2, 110 acres; no. 3, 210 acres; no. 4, 220 acres.

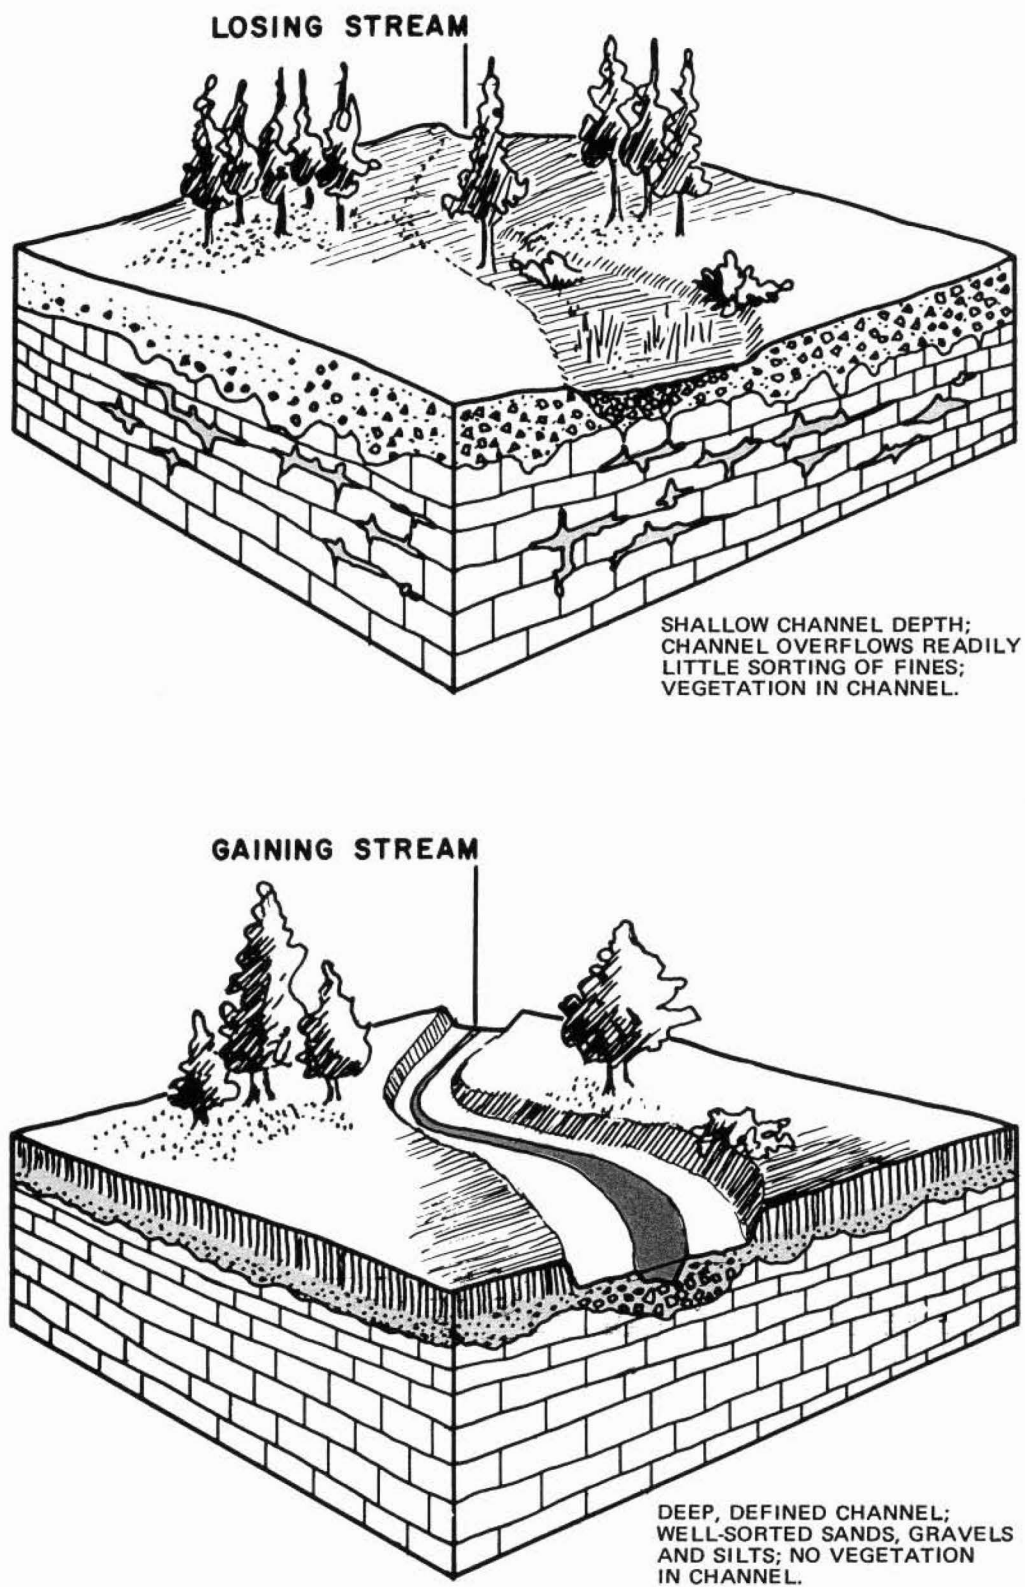
Figure 13

Schematic diagrams of valley cross sections showing a poorly defined channel (losing stream) and a well defined channel (gaining stream).

A continuous flow of water is usually indicative of a relatively impermeable valley (lake) bottom. As shown in figure 13, absence of vegetation in the channel, well sorted or stratified sands and gravels, clay-rich soil zones, and terraces are indicators of a gaining reach of the stream even though the stream may be dry at the time of investigation due to climatic conditions or small drainage area. Many

Generally, a dry, poorly defined stream channel, as shown in figure 13, is

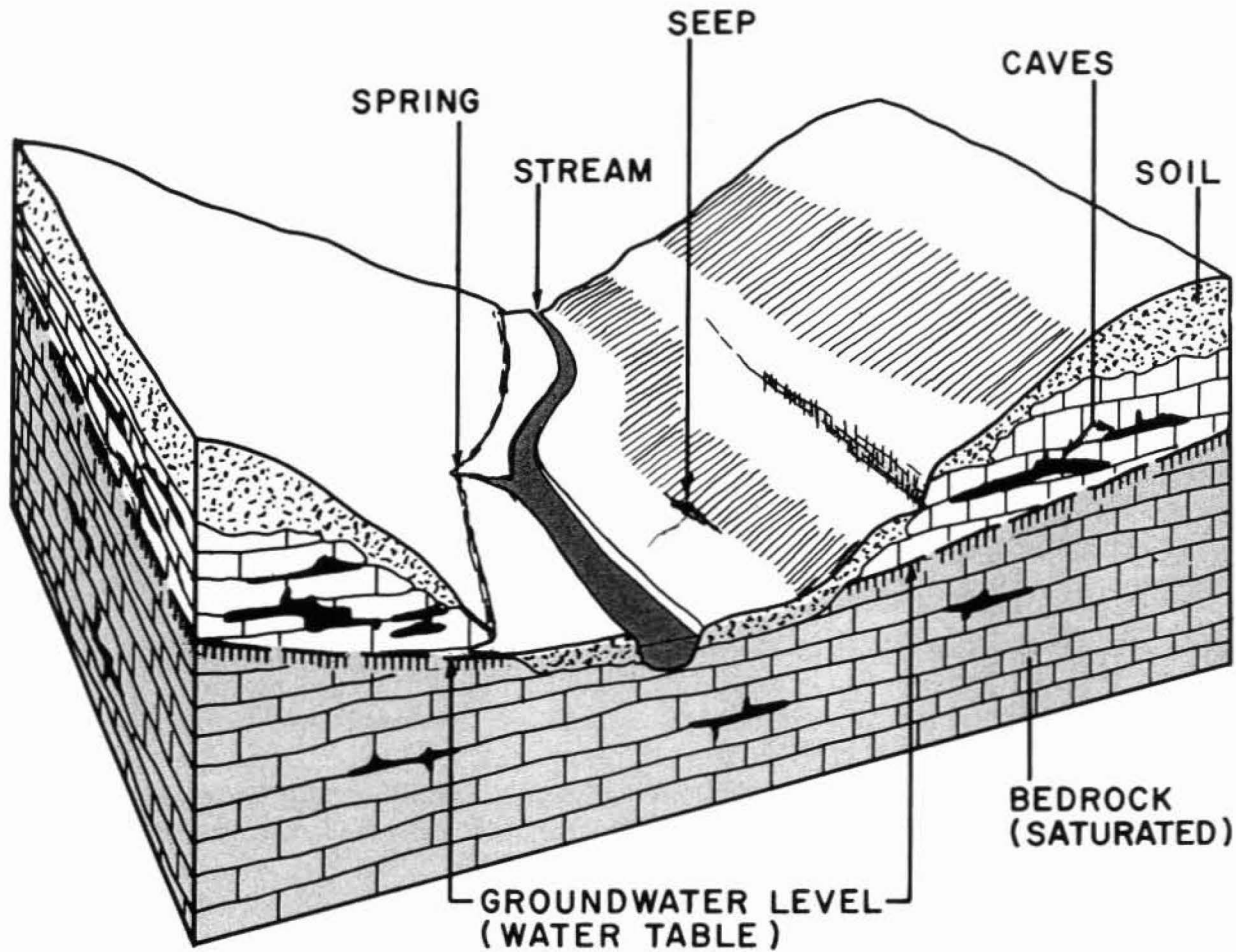
Figure 14

Schematic diagram of a valley which intersects the groundwater level.

Springs, seeps and perennial flow are evidence of a high water table level in many cases. A water table that is high enough to be intersected by a valley is likely to cause a perennial flow into the stream as shown in figure 14. Springs and seeps are ground water being discharged at the surface. Perennial flow caused by high water-table level does not always indicate impermeable bedrock in the valley bottom.

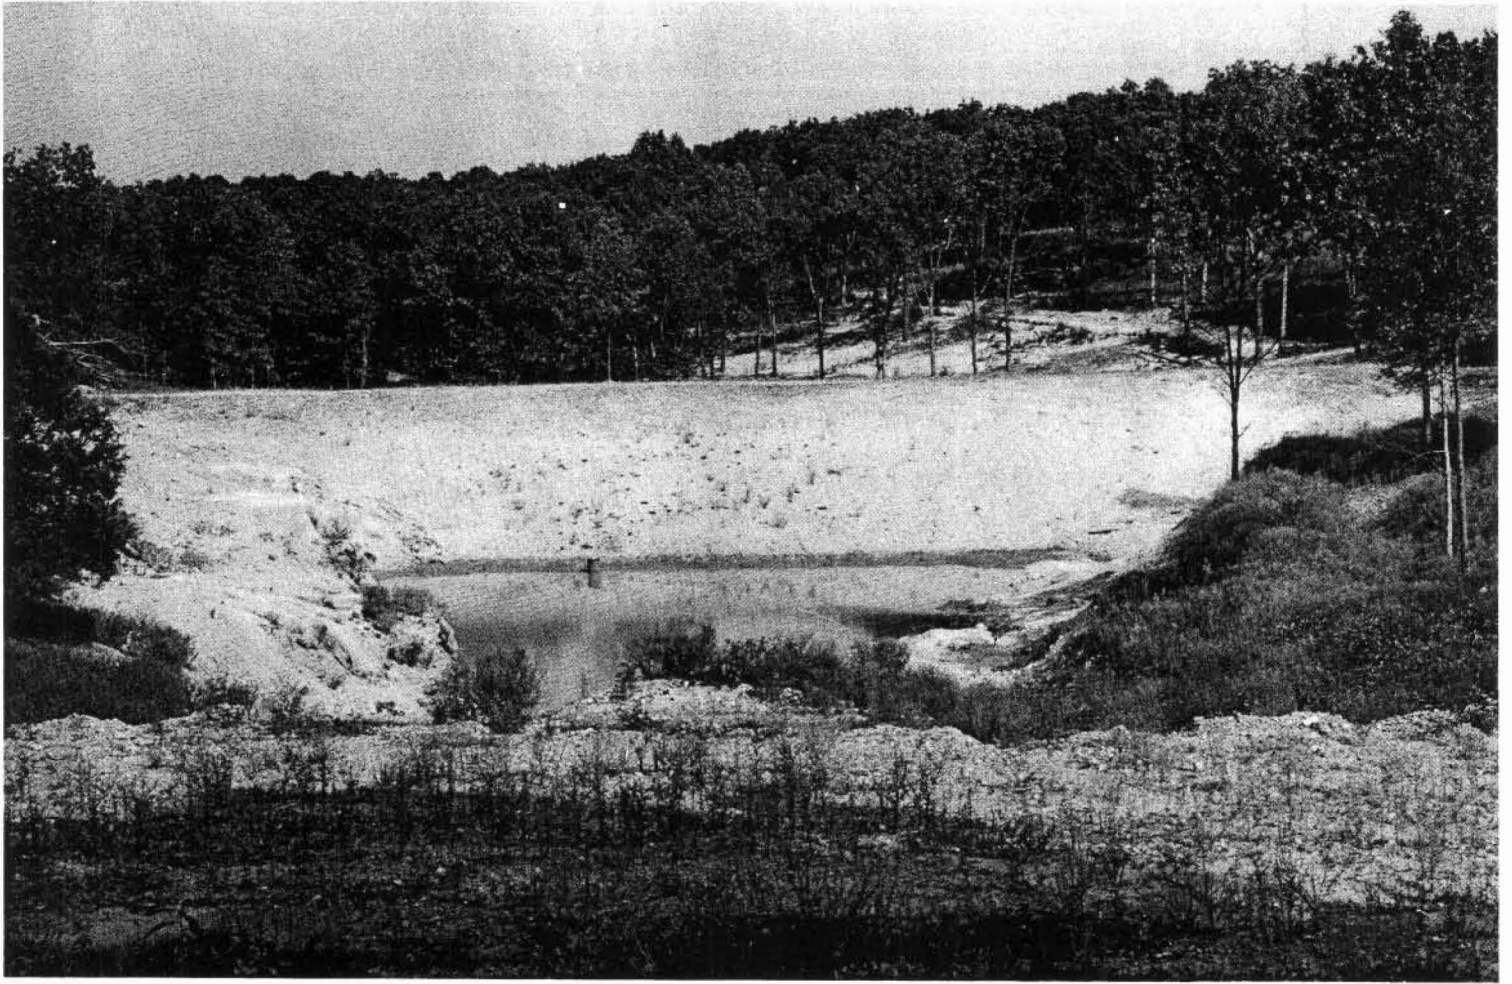
Figure 15

This obviously unsuccessful lake should never have been constructed in this location because of adverse geologic conditions. It would be uneconomical to repair. Photo by David Hoffman.

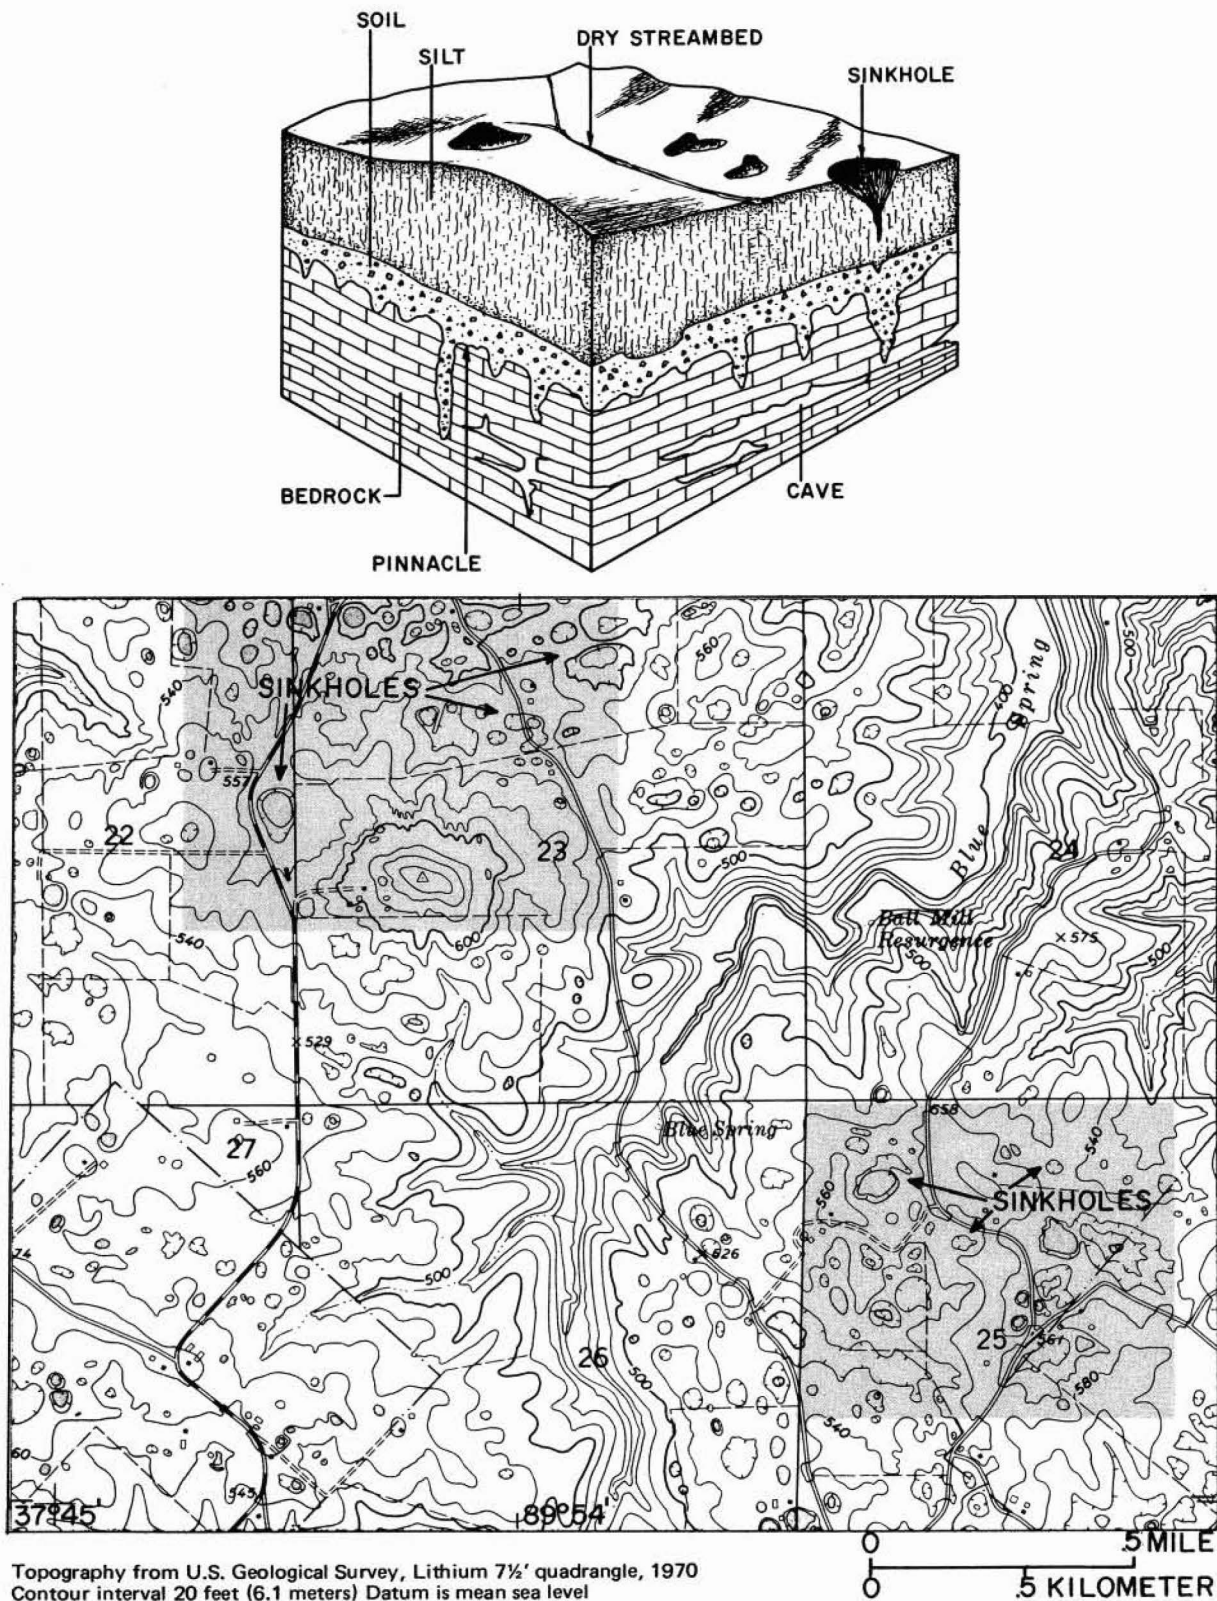
Figure 16

Schematic diagram showing karst features (including sinkholes) and solution work in joints and bedding planes. The topographic map shows karst features.

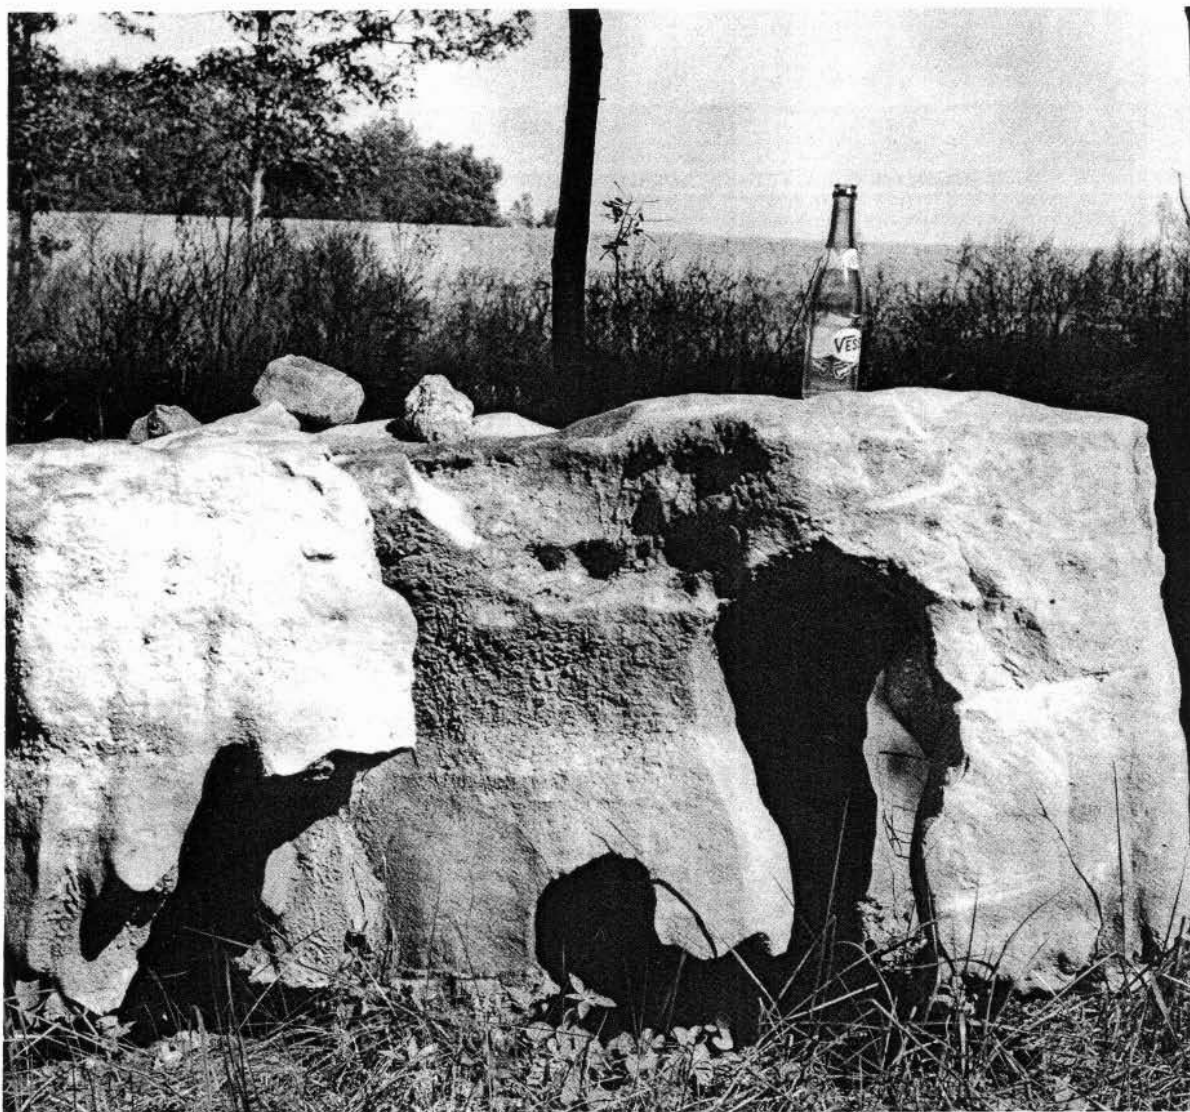
Figure 17

Solution work caused by running water makes for a permeable lake bottom. Photo by Jerry D. Vineyard.

Pinnacles (spire-shaped pillars of rock) are formed by solution along joints or cracks in the bedrock, or by differential weathering caused by abnormalities present in the rock. This phenomenon is not too unlike the sinkhole-cave relationship. The space between the pinnacles is not expressed on the surface as a depression, but rather as a filled depression (fig. 16). Thus, there may be no surface evidence of the problem. Bedrock may be present at the surface at one point, but 20 to 30 feet (6 to 9 m) away the soil may be many feet thick. The thick soil filling the crevice between the pinnacles is usually very permeable and may result in serious water loss from the lake (fig. 17).
