a guide for the
geologic and hydrologic evaluation
of small lake sites in missouri

BY THOMAS J. DEAN
JAMES H. BARKS
JAMES H. WILLIAMS

MISSOURI DEPARTMENT OF NATURAL RESOURCES
DIVISION OF GEOLOGY AND LAND SURVEY

Dean, Thomas J., James H. Barks and James H. Williams, 1976, A GUIDE FOR THE GEOLOGIC AND HYDROLOGIC EVALUATION OF SMALL LAKE SITES IN MISSOURI: Mo. Dept. of Natural Resources, Geological Survey, WR 31, 56 p., 24 figs., 2 app.

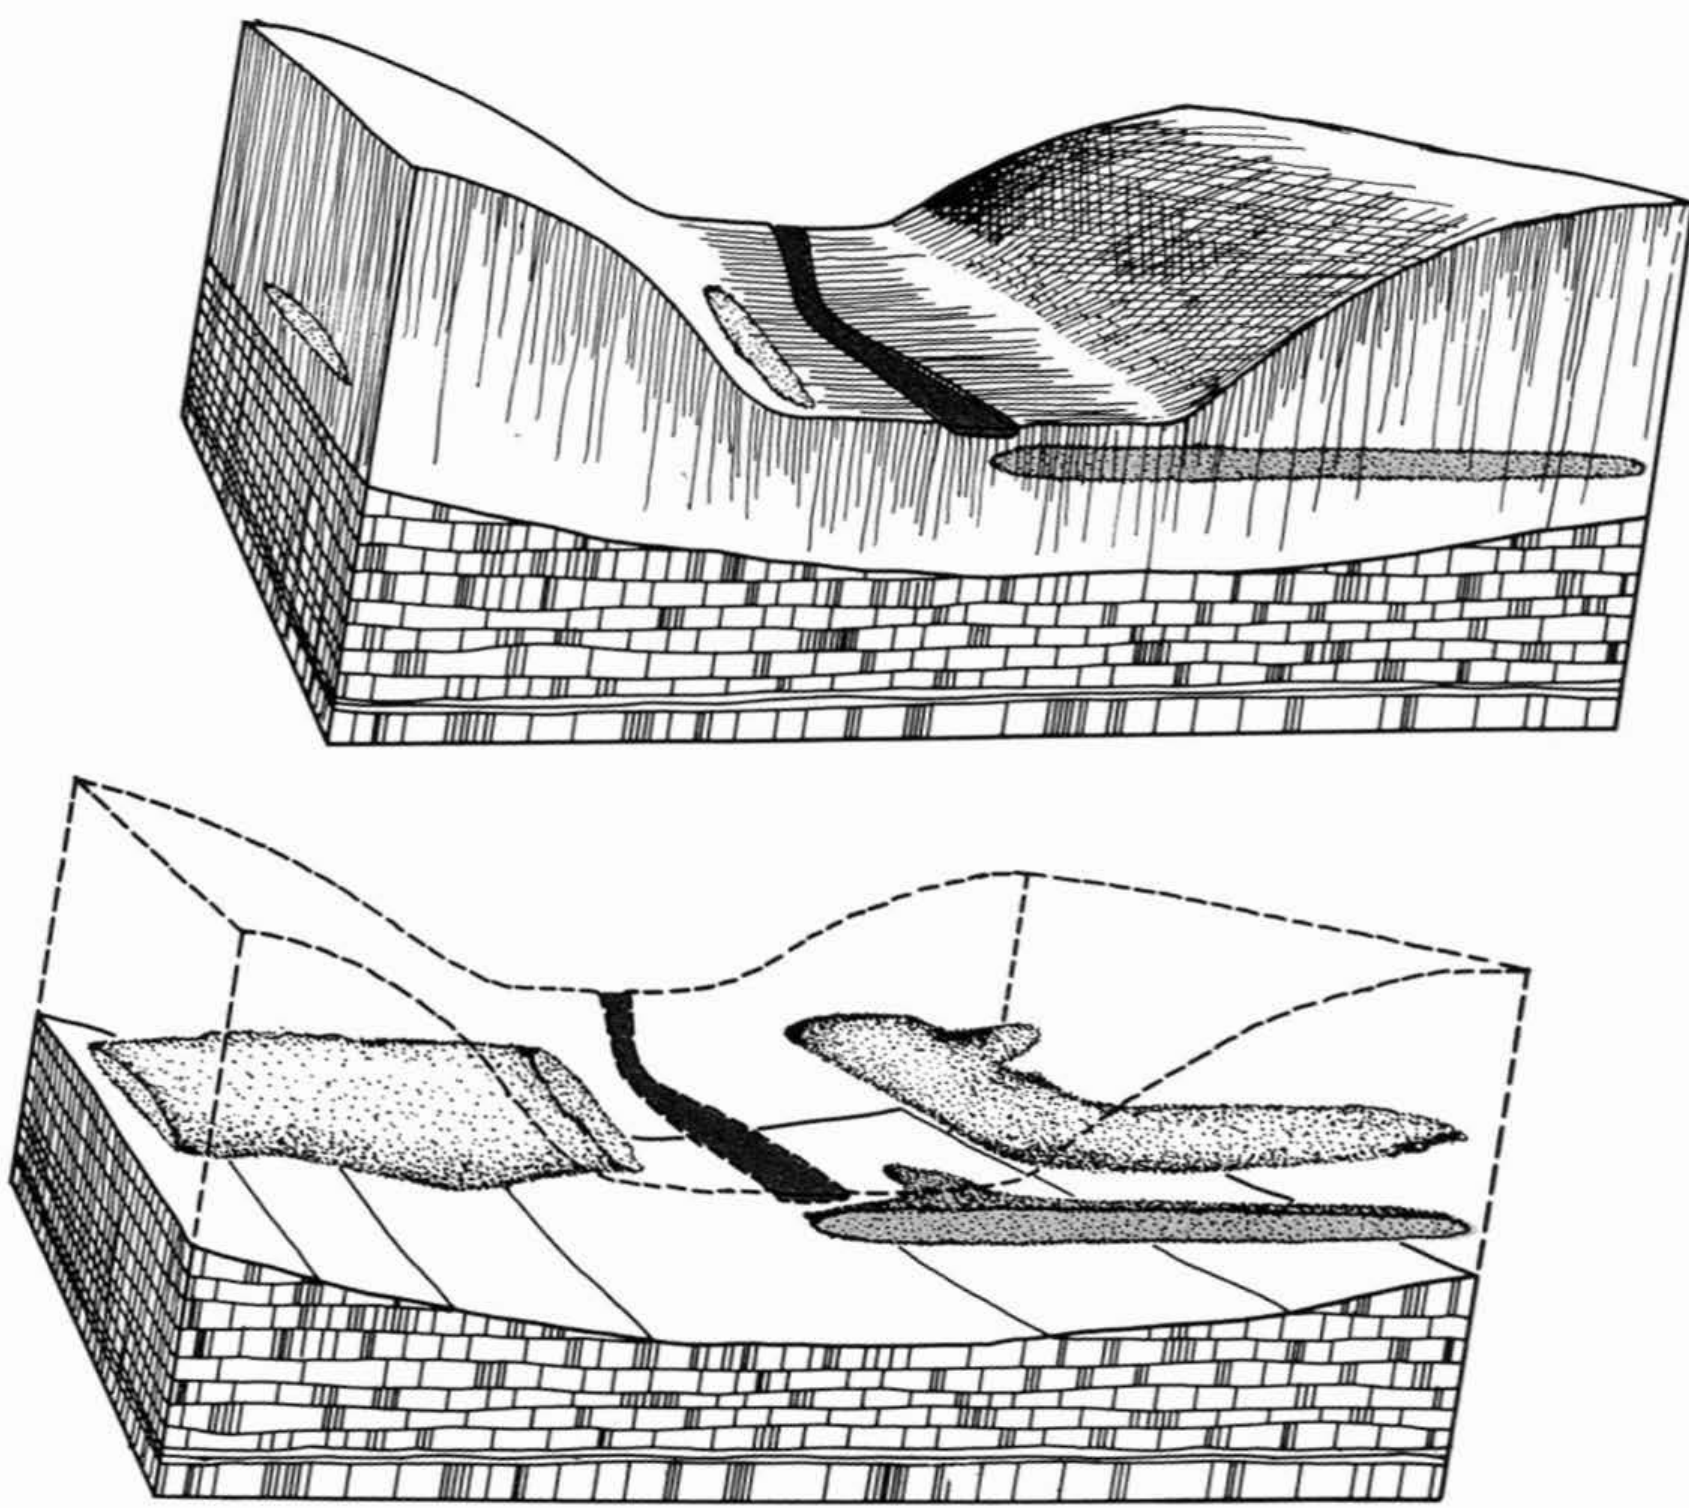
Figure 18
Schematic diagram of a valley cross section with sand pockets in glacial till and deep alluvium.

Glacial soils (Area 1) have pockets or lenses of sand and gravel, as shown in figure 18, which cannot always be predicted from surface evidence. These coarse textured materials create serious leakage problems where they are located in the valley slopes or lake bottoms.

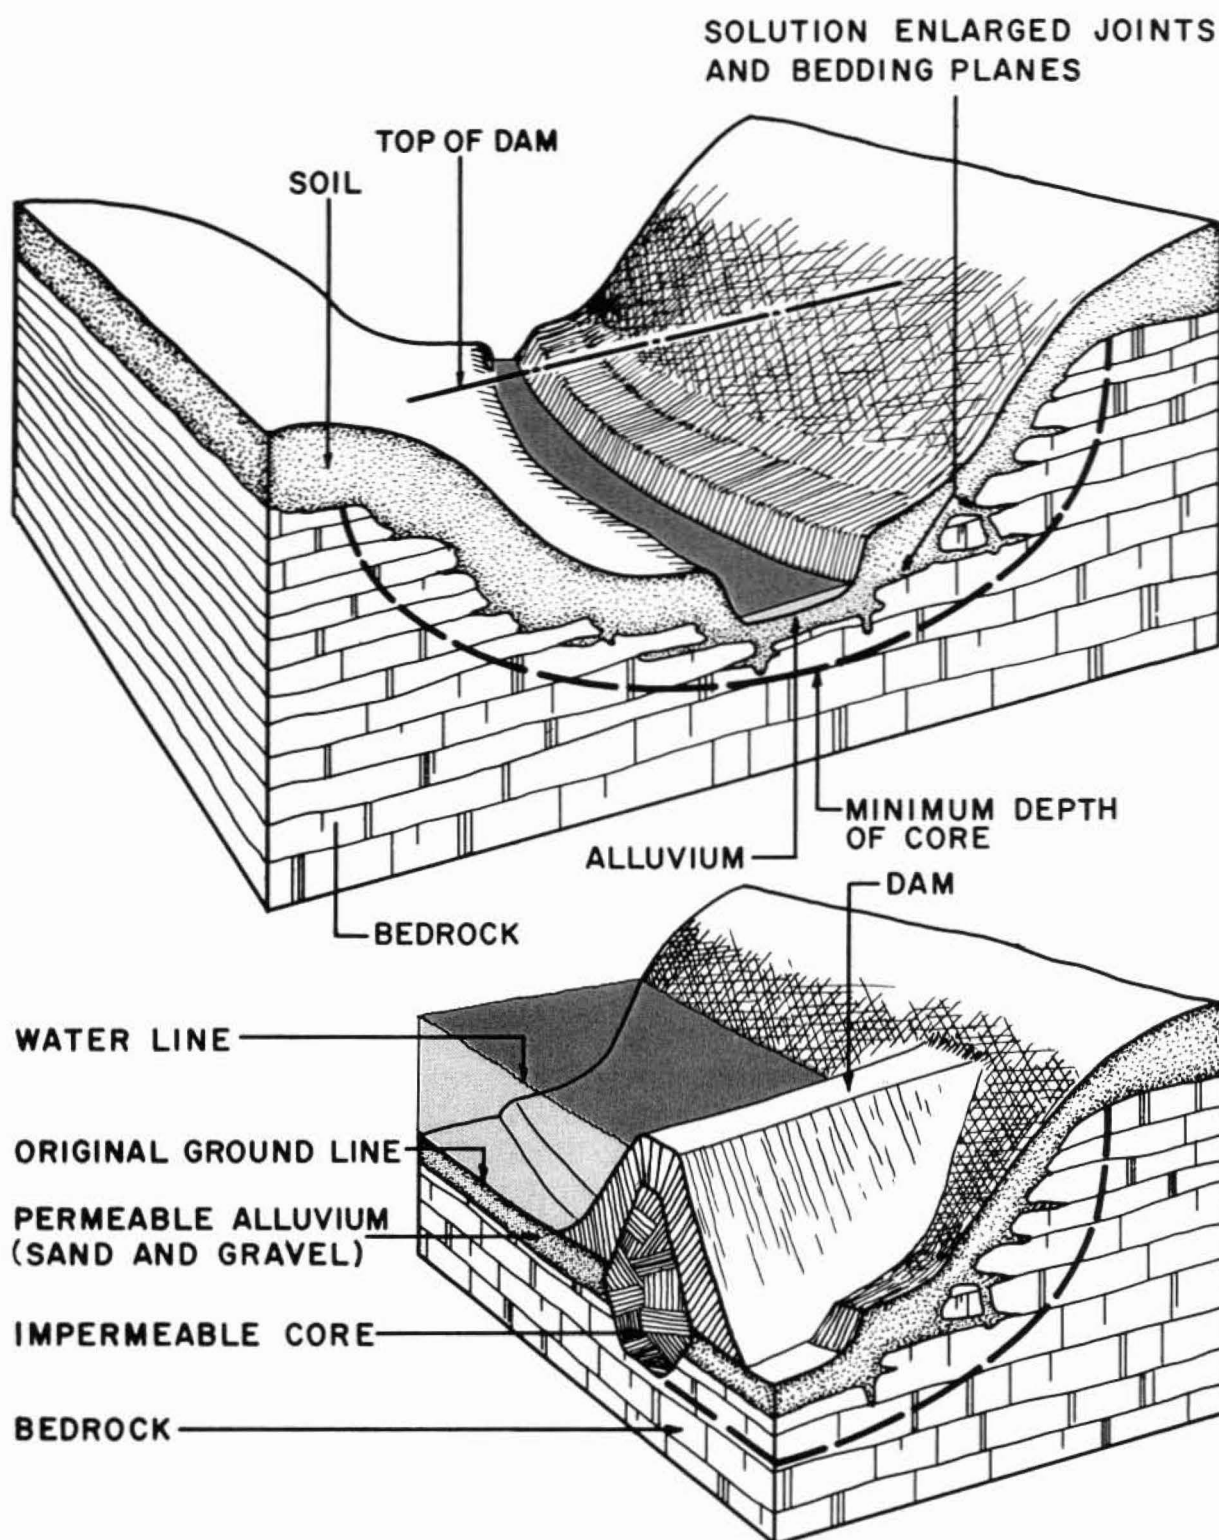
Figure 19
Schematic diagram of the core of a dam.

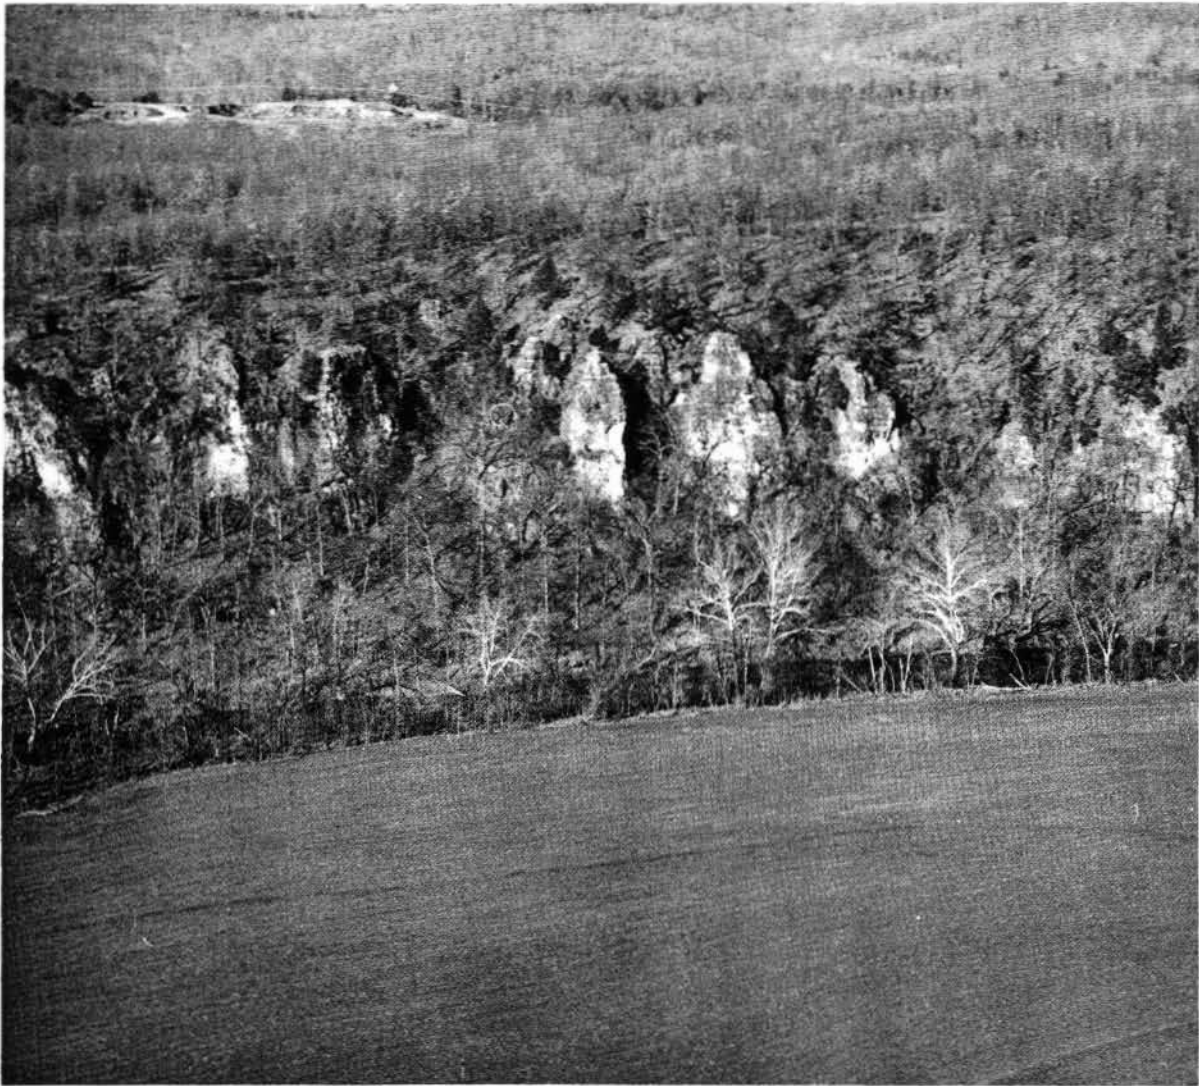
Figure 20

Extensively weathered areas resulting in extremely permeable bedrock (where caves and sinkholes are likely) are not good water impoundment settings. Photo by David Rath.

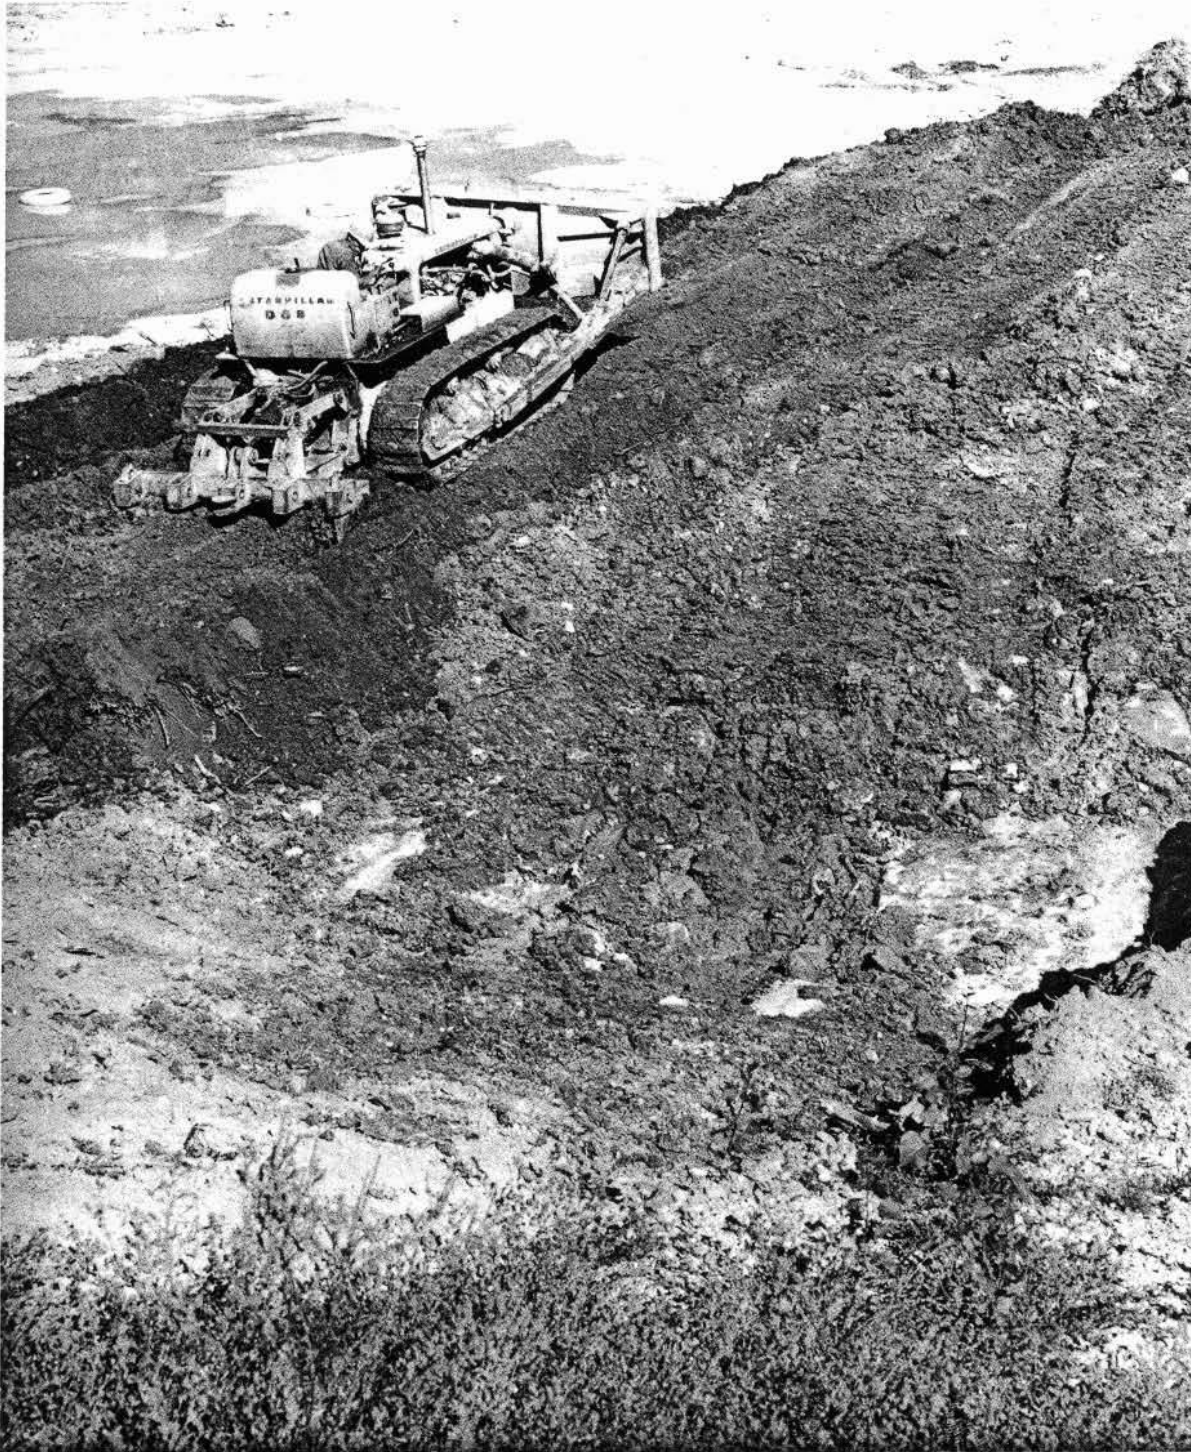
Figure 21

A leaky lake can sometimes be repaired by sealing the permeable limestone rock in the lake bottom. Photo by Jerry D. Vineyard.

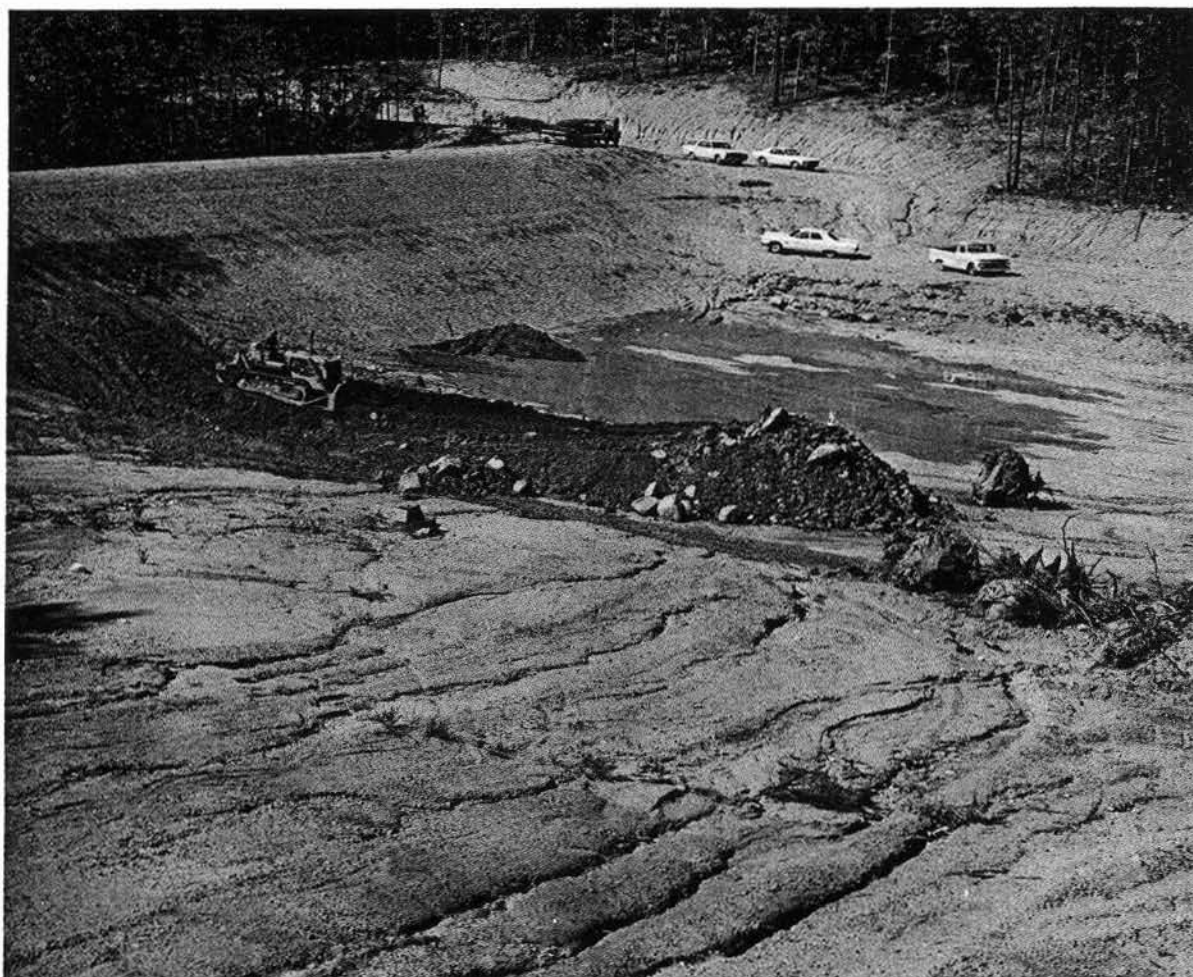
Figure 22

To prevent leakage under a dam, a clay pad can be put in the lake bottom. Photo by Jerry D. Vineyard.

venting water from entering the bedrock. Padding is used mainly in very small lakes where the entire basin below the waterline can be covered (fig. 22).

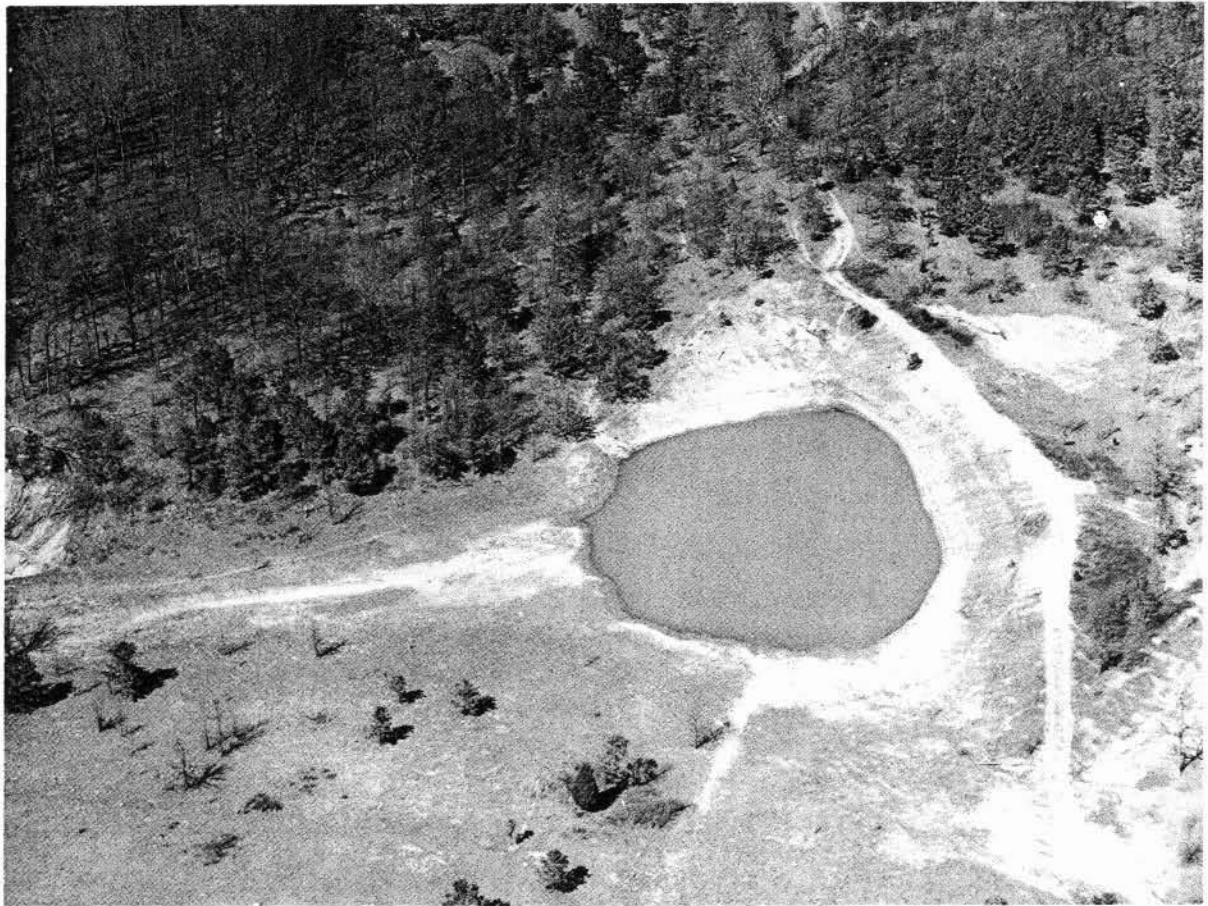
Figure 23

The potential for collapse of the bottom of this lake could probably have been predicted by a preconstruction investigation. Photo by Jerry D. Vineyard.

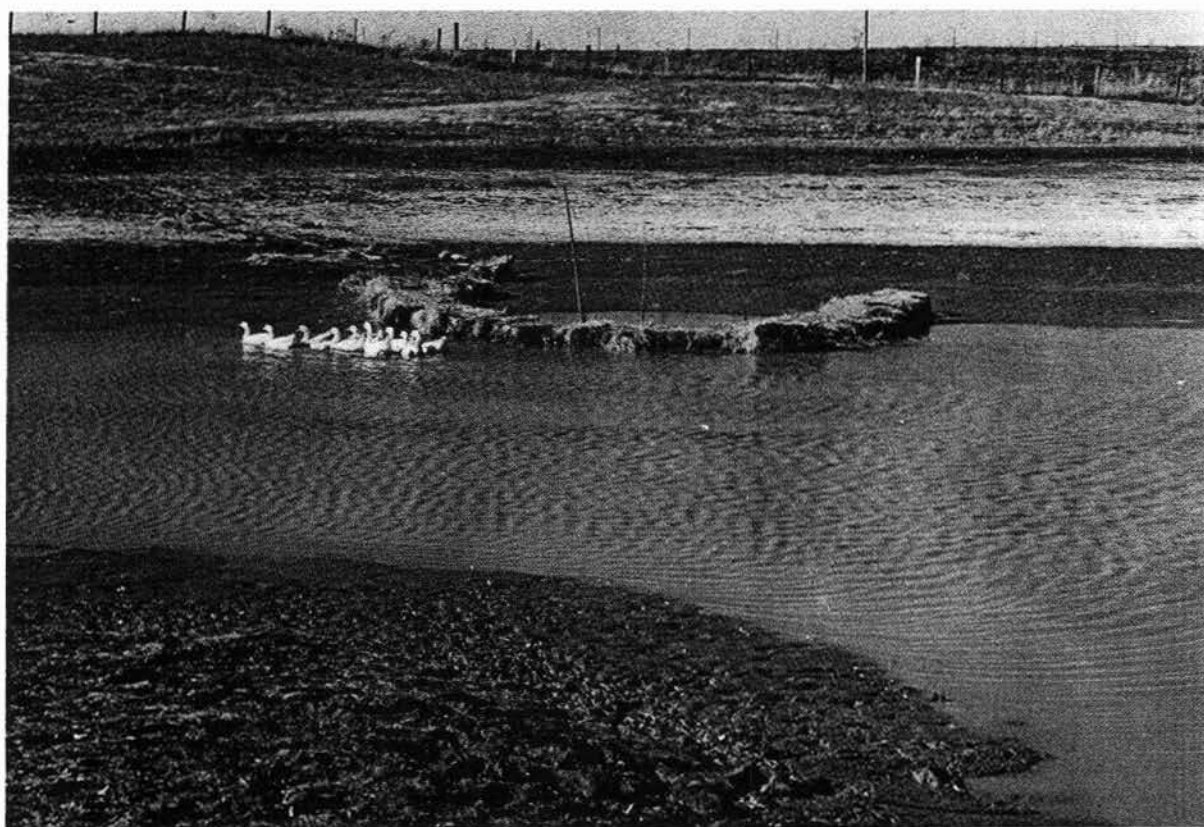
Figure 24

Siltation of a lake can quickly destroy its usefulness. Photo by Jerry D. Vineyard.
